To All Lamborghini Dealers and Licensed Service Point
From Customer Service Department
Subject Megafuse Replacement
Group LB824.9.37
Date 05.09.2007
Pages 6

Megafuse replacement

Murciélago (Coupè and Roadster) from VIN B72400 to VIN B82739.

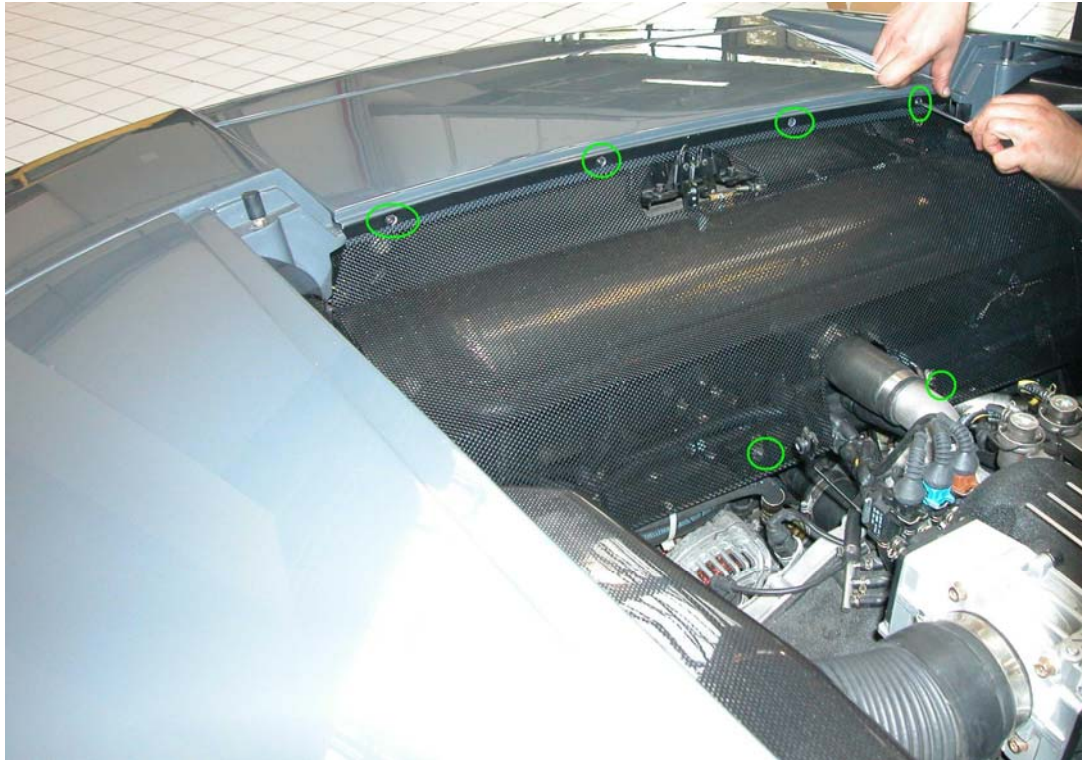
Pict. 1

- 1.1 Adopt all precautions to work safe and prevent car damages.
- 1.2 Disassemble the cover grill for the exhaust box removing the 6 screws as shown in picture 1.

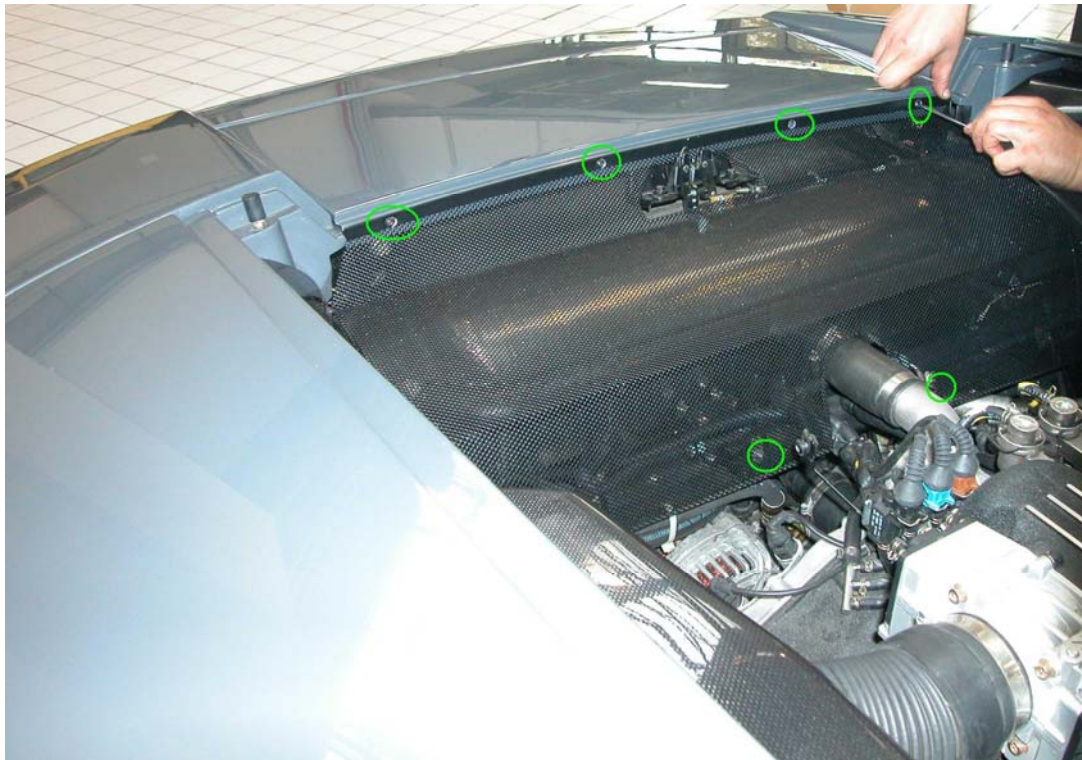
Fig.1

- 1.1 Adottate tutte le precauzioni per prevenire danneggiamenti alla vettura e per lavorare in sicurezza.
- 1.2 Smontare la griglia di copertura relativa allo scarico, rimuovendo le 6 viti come mostrato in figura 1.
