Subject Chain Tensioner Torque.

Aventador LP700 MY 2012 From VIN CLA0091 to VIN CLA00188.

Campaign Code: L834-A.05.11

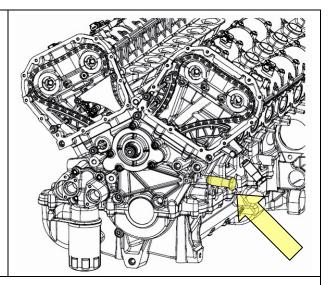
Check with a torque wrench that the value applied to the chain tensioner bolt is equal to **55Nm**, in case is lower tighten it under specification.

Prescribed torque: 55Nm.
