Subject Seat Heater Electric Pin For RHD Vehicles.

Seat heater electric pin inversion for RHD vehicles.

Lamborghini Aventador RHD version LP-700 My 2012 from Vin CLA00091 to CLA01058

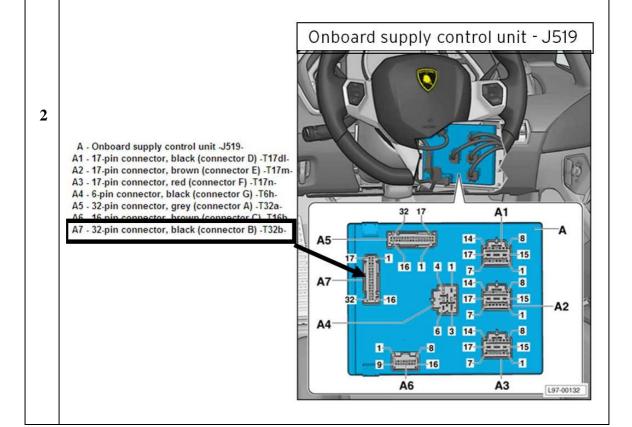
Remove the lower side dashboard (08 58 03) cover to access the BCM1 and identify the 32 pin black connector A7 as shown in the picture

Disconnect the black 32 pin connector from the BCM1 control unit – J519

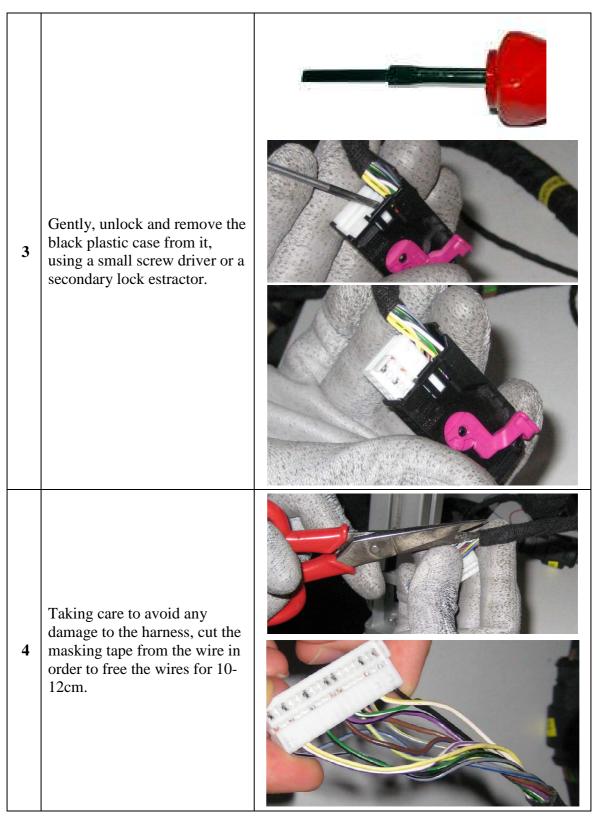
5 Identify the pin locations in positions 14 and 19

Using a generic connector pin estractor, gently draw out the No.14 terminal (white/yellow wire) and No.19 terminal (white/purple wire) from the 32 pin black connector and swap the two terminals.

Do not remove all terminals from the connector.

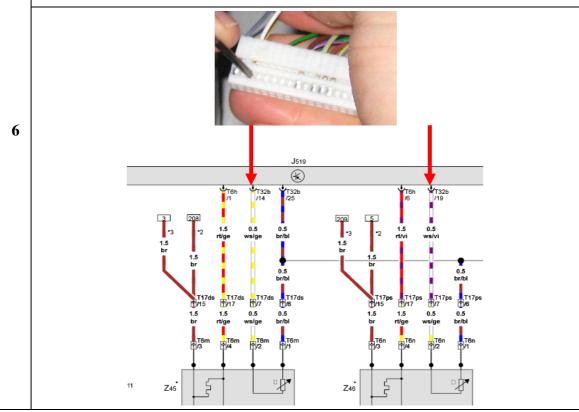
7	Bend the white-purple cable and fix it using masking tape, the as shown the picture.	
8	Cover all the harness with the masking tape.	
9	Put again the black plastic case on the 32 pin connector and fix it in the BCM1.	
10	Ensure that the connector is well fixed in its position.	
11	Reconnect the negative battery cable.	
12	Check that both left/right seat heaters fully operate well	
13	Do the electric windows learning procedure (104207).
