To All Lamborghini Dealers and Licensed Service Point.
From After Sales Department.
Subject Engine Crossbar Spacer Installation
Group 07.01.00
Date 27/07/12
Pages 5

Installation of engine crossbar.

Aventador LP 700 My 2012 from Vin CLA00091 to CLA00922

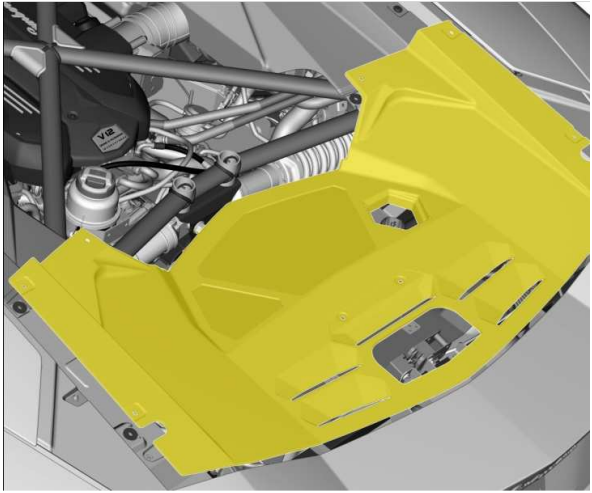
1	Operation to be performed rigorously at cold engine!
2	Open rear hood (082700)
3	<p>Remove rear engine bay Es- thetical cover (081303).</p>

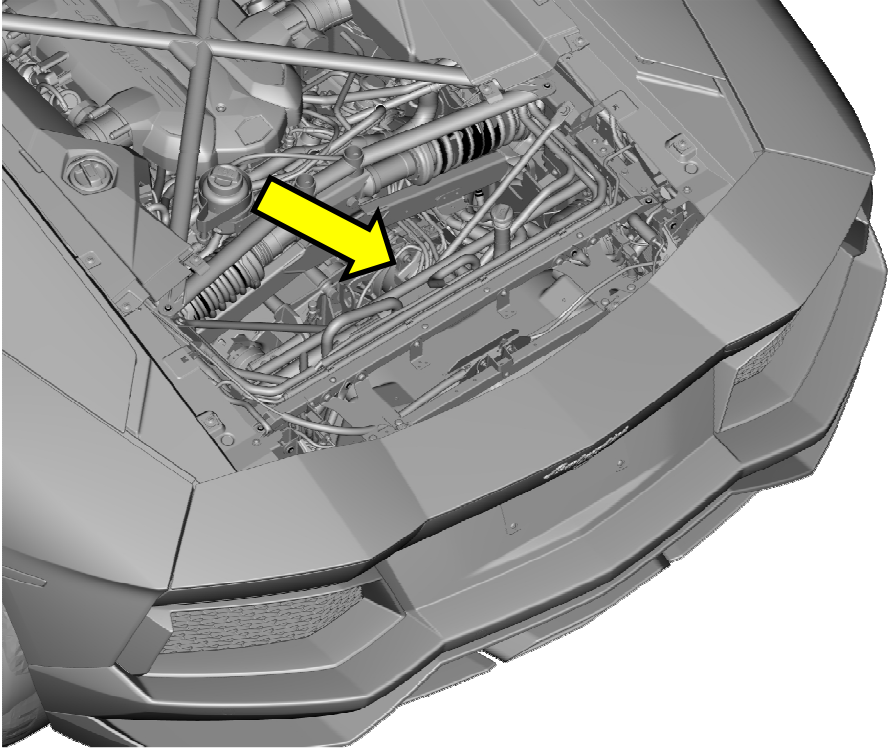
4	<p>Localize the working area</p>

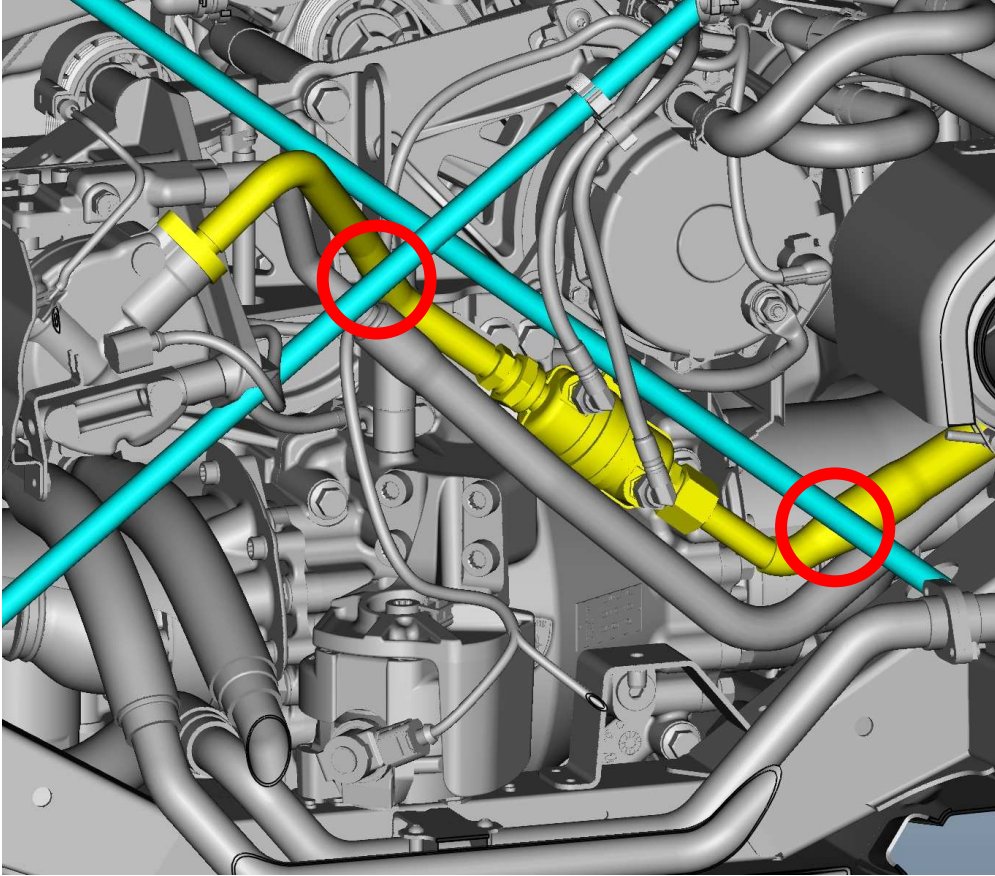
As a continuous product monitoring, Automobili Lamborghini Spa has found that in rare cases and under really extreme usage conditions a slight noise might be heard coming from engine bay.

<p>5</p>	<p>Localize the contact points between engine crossbars (cyan color) and Air conditioning hose (yellow) .</p>

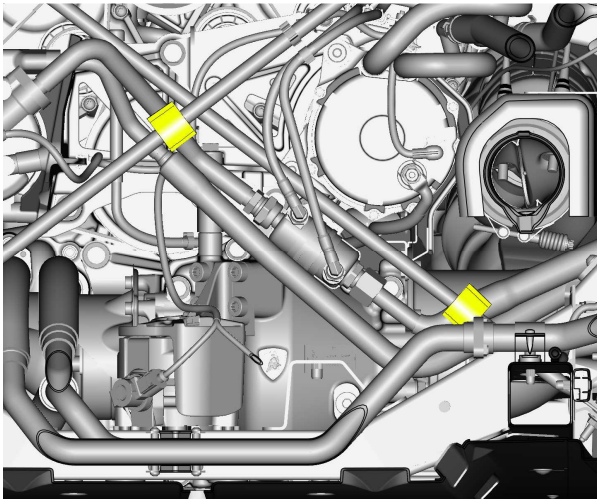
</p> <p>Fit for each of the 2 points of contact between engine crossbars and A/C hose a rubber spacers- N10761201</p> <p>Make the A/C hose approach to crossbar to ensure they may eventually touch each other in the centre of spacer.</p>

Install spacer on engine crossbar.
