L83X-  
A.09.14  
+  
L83X-  
A.10.14

**Subject**  
Air duct update.

All Lamborghini Model Aventador Coupè Roadster MY 12,13 and 14 from VIN **CLA00091** to **VIN ELA02533**.

As a result of continuous product monitoring, Automobili Lamborghini Spa has found that on some vehicles cooler air ducts may get deformed.

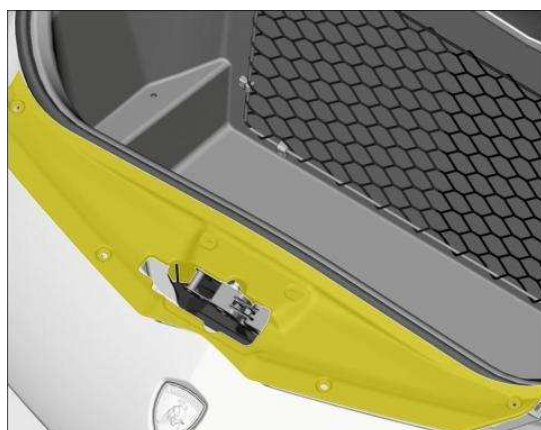
1. Secure vehicle to the lift appropriately before jacking in order to work safe from risks.
2. Trunk closing frame disassembly.

Remove 6 screws that fix front hood cover and then the cover itself.

Screw tightening.  
Torque: **2.5 Nm.**

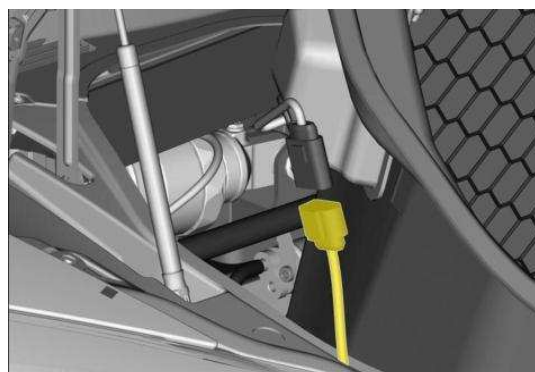
Lift trunk and disconnect plug from the 12V socket.

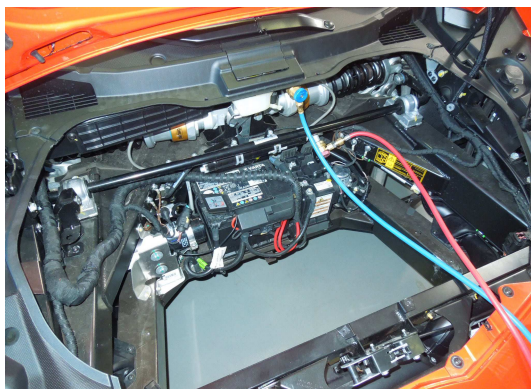
4. A/C system discharge.

- Connect hoses of A/C charging station to vehicle through HP and LP quick connectors.

- Operate phase of refrigerant fluid savage.

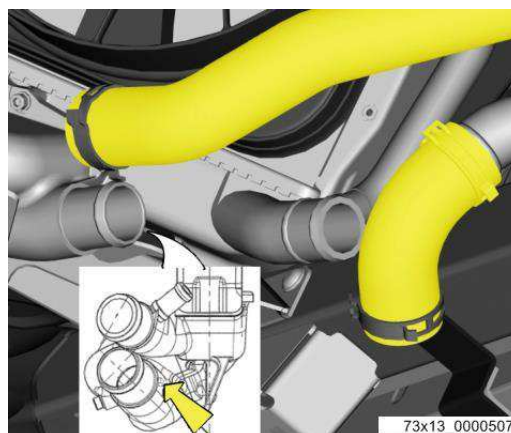
Open 2 cable clamps and extract 2 cooling pipes.

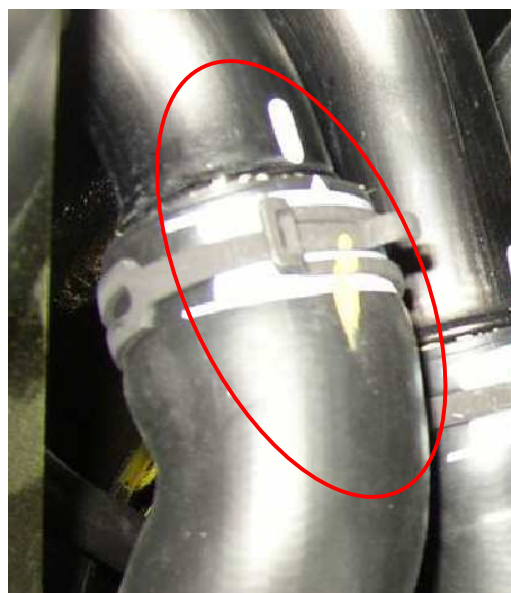
During reassembly align marks respectively present on radiator and pipe, to install component as it was in origin. **If any marks are present, use a marker pen to sign them before disassembly.**

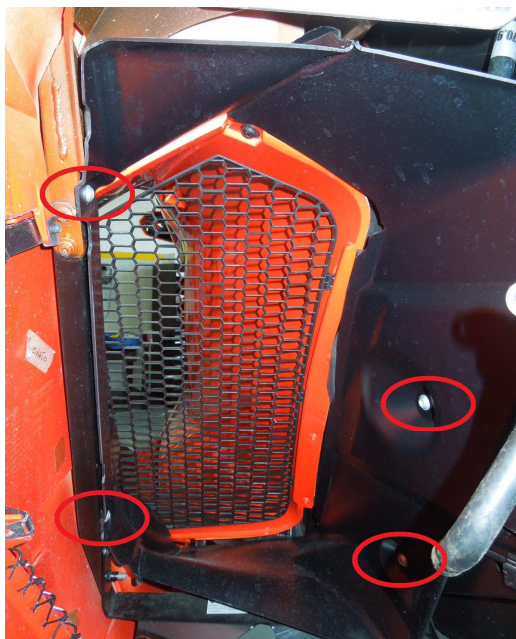
## 12. Air duct disassembly.

Remove 4 screws and take component off.

Screw tightening.  
Torque: **9Nm**

Replace air duct.

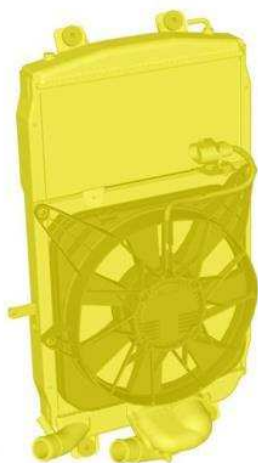
Now remove right radiator assembly that includes electric fan, cable clamp bracket, washers, spacers, buffers and condenser.
