To All Lamborghini Dealers and Licensed Service Point
From Customer Service Department
Subject Engine bonnet release cable routing
Group LB715.8.03
Attachments -
Date 16.10.2006
Pages 5

Engine bonnet release cable routing

All MY06 Gallardo Spyder from VIN G64126 to VIN G74360.

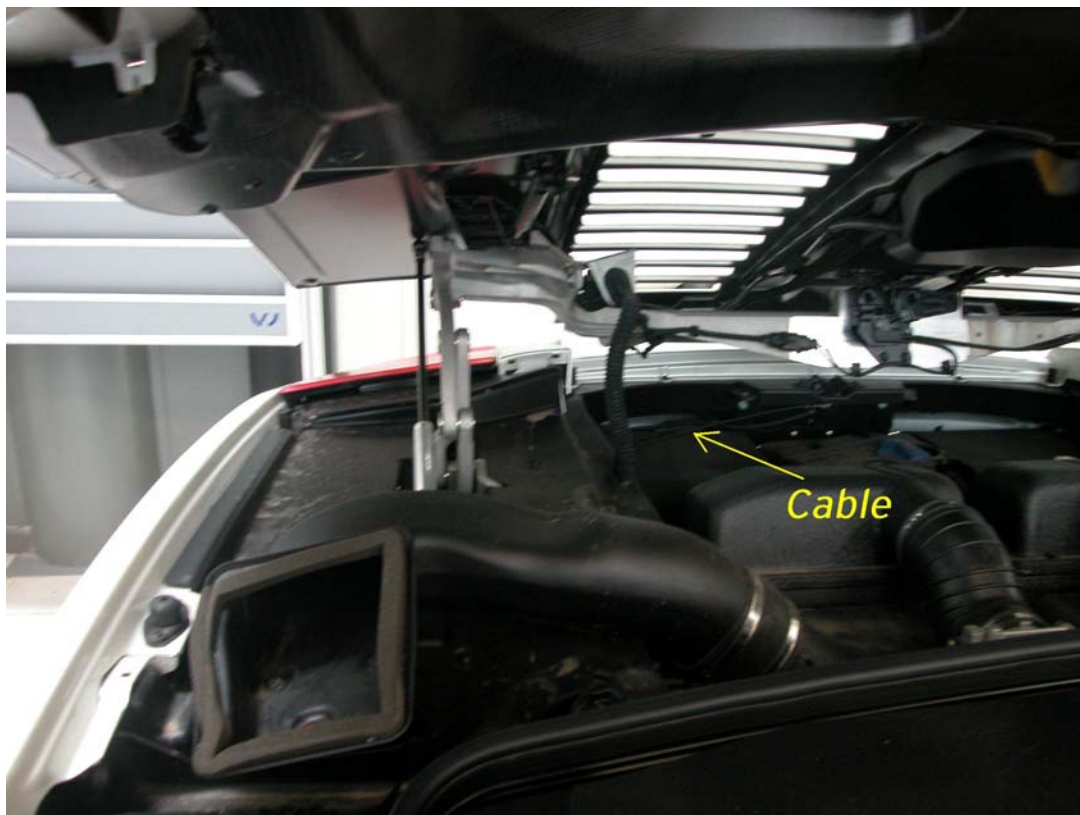
Pict. 1

- 1.1 Adopt all precautions to work safe and prevent car damages.
- 1.2 Open the engine bonnet in service position and check the opening cable routing near the frame of the car .

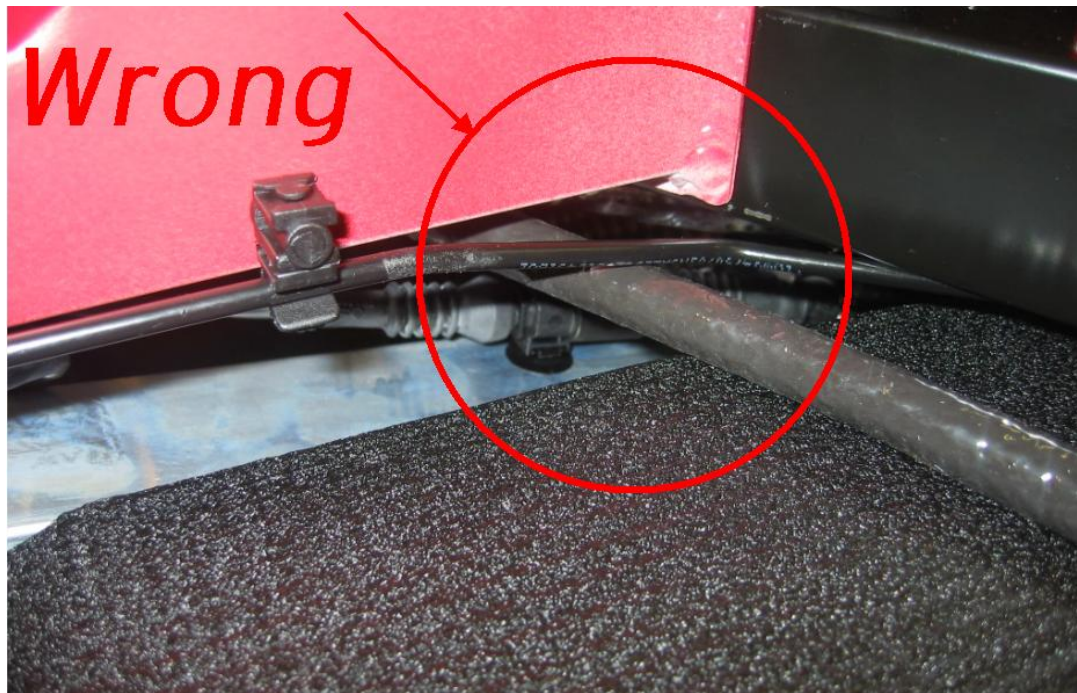
Pict. 2

The heat from the exhaust box could fuse the opening cable so it is necessary to check the routing of the cable.

- 1.3 The cable should not be in contact with the exhaust box, the wrong routing is shown in picture 2 and the correct routing in picture 3.

1.4 If the routing of the cable is not correct as shown in picture 2, please change the routing.
