From Customer Service Department Subject Heat protection opening cable

Group LB715.8.03

Heat protection on opening cable for the engine bonnet

All MY06 Gallardo Spyder from VIN 2623 to VIN 4118.

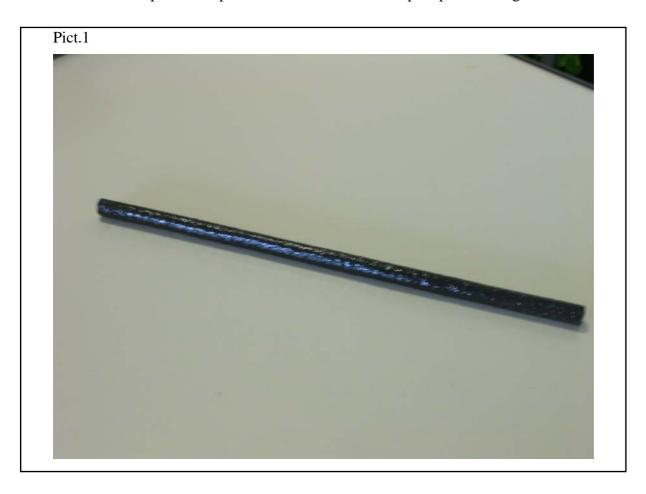
1.1 One heat protection p/n: **07L906099** available on spare parts catalogue.

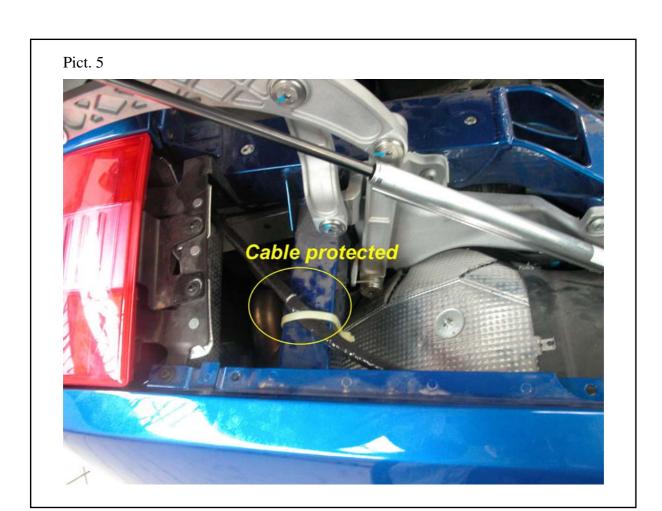
- **1.6** Insert the new heat protection on the cable.
- 1.7 Now the entire cable is protected from the engine's heat.
