To All Lamborghini Dealers and Licensed Service Point

Subject Auxiliary Electric Vacuum Pump Cover

Group 611.01.00 Date 02/08/2013

All Lamborghini Aventador LP 700 Coupe and Roadster MY 12 and 13 from VIN CLA0091 to VIN DLA01981.

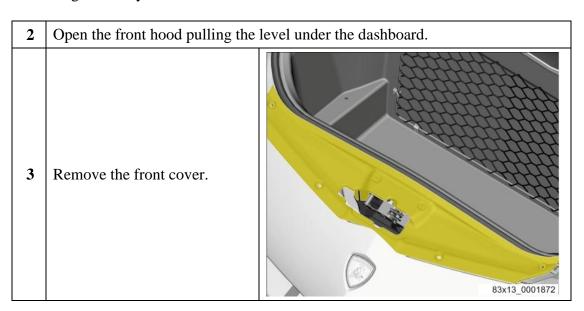
4	Unscrew the 4 screws which secures the trunk. Torque 8 Nm.	83x13_0001902
5	Lift the trunk and disconnect the 12V socket connector.	83x13_0001904
6	Remove the trunk.	83x13_0001905
