Service Bulletin

Bulletin No.: 12-08-51-002E

Subject: Spray-in Bed Liner General Information and Repair Procedures

Models: 2013-2014 Chevrolet Silverado HD 2500/3500 Series
2014 Chevrolet Silverado 1500
2015-2016 Chevrolet Colorado, Silverado
2013-2014 GMC Sierra HD 2500/3500 Series
2014 GMC Sierra 1500
2015-2016 GMC Canyon, Sierra
Equipped with Spray-in Bed Liner (RPO CGN, PDL)

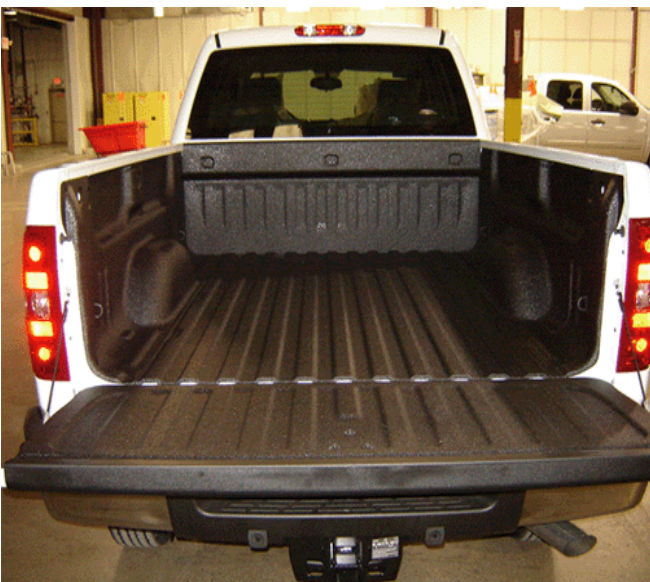
2968662

Entire bed

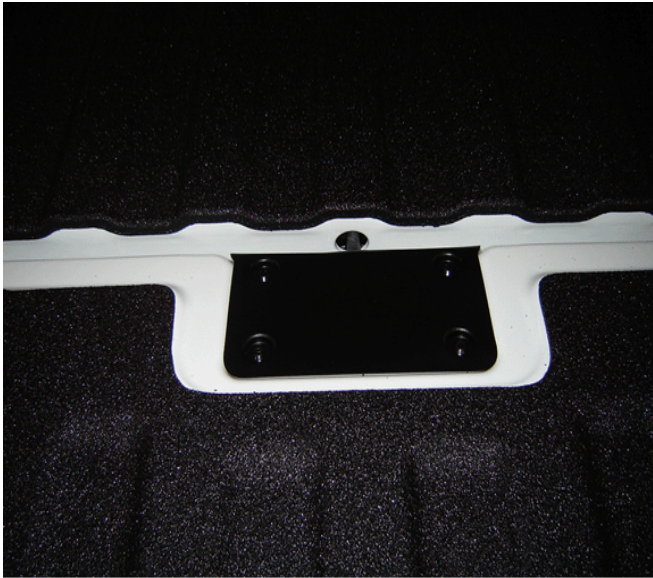
2968687

Bed floor (with rear camera access panel, gate open)

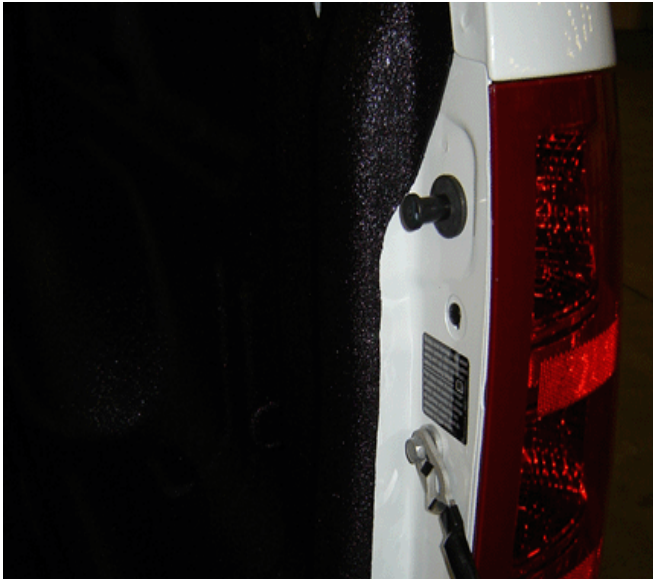
2968690

Tailgate opening view
