Service Bulletin

Subject: Front Seat Lateral Movement and/or Click Type Noise While Driving

Models: 2014 Chevrolet Silverado 1500
2014 GMC Sierra 1500

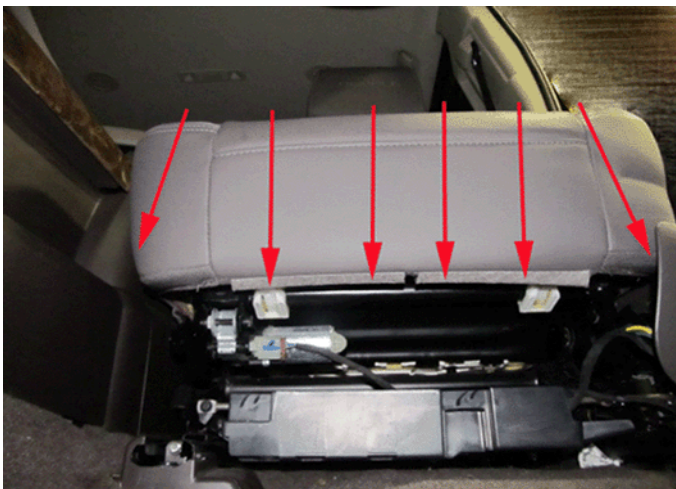
Note: It is not necessary to completely remove the seat cover and pad, only the side and front retainers need to be released. The rear of the cover can remain attached.

1. Partially remove the forward half of the lower seat cushion cover and pad on the affected seat (this procedure includes removing the seat assembly from the vehicle). Refer to Front Seat Cushion Cover and Pad Replacement in SI.

Place the seat assembly on a suitable work area. Use care to place the seat on a soft clean surface to prevent damage to the seat upholstery.

If installed previously, remove the two U-clips located in the front corners.
