# Service Bulletin

**Subject:** 5th Wheel Or Camper Wiring Harness Location

**Models:** 2015-2016 Chevrolet Silverado  
2015-2016 GMC Sierra  
With 5th Wheel / Camper Harness (RPO UY2)

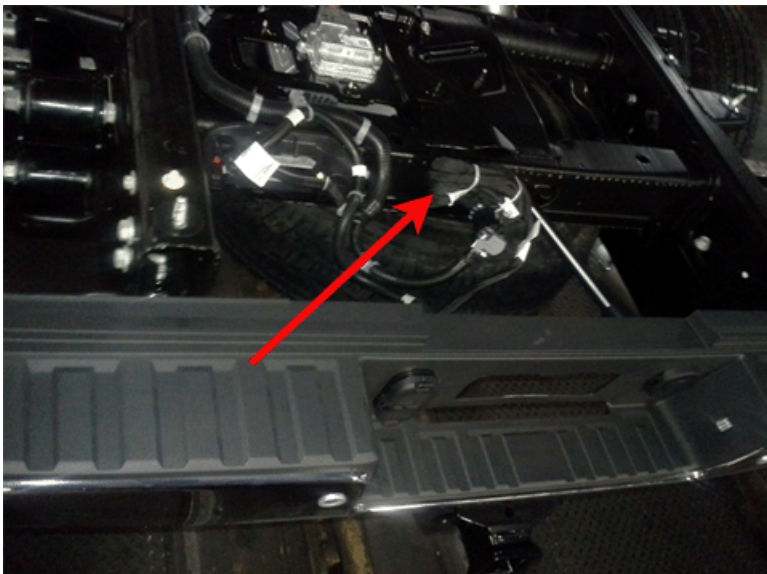
Starting with the 2015 model year, the location has changed to the rear of the pickup box – forward of the rear bumper and attached to the rear frame cross member, as shown below. NOTE: Picture below was taken with the pickup box removed.
