Bulletin No.: PIC6148

Service Bulletin

Subject: Possible damage to High voltage connector

Models: 2016 Chevrolet Volt

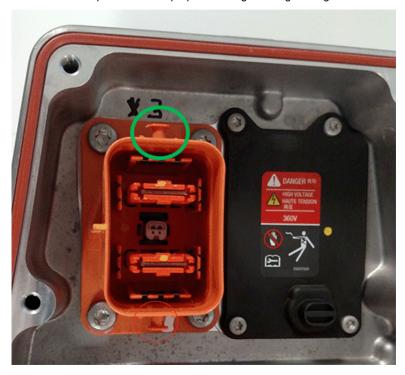
During service of the high voltage battery the tabs on X3 could be damaged.

Please review SI procedures for proper handling of all high voltage connections.

Please make sure to use caution when removing and installing this connector.

Warning: If the Tabs on the connector are broken the Hybrid/EV Battery Contactor Assembly (A28) would need to be replaced, the connector is not serviced separately.

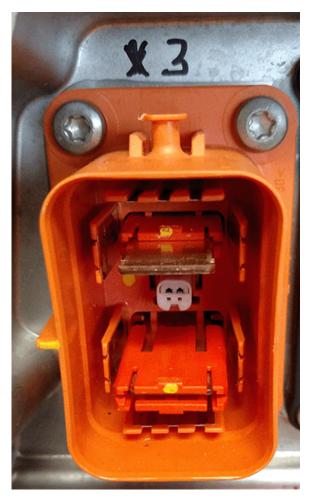
The terminal protectors could stick in the down position. Make sure they are pulled out, if they are stuck down you can use a plastic trim stick or insulated screwdriver.

Connectors need to be square to each other before the cam lock is engaged.

Push the cable onto Hybrid/EV Battery Contactor Assembly (A28) connector until the lever begins to rotate, initiating engagement. After that, the lever can be used to complete the connection until the locks click for both the connector and the lever, indicating completion. If force seems excessive, do not proceed as the connector on the Hybrid/EV Battery Contactor Assembly (A28) may break.
