# Service Bulletin

## PRELIMINARY INFORMATION

**Subject:** Water Leak In Rear Floor Area

**Models:** 2011 - 2015 Chevrolet Camaro Convertible

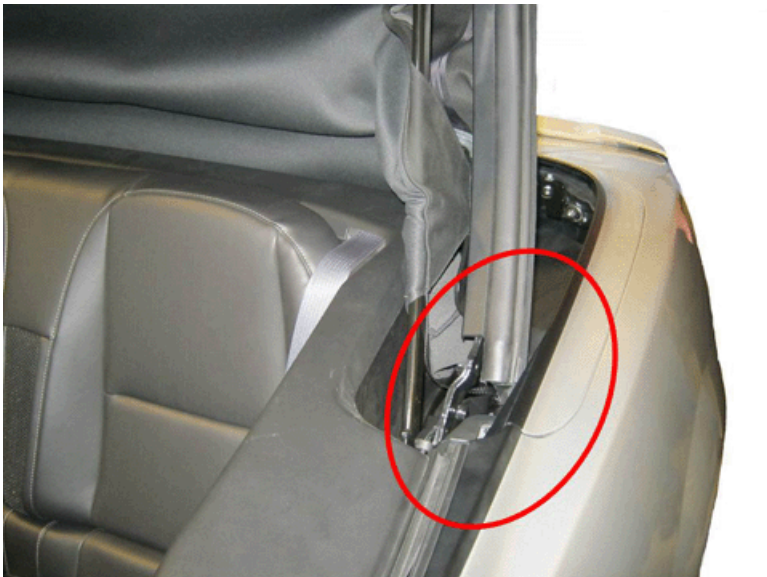
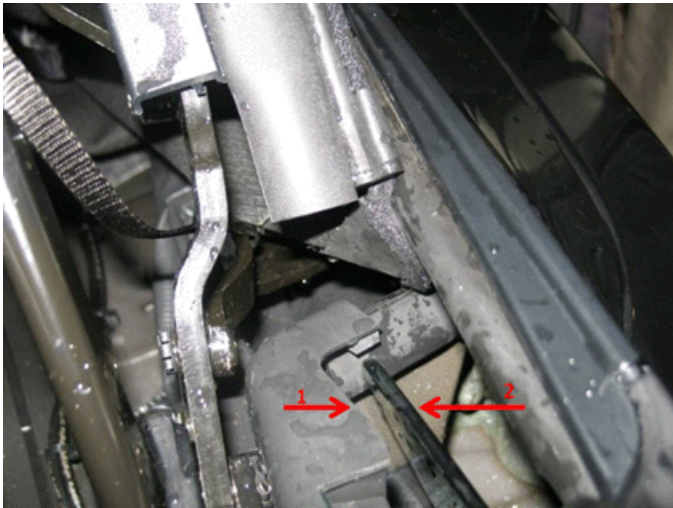
Everything to the inboard side of the rear quarter glass is considered a dry area; water should not be in the "dry area" (1). Everything to the outboard side of the rear quarter glass is considered the "wet area" (2). It is acceptable and by design that water is present on the outboard side of the rear quarter glass and in the area of the quarter glass regulator that the front drain spills into.

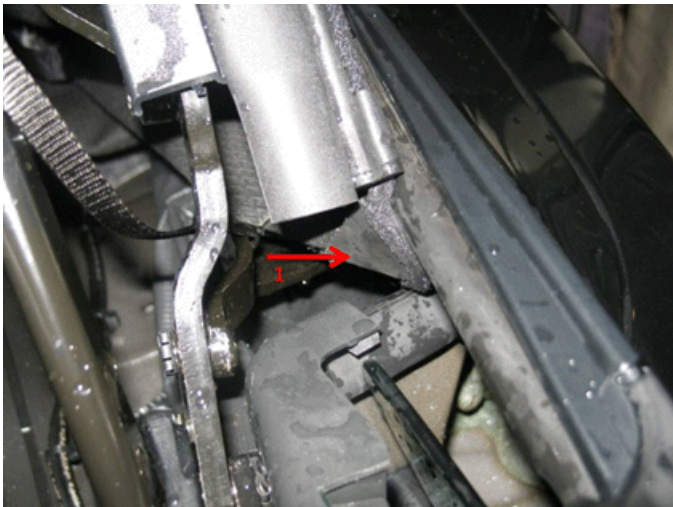
Correct Position

The water diverter that is sewn into the canvas top may be on the "dry side" of the vehicle.

With the top in the closed and latched position, have an assistant stand outside of the vehicle and run water over the top of the car. While sitting in the back seat, lift the headliner up in the area behind the quarter window. With the water running, look past the headliner to confirm the water is draining into the water management bag. If the water doesn't drain into the water management bag verify that the plastic water diverter (1) that is sewn into the top is on the "wet side" of the trim. The two pictures below show this plastic diverter in both the correct and incorrect positions.

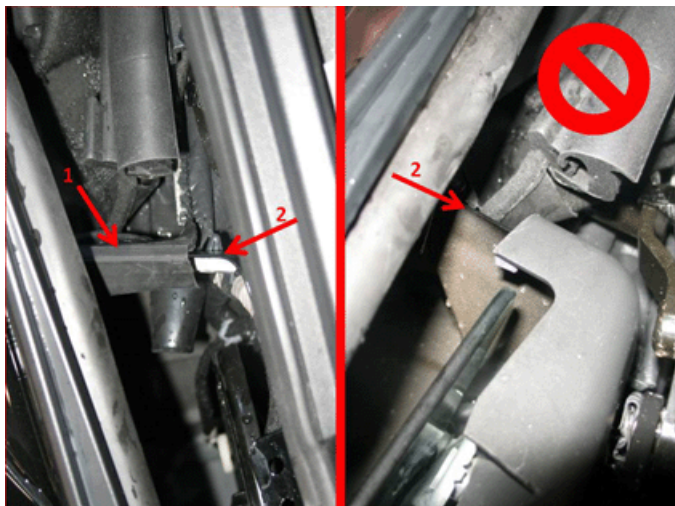
Verify the front of the water management bag is properly attached to the body sheet metal panel. In the photo below, the water bag (1) is correctly positioned and attached to the vehicle's sheet metal (2) in the LH photo. The RH photo shows the bag where it is not attached (2) to the sheet metal of the vehicle.

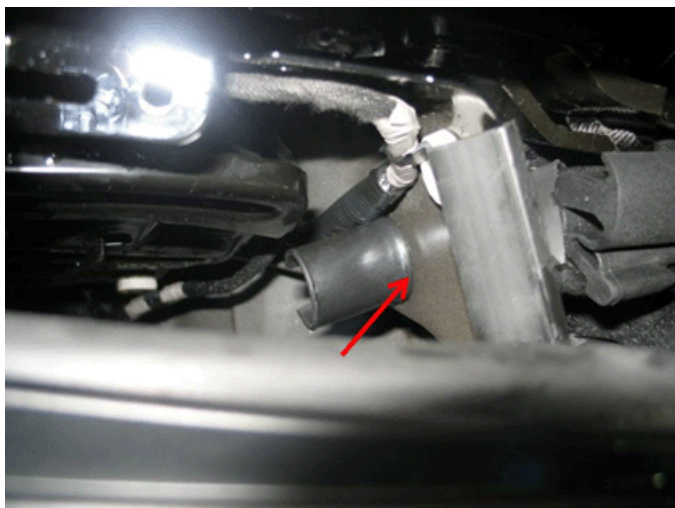
Inspect the front drains for proper installation. This can be difficult to confirm due to the limited space and limited visibility in this area. The following picture illustrates a drain that is not fully seated in position. The front drains are difficult to install and may not be fully seated in the body sheet metal panel. If the front drains were previously dislodged, it is possible that the drain may have taken set and will not remain in place. Replace the water management bag ONLY if the drain will not stay in place. Water management bag replacement can only be performed after removing the top from the vehicle.

**Important:** It is normal for the quarter glass window to make light contact with this drain when the window is rolled down. Modifications to the upper lip of the drain can be made if cycling the window results in the drain tube being pushed out of the sheet metal. An opening on the top of the drain tube that resembles the opening on the bottom of the tube can be made for this condition. The drain will not fall out of the body sheet metal unless the drain is not fully seated.

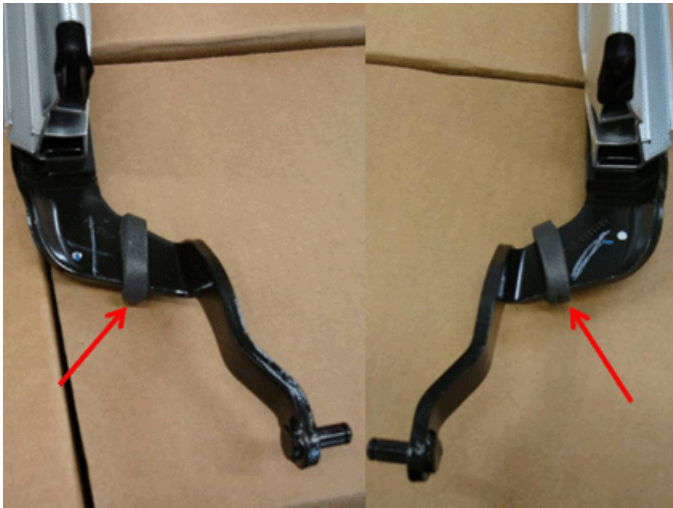
Verify the presence and proper location of the foam tape on both the left and right side 5 bow brackets, as shown in the following photograph.

By design, water runs along the folding top and down to the 5 bow and 5 bow brackets. It runs down until it hits the pieces of foam. Once it reaches this foam, it can no longer wick down the brackets and into the vehicle. Instead, the water drips off the brackets, directly into the water bag located directly below these foam pieces. If the foam pieces are damaged or missing, they will need to be replaced. If the foam pieces are still present, an additional layer of foam tape may be added on top of the existing foam pieces. This will make the foam stand taller, preventing water from overcoming the height of the foam. This peel-and-stick foam tape can be purchased at any local home improvement or hardware store.

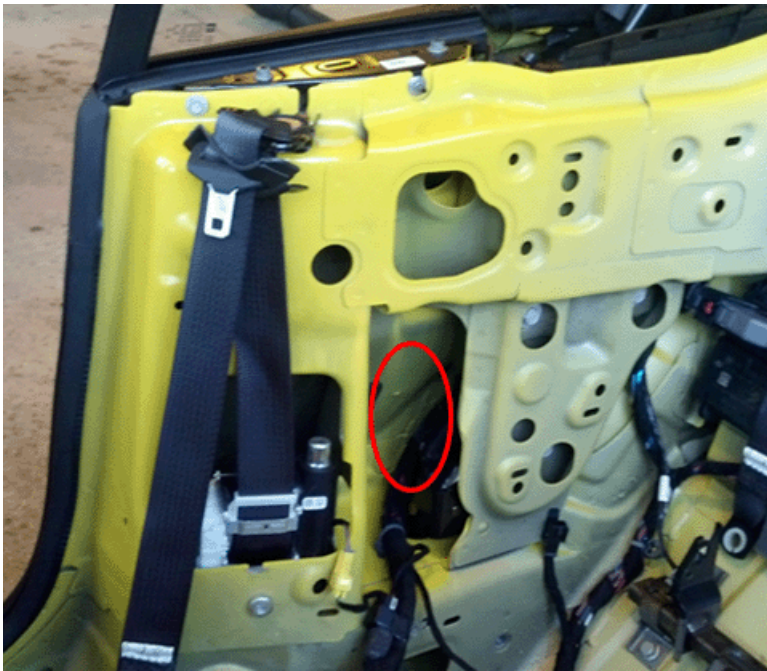
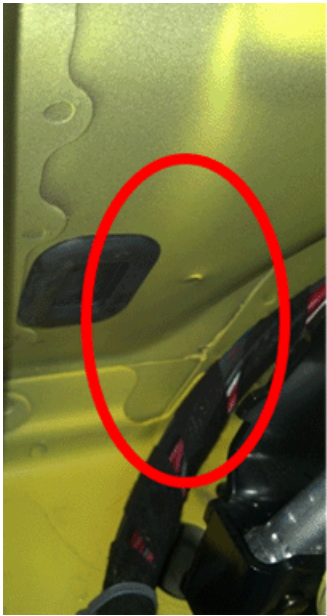
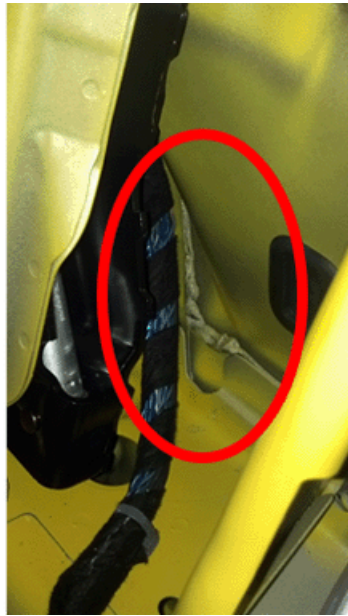
Inspect the area of the vehicle where the folding top frame is fastened in place. There may be water leaking into the vehicle between 2 pieces of sheet metal in the quarter panel area. When comparing the body seams on both RH and LH sides of the vehicle, it may be noticed that there is visible seam sealer protruding from the body seams on only one side of the vehicle. If there is no visible seam sealer on the side of the vehicle that has the leak, this may be the cause for the concern. The first photograph below shows the area in question. The second photo shows a close up view of the circled area and the potential leak in the body seam. The LH side of the photo shows a body seam that has not been properly sealed. The RH side of the photo shows a body seam that has been properly sealed.
