FORD:

2015-2017 Edge

ISSUE

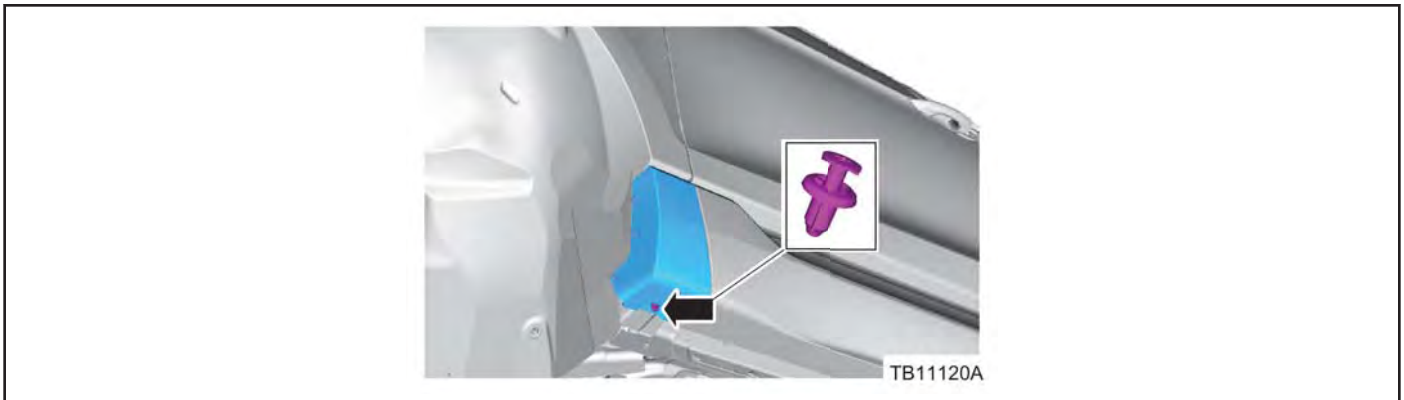
Figure 1 - Article 17-0056

1. Raise the vehicle. Refer to Workshop Manual (WSM), Section 100-02.
2. Remove and discard the attachment lower retainers from the left and right side rocker panel moulding end caps located behind the front tires. (Figure 1)

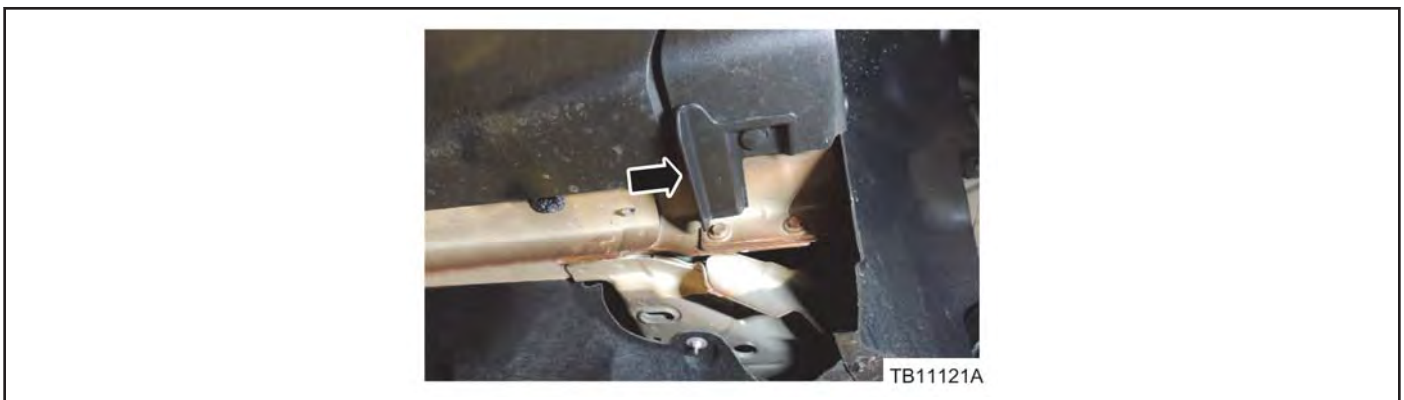
Figure 2 - Article 17-0056

3. Install the mini mud flaps under the rocker panel moulding end caps using a new attachment lower retainer. (Figure 2)
