Service Bulletin

Subject: Exhaust Rattle Noise Originating from Rear of Vehicle

Brand:	Model:	Model Year:		VIN:		Engine:	Transmission:
		from	to	from	to		
Chevrolet	Camaro	2016	2017			LT1 or LGX	All

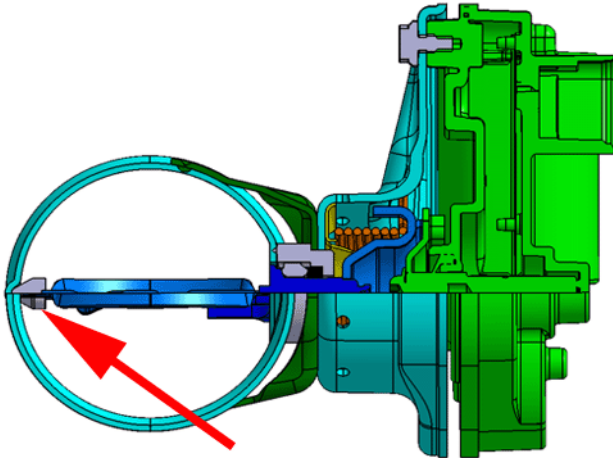
Involved Region or Country	North America, Europe, Israel, Middle East, Korea, Russia, South America, China
Additional Options (RPO)	Equipped with Performance Exhaust RPO NPP
Condition	Some customers may comment on an exhaust rattle originating from the rear of the vehicle.
Cause

<p>This may be caused by the ceramic pin on the exhaust valve.</p>

If you encounter a vehicle with the above concern, complete the following steps to bond the ceramic pin to the valve:
