TECHNICAL SERVICE BULLETIN

Water Stains On Headliner

17-2218

Ford
2013-2018 Escape
2013-2018 C-MAX Hybrid
2013-2018 Focus

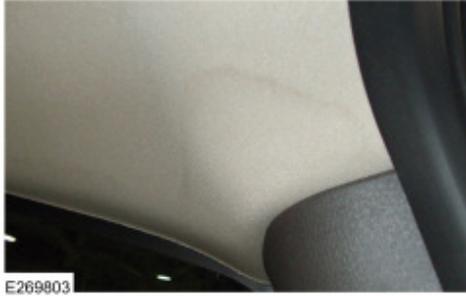
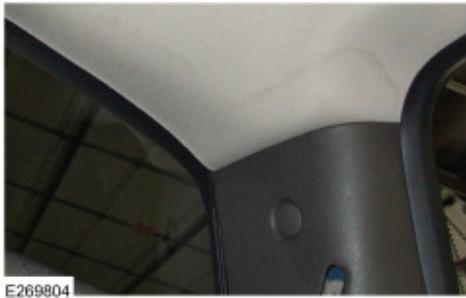
Figure 1

- Does the headliner have water stains?
 - Yes - proceed to Step 2.
 - No - this article does not apply.
- Fully open all vehicle doors.
- Identify the area(s) of the headliner to be cleaned. (Figures 1-2)

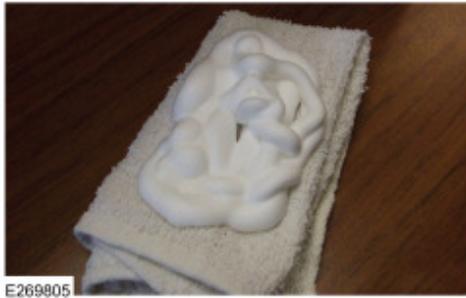
Figure 3

4. Saturate a clean white cotton towel with water and wring out excess water.
 - (1). In areas with hard water, use of distilled water is recommended.
5. Apply a significant amount of Motorcraft® ZC-54 Professional Strength Carpet and Upholstery Cleaner or equivalent to the towel. (Figure 3)
 - (1). Follow all manufacturer's product handling recommendations.

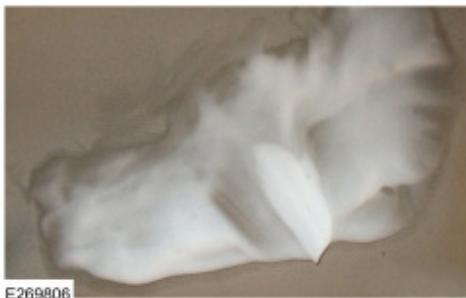
Figure 4

6. Apply a layer of Motorcraft® ZC-54 Professional Strength Carpet and Upholstery Cleaner or equivalent to the water stained area(s) of the headliner and allow to soak for one minute. (Figure 4)

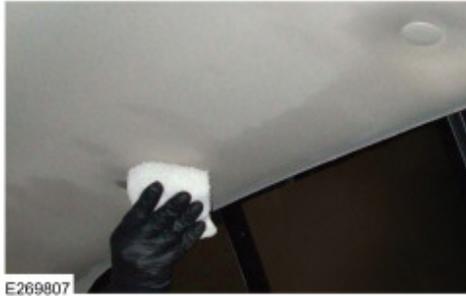
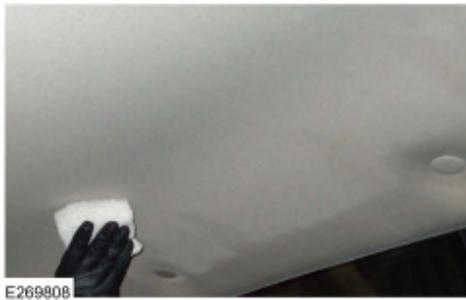
Figure 5

7. Starting at the outer edge of the headliner work the towel in one direction toward the center of the headliner. Make sure to use even pressure to maintain a dry edge. (Figures 5-6)
