Service Bulletin

Subject: Rear 60% Seatback Locked in Down Position When Folded, Will Not Return to Upright Position

Brand:	Model:	Model Year:		VIN:		Engine:	Transmission:
		from	to	from	to		
Buick	Encore	2013	2016			All	All
Chevrolet	Trax	2013	2016				
Opel	Mokka	2013	2016

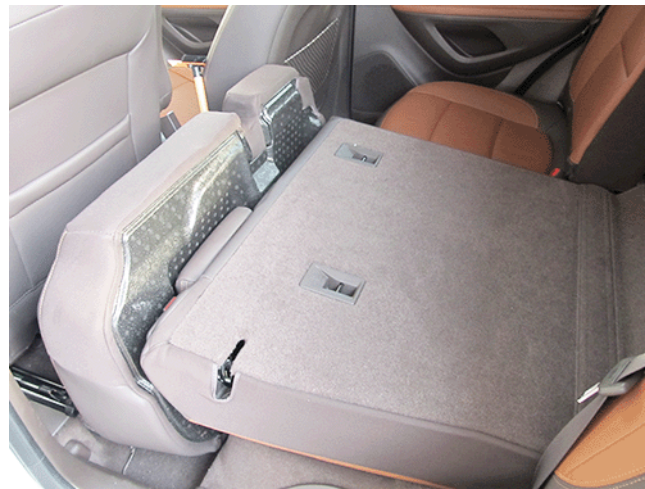
Some customers may comment that after folding the 60% seatback, it is locked in the down position and will not return to upright.
