## TECHNICAL SERVICE BULLETIN

### 2017 Driver's Power Seat Function Inoperative - Built On Or Before 12-Jun-2017

18-2025

<b>Ford</b> 2017 Fusion
<b>Lincoln</b> 2017 MKZ

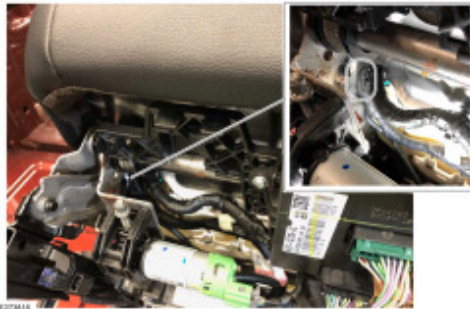
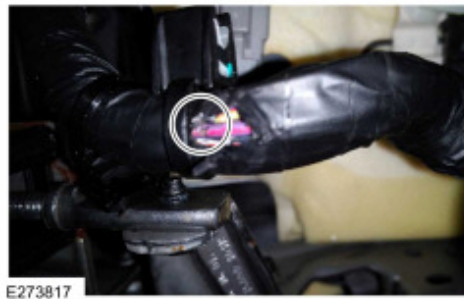
1. Check the vehicle build date. Was the vehicle built on or before 12-Jun-2017?
  - (1). Yes - proceed to Step 2.
  - (2). No – this article does not apply.
2. Visually inspect the seat wiring harness by looking from the front, under the driver's seat. When looking from the front under the seat the chafe point is located on the left side and is rubbing on the seat adjustment framing. Is there chafing to the wire harness? (Figures 1 - 2)
  - (1). Yes - proceed to Step 3.
  - (2). No – this article does not apply. Refer to Workshop Manual (WSM), Section 501-10.

3. Remove the seat. Refer to WSM, Section 501-10.
4. Repair the wire concern. Refer to cell 5 in the Wiring Diagram (WD). The wire harness should also be wrapped with Coroplast wire harness tape or equivalent available from the Rotunda Technician Tool Program (RTTP).
5. Relocate the wire harness clip from the seat frame and attached it to the track sinuous wire. (Figures 3 - 4)
