## SERVICE BULLETIN

**APPLICABILITY:** 2001~07MY Legacy/Outback H-6  
 2003~08MY Forester 2.5L N/A and Turbo  
 2009~13MY Forester N/A  
 2004~11MY Impreza 2.5L N/A

**NUMBER:** 04-13-09R  
**DATE:** 12/14/09  
**REVISED:** 06/17/15

**SUBJECT:** Power Steering Pump Relief Valve

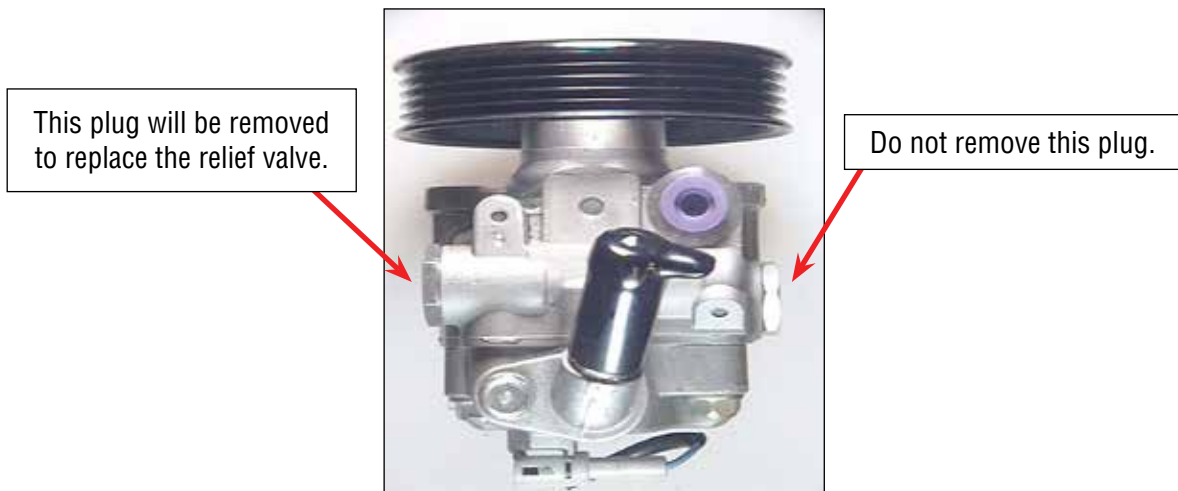
- Park the vehicle on a dry solid surface (concrete preferred). With the engine idling, transmission in park or neutral with the parking brake applied, turn the steering wheel to the full right or left position. If the noise is heard, replace the relief valve.

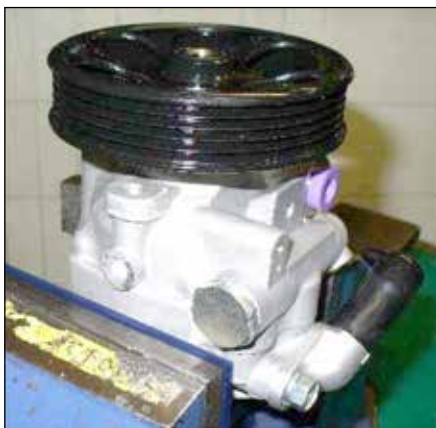
- Remove the power steering pump; refer to the applicable service manual.

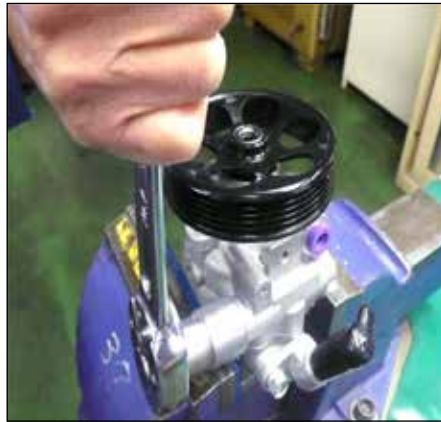
- Place the power steering pump in a vise.

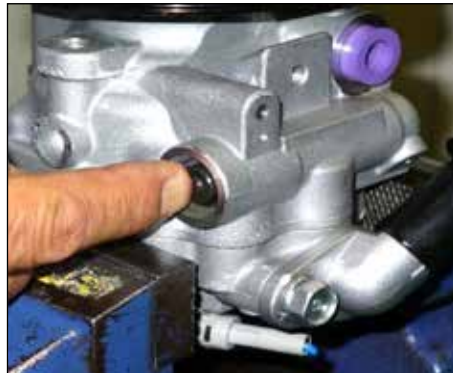
- Install a new relief valve.
