# TECHNICAL SERVICE BULLETIN

## Steering Gear Clatter Noise Over Bumps On Extremely Rough Road Surfaces

**18-2392**  
21 December  
2018

Lincoln 2015-2019 MKC
--------------------------

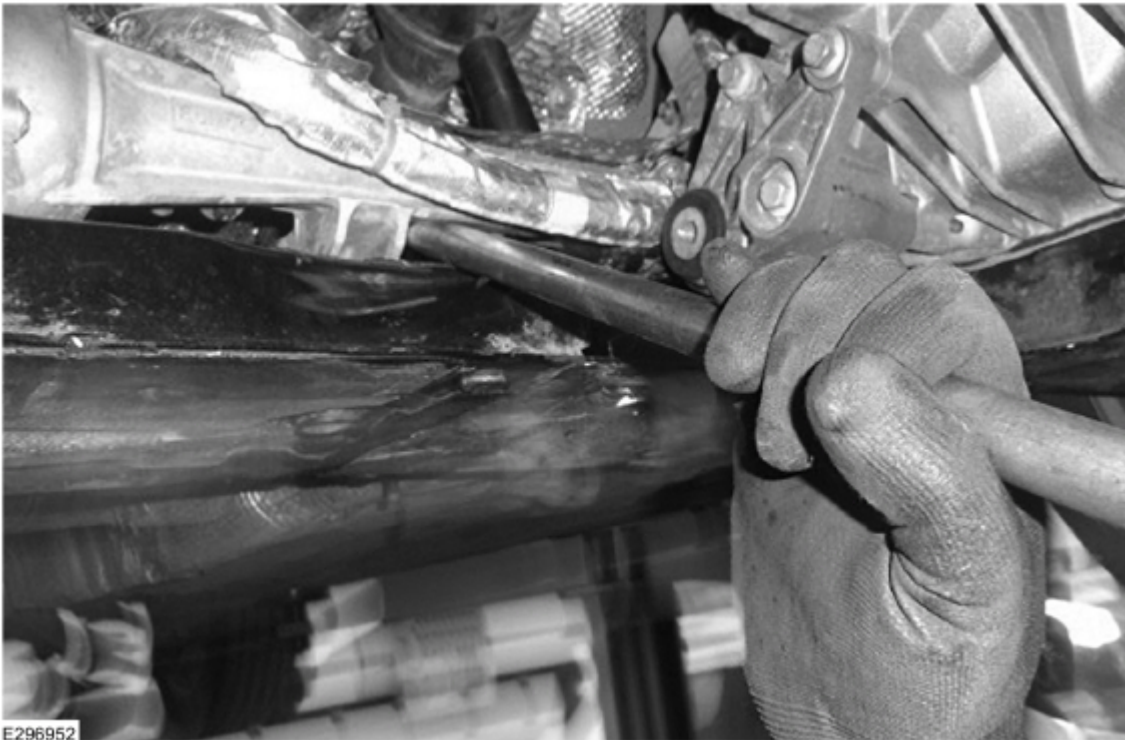
Figure 6

**10.** Tighten only the central bolt. (Figures 6 - 7)

- (1). Step 1: Tighten to 110 Nm 82 (lb-ft)
- (2). Step 2: Loosen 360°
- (3). Step 3: Tighten to 56 Nm (42 lb-ft)
- (4). Step 4: Tighten 180°
