### PIC6142A Burning Odor on Volts When Operating in Extended Range, Hold, or Mountain Modes

Brand:	Model:	Model Years:	VIN:		Engine:	Transmissions:
			from	to		
Chevrolet	Volt	2016	All	All	All	All

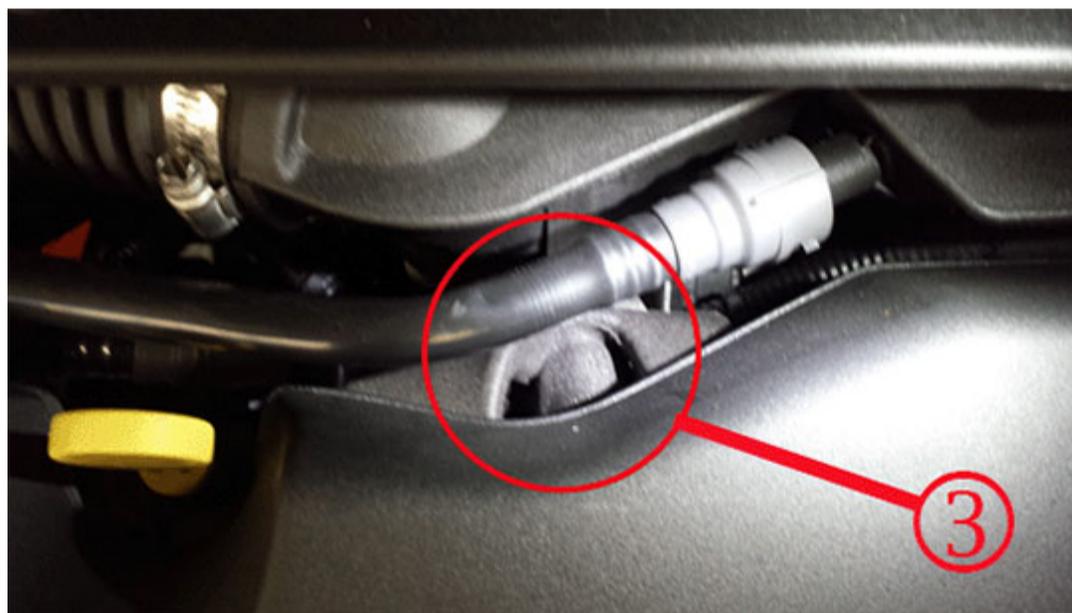
##### **Engine Cover Foam not installed correctly**

**3) Foam installed folded over, contacting the line**

**Please inspect the Engine cover and Compare to the pictures to see if the foam is folded.**

- 1) If the Foam is deformed then replace the cover.**
- 2) If a burning odor was noted replace the cabin filter also.**

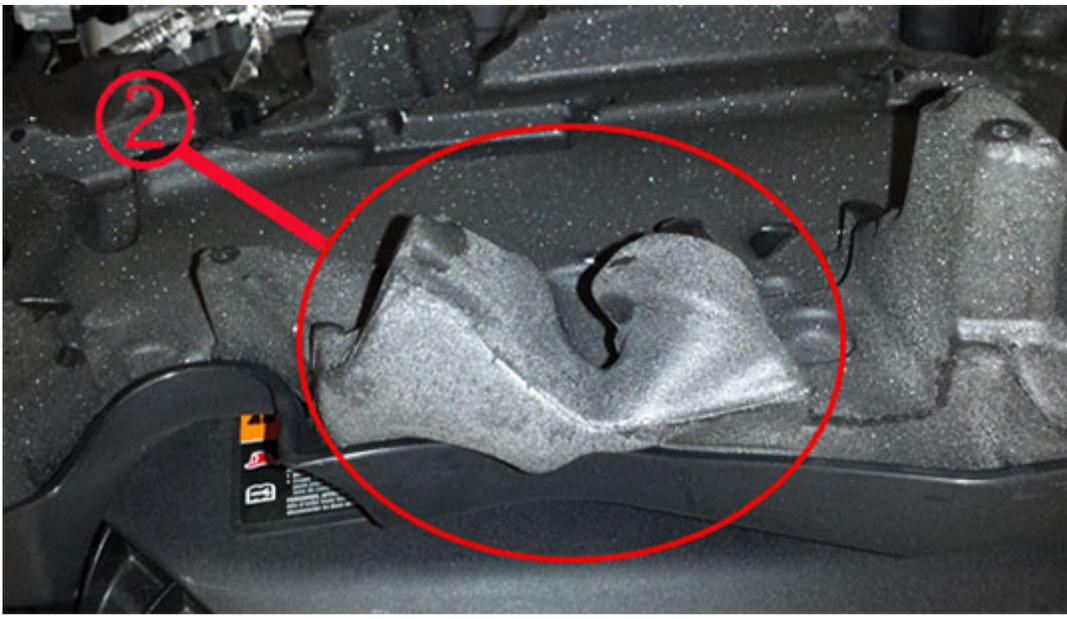
**2) Foam is Deformed from heat**
