# **Preliminary Information**

# PIT5363E Click or Tick Noise Heard Inside Cab with Engine Running

Brand:	Model:	Model Years:	VIN:		Engine	Transmissions:
			from	to	Engine:	Hansinissions.
Chevrolet	Colorado	2015 - 2019	All	All	All	All
GMC	Canyon	2015 - 2019	All	All	All	All

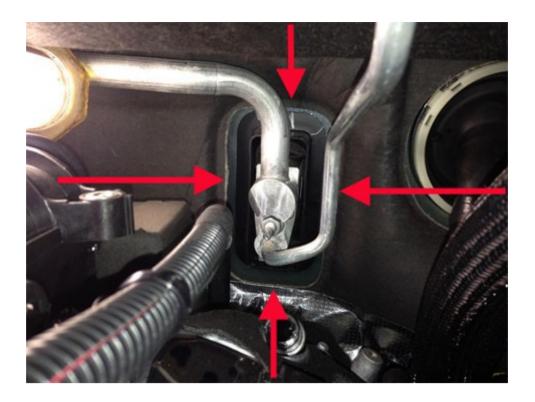
**Seal Missing**

During vehicle build a possibly exists that an acoustic seal was knocked out of place during assembly.

With this acoustic seal dislodged or missing the High Pressure Fuel pump tick / click noise can be heard easily inside the cab of the truck.

If the seal is missing replace it with one from Kit Part Number 23135690. Reference the Blower Upper Case Replacement section of SI to assist with seal replacement.
