**87-18-08 - Air Conditioning, Cleaning of the R1234yf Refrigerant Circuit (U.S. Only)**

Release date: 6/14/2019

Debris can be dispersed throughout the refrigerant circuit after A/C component damage. In order to maintain A/C operating efficiency, it is important to flush the refrigerant circuit after A/C component repairs.

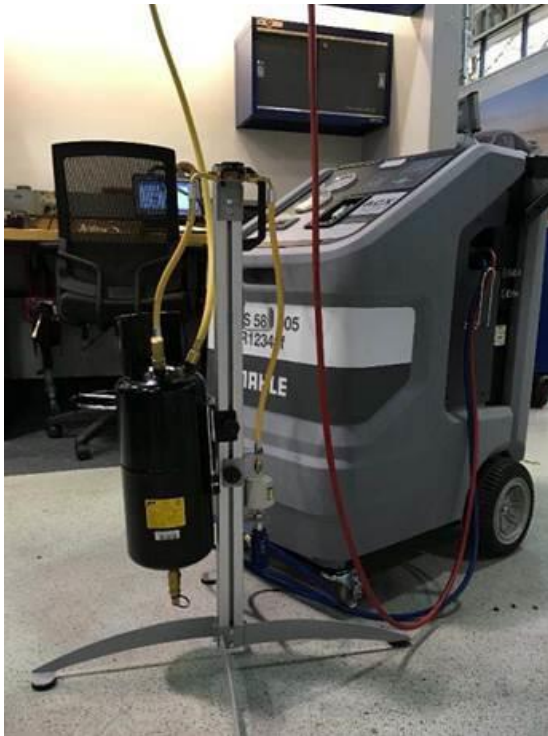
**Figure 1.** The VAS581005 Air Conditioning Service System with Flushing Device.

Use the MAHLE R1234yf A/C Service Unit VAS581005 and the R1234yf Flush Kit RTI360831040 (Figure 1).

Used for effective refrigerant handling and air conditioning circuit flushing after air conditioning component failure.

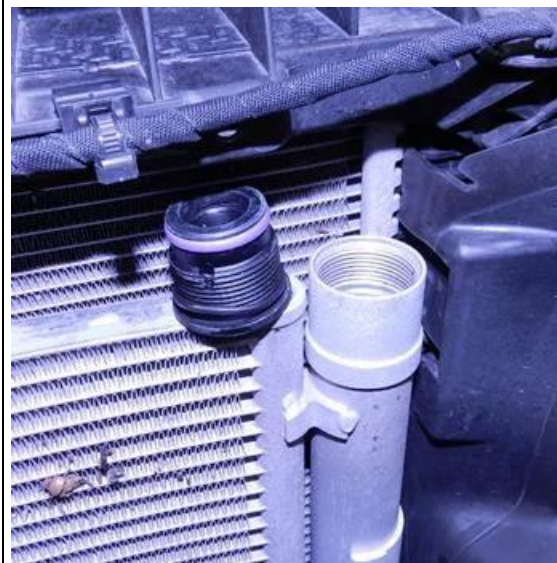
**Figure 2. Location of the Receiver Drier**

6. Remove receiver drier cartridge.

Reinstall cartridge cap with O-ring. (Figure 2)

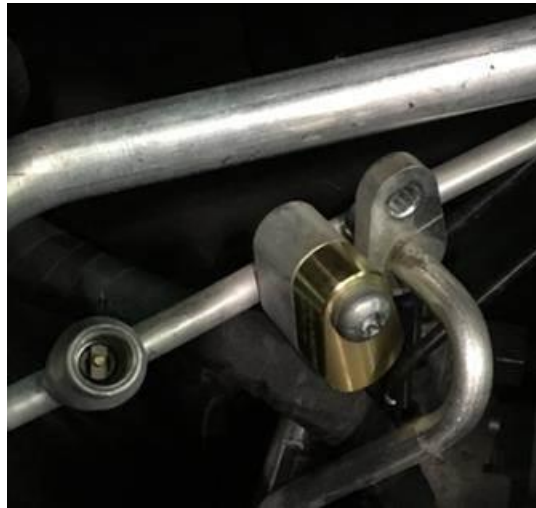
Figure 4a. Installation of high side rear A/C Line connection block adaptor VAS 6338/63

(Atlas Only) The rear A/C unit refrigerant lines must be disconnected and replaced with block off adaptors VAS 6338/5 and VAS 6338/63 before performing the front A/C unit flush procedure.

8. (Atlas Only) Disconnect rear refrigerant lines and install adaptors VAS 6338/5 and VAS 6338/63 as shown. (Figure 4a, 4b)

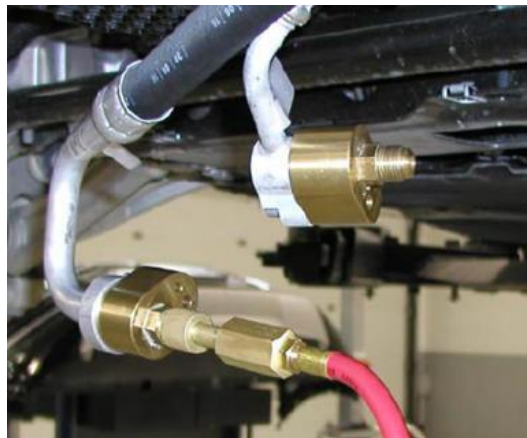
Figure 7.

11. Attach high side A/C Recovery machine hose with VAS 6338/48 fitting to low side compressor hose adaptor VAS 6338/12. (Figure 7)

This connection strategy allows for a system flush *in the opposite* direction of the normal refrigerant flow.

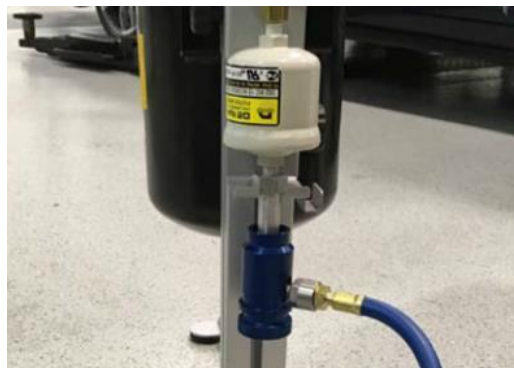
Figure 8.

12. Connect the low side A/C machine coupler to the flush tank filter adaptor. (Figure 8)

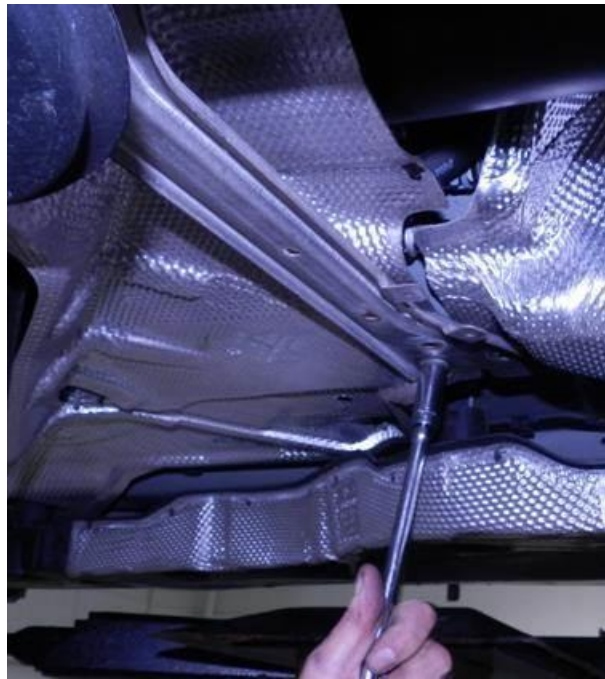
**Figure 11.**

21. Remove the cross bar located in the center under carriage area. (Figure 11)

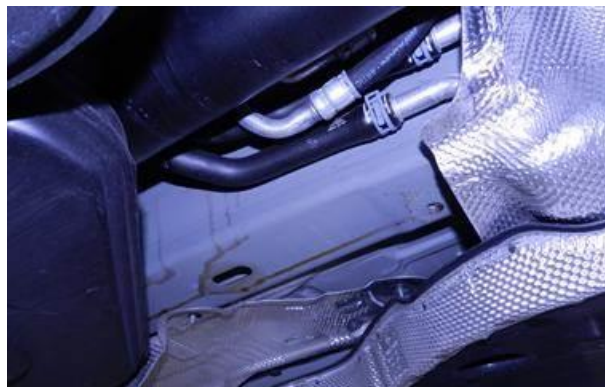
**Figure 12.**

22. Remove middle heat shield from under previously removed cross bar to access rear expansion valve. (Figure 12)

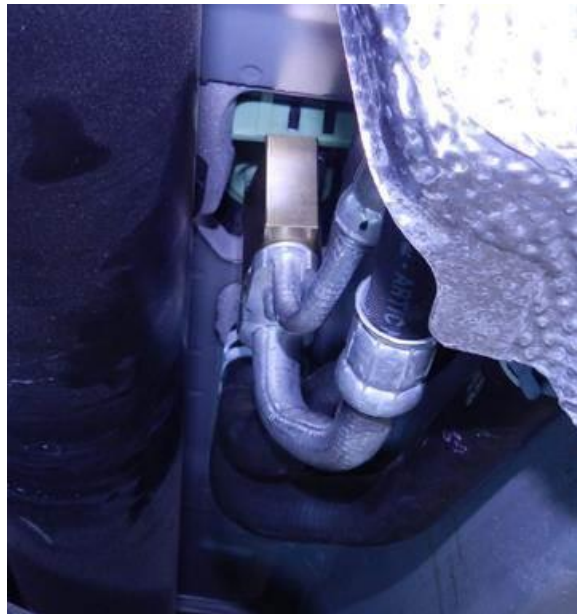
**Figure 13.** Location of rear air conditioning unit expansion valve.

23. Remove rear expansion valve and install VAS6338/38 as shown. (Figure 13)

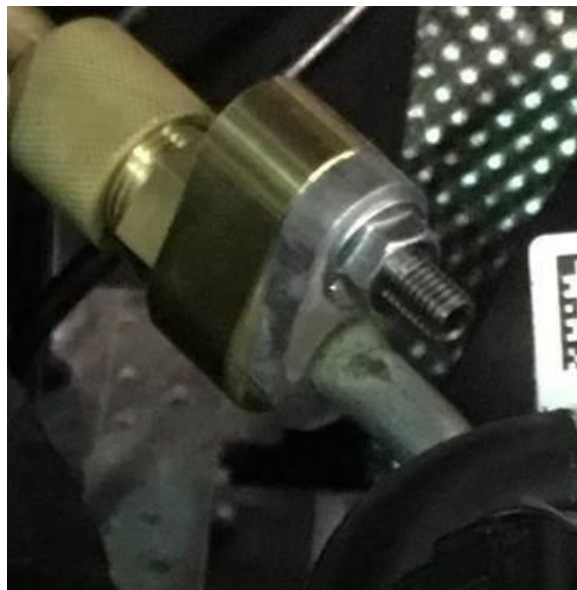
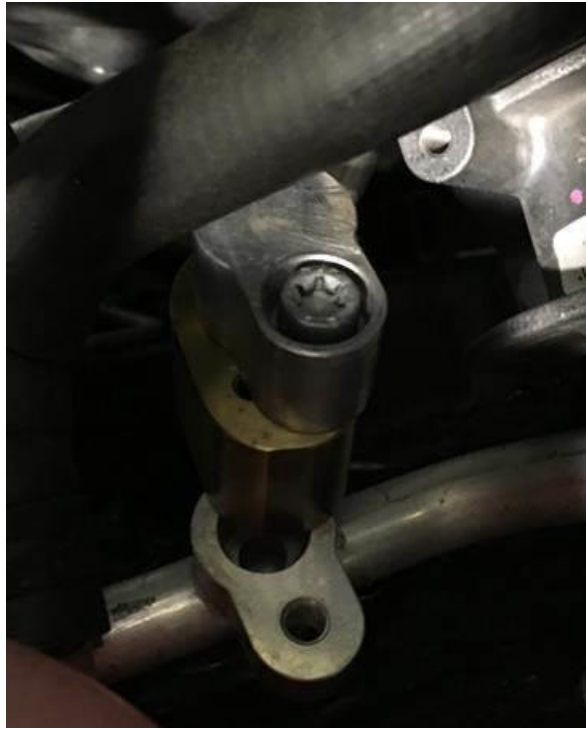
**Figure 14.** Location and connection of the adaptors for the rear unit A/C lines

24. Connect the VAS 6338/3 and VAS 6338/60 to the rear refrigerant A/C lines previous disconnected in step 12. (Figure 14)

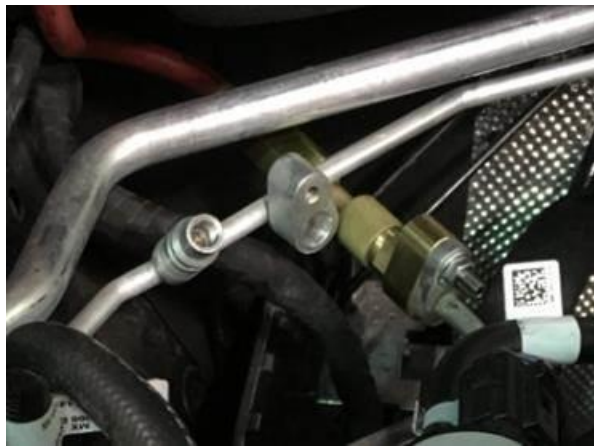
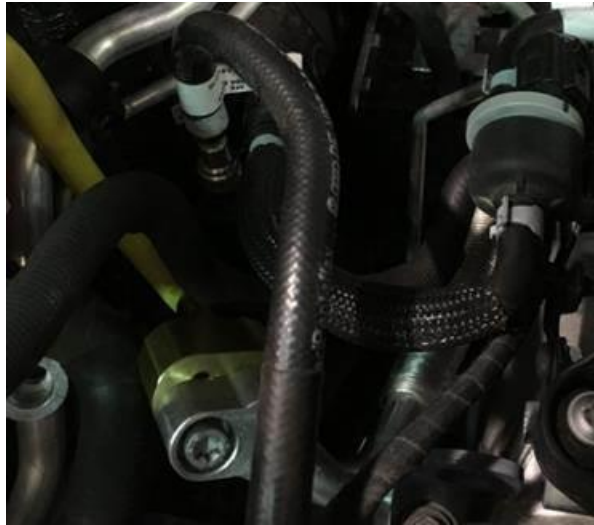
**Figure 15.** Attaching service station and flush hoses to rear A/C lines.

25. Connect the VAS 6338/3 and VAS 6338/60 to the rear refrigerant A/C lines.

26. Connect the VAS 6338/48 to adaptor VAS 6338/60

27. Connect flush tank hose (Yellow) to the high side compressor hose adaptor VAS 6338/3. (Figure15)

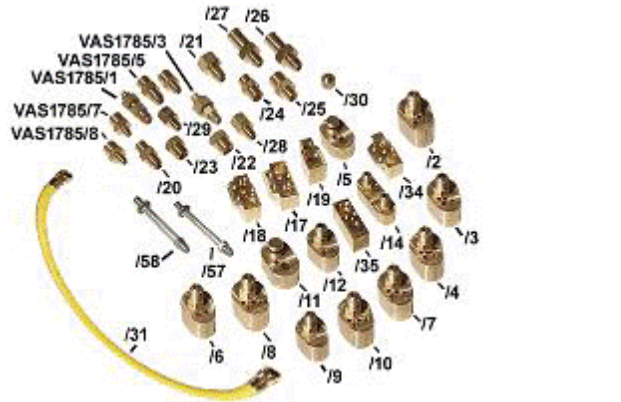
<p>VAS 6338/1</p>
<p>Refrigerant circuit adapter for MAHLE A/C Service Unit and R1234yf Flush Kit</p>

<p>Adapter set for refrigerant circuits</p>
