87 Air conditioning does not blow cold

87 19 92 2042340/5 June 27, 2019. Supersedes Technical Service Bulletin Group 87 number 17-83 dated September 25, 2017 for reasons listed below.

Model(s)	Year	VIN Range Vehicle-Specific Equipment		
Q3	2015 - 2016	All	Not Applicable Not Applicable	
Q3	2017	000001 - 007836

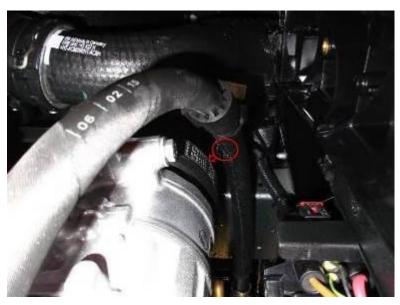
The technical diagnosis reveals that there is no refrigerant in the circuit. The refrigerant hose that connects the suction side of the compressor to the condenser is found to be damaged, as the rubber portion of the hose is making contact with the compressor pulley (Figure 1 and Figure 2).

A production issue with the assembly gauge used during assembly of the hose was found. This issue caused the hose to be assembled with an incorrect geometry. As a result, the lie intended

to keep the hose away from the air conditioning compressor pulley was compromised.

Figure 2. Point of hose contact with air conditioning compressor pulley – rear view.

Replace the damaged refrigerant hose and ensure that the natural lie of the hose is away from the air conditioning compressor pulley. Evacuate and recharge the refrigerant circuit and replace any lost PAG oil that may have been discharged from the system. Failure to maintain the correct total amount of PAG oil in the circuit will lead to premature air conditioning compressor failure.
