Service Bulletin

Bulletin No.: 12-08-51-002J

Subject: Spray-in Bed Liner General Information and Repair Procedures

Models: 2013-2014 Chevrolet Silverado HD 2500/3500 Series
2014 Chevrolet Silverado 1500
2015-2019 Chevrolet Colorado, Silverado
2013-2014 GMC Sierra HD 2500/3500 Series
2014 GMC Sierra 1500
2015-2019 GMC Canyon, Sierra
2020 Holden Colorado
Equipped with Spray-in Bed Liner (RPO CGN, PDL)

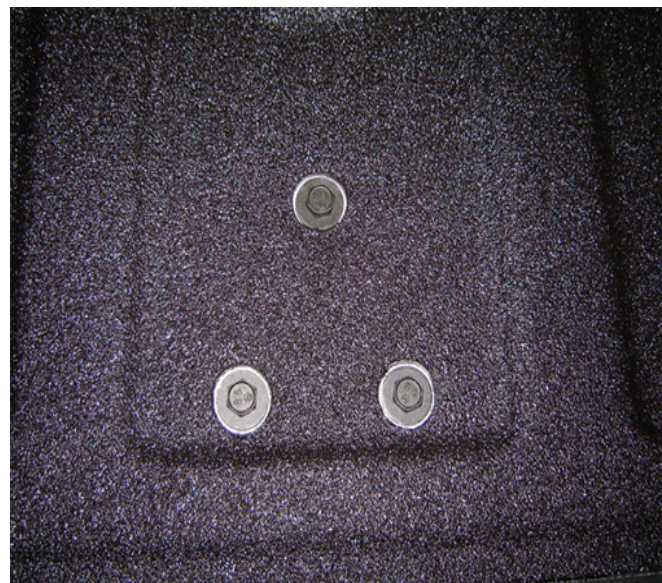
2968665

Tailgate handle bolts

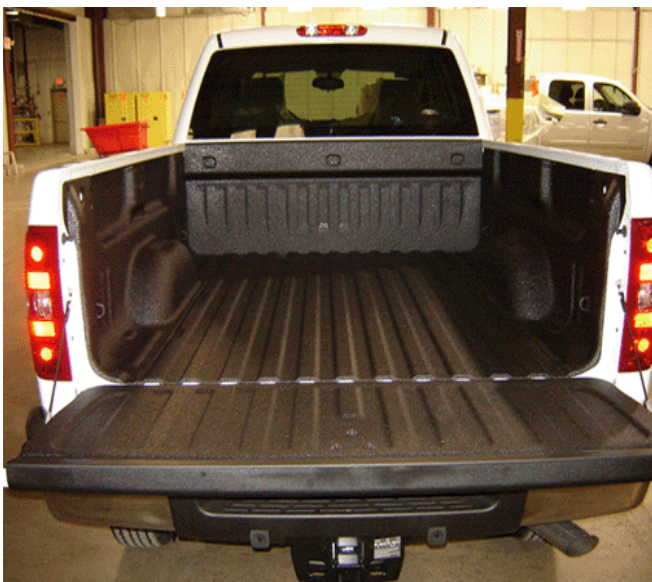
2968662

Entire bed

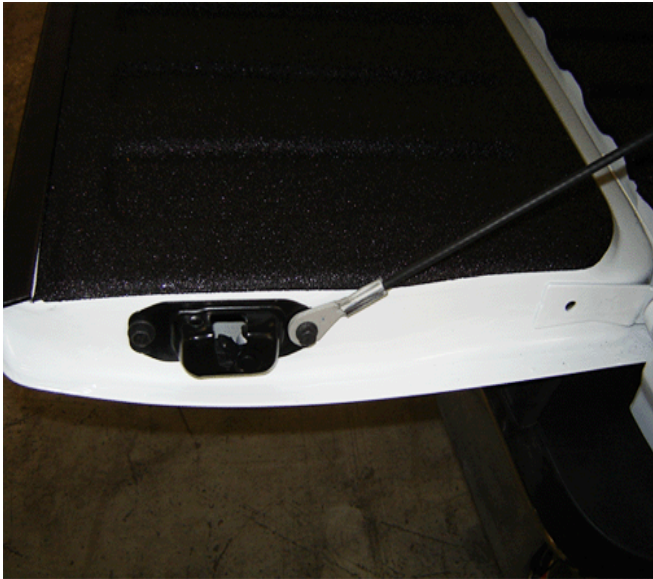
2968672

Tailgate side view

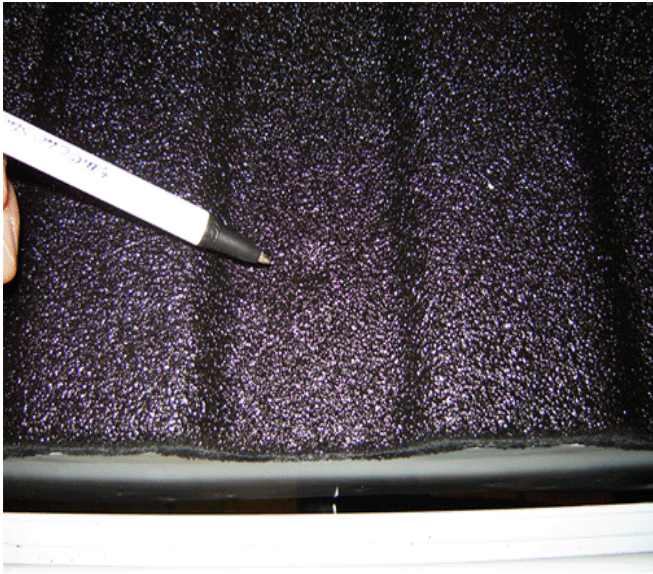
2968675

Because the bed liner material is sprayed on evenly, any variation in the bed such as seam sealer or spot welds in the sheet metal will show underneath the spray on coating. This is an expected condition. The coating does not completely fill in these variations.

Spot weld under bed liner example

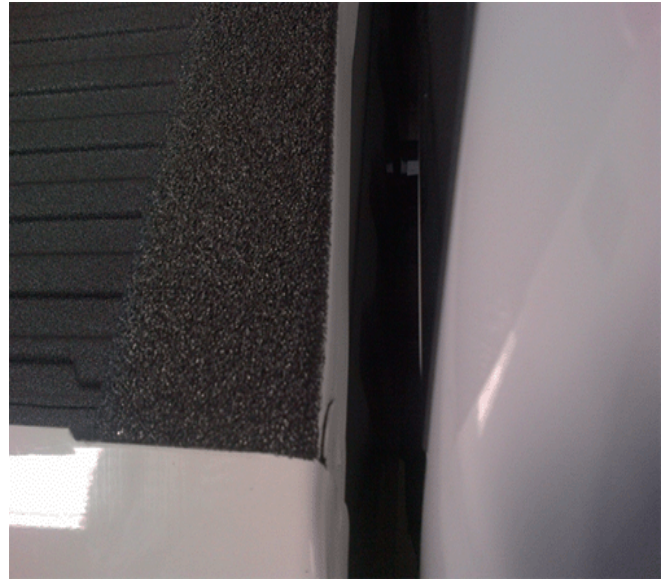
2968678

Bed header panel close up

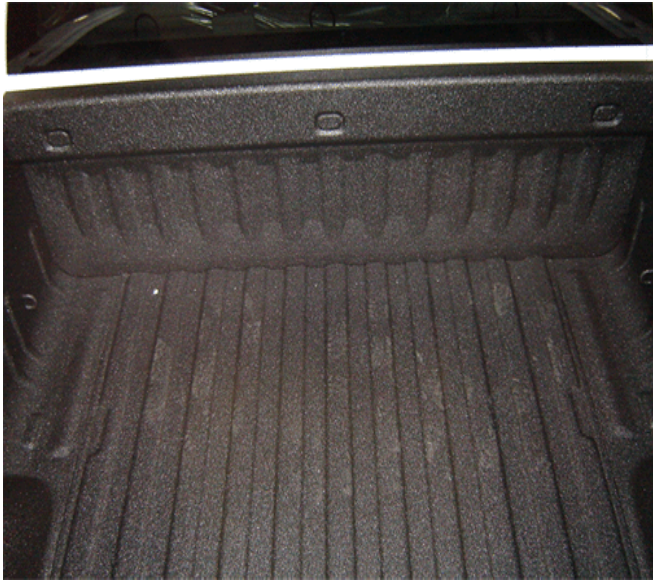
2968676

Bed header panel

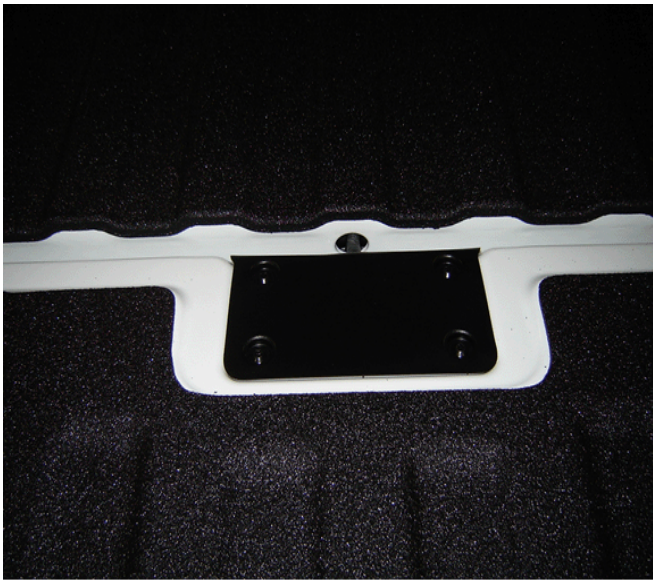
2968687

Bed floor (with rear camera access panel, gate open)

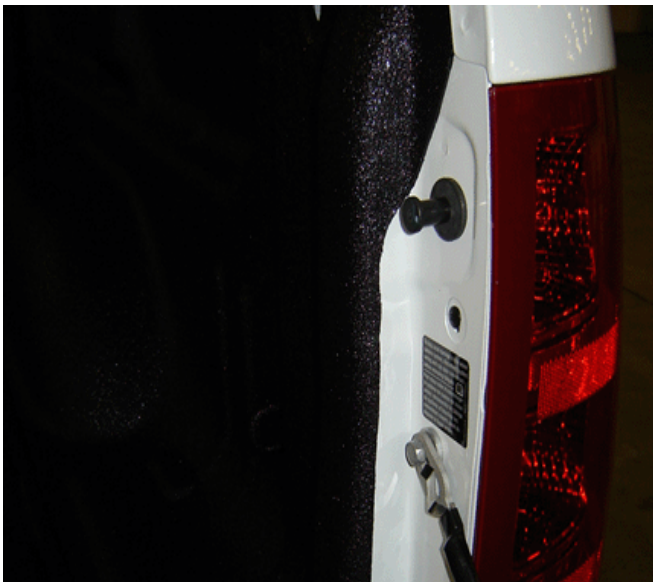
2968690

Tailgate opening view
