## TECHNICAL SERVICE BULLETIN

### Poor A/C Performance - Evaporator Case Can Now Be Serviced Separately From The Climate Control Housing Assembly

**19-2166**

<b>Ford</b> 2015-2019 Transit
----------------------------------

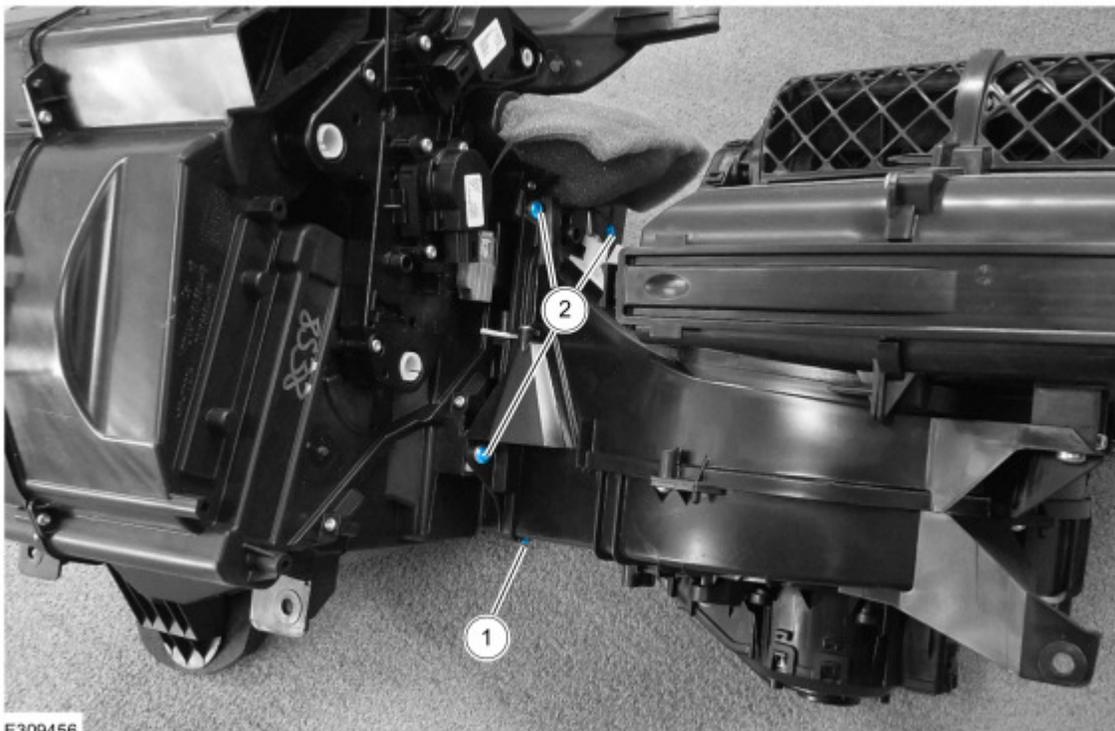
Figure 1

Item	Description
1	Retaining clip
2	Retaining screws

- Inspect the A/C system. Does the system show signs of leaks in components other than the evaporator?
  - (1). Yes – this article does not apply. Refer to Workshop Manual (WSM), Section 412-00.
  - (2). No – proceed to Step 2.
- Remove the climate control housing. Refer to WSM, Section 412-00.
- Remove the retaining clip from the bottom of the case. (Figure 1 Callout 1)

4. Remove the 3 retaining screws and separate the blower motor case from the evaporator case. (Figure 1 Callout 2)
5. Attach the blower motor case to the new evaporator case and install the 3 retaining screws. Tighten the 3 retaining screws to 3.7 Nm +/- 0.6 (32.75 lb-in +/- 5.31).
6. Install the remaining clip.
7. Reinstall the climate control housing. Refer to WSM, Section 412-00.
