## PIC6254D Information on Servicing the 1LE Vinyl Hood Wrap

Models

Brand:	Model:	Model Years:	VIN:		Engine:	Transmissions:
			from	to		
Chevrolet	Camaro	2017 - 2019	All	All	All	All

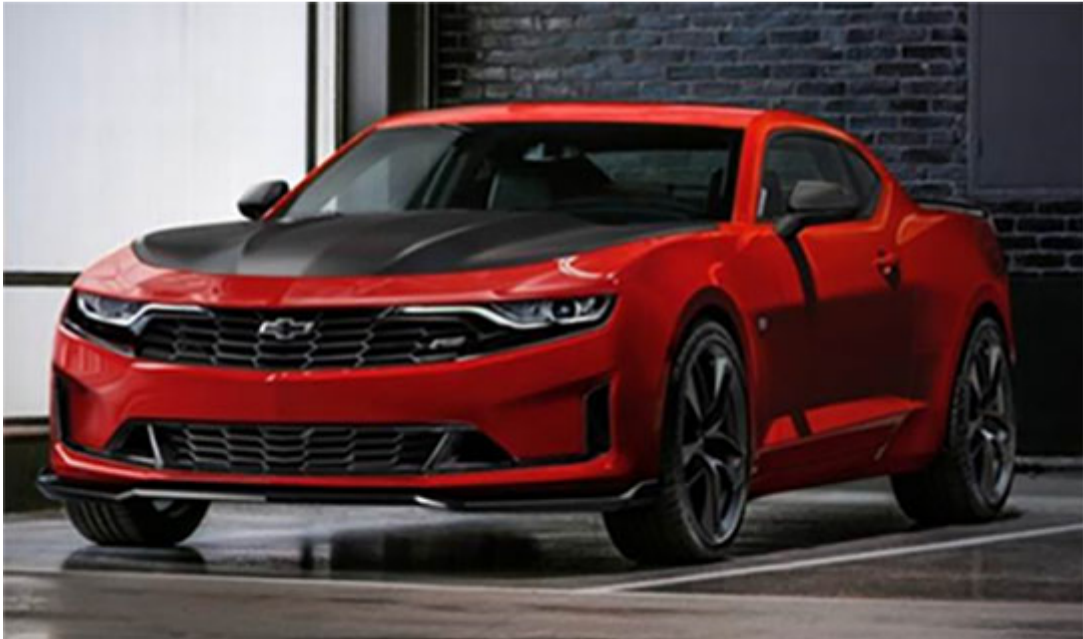
L4 Turbo 1LE

<b>Involved Region or Country</b>	<b>North America</b>
<b>Additional Options (RPO)</b>	<b>Equipped with the 1LE track package, RPOs A1X, A1Y, or A1Z</b>
<b>Condition</b>	<b>All 2017 - 2019 Camaro 1LE cars come equipped with a vinyl hood wrap that is applied before the cars arrive at the dealership. Some dealerships may be looking for additional information on this wrap when it comes to care, cleaning, or in some situations, replacement of the entire hood wrap.</b>
<b>Cause</b>	<b>These hood wraps are all made of a matte finished vinyl material and all of them are black in color. They can be damaged if they are not cared for properly. The most common complaints are smudges or stains that are usually the result of fingerprints, improper cleaning practices, and/or products or leaves that remain on the car and create an outline on the vinyl. In some situations, the customer may even comment about small rips / other physical damage to the wrap itself.</b>

If any suspect damage is found on one of these hood wraps, dealerships are to first attempt to clean the hood before taking any other action.

Hand washing is recommended using a mild detergent and water. Immediately rinse the vehicle and dry the graphic with a soft squeegee and/or soft cloth to help restore the graphic's luster.

- Touchless car washing systems may be used. To avoid water spotting on graphic, always go through the drying cycle.
- To remove tar and bugs from the graphic, use a commercial cleaner designed for such use, but do not rub vigorously. Immediately wash with a mild detergent / water solution, rinse with water, and dry.

If the concern remains and it's determined a new hood wrap is needed, the 1LE hood wrap (Hood Wrap Decal) can be obtained thru GM Service Parts. All 1LE's use the same part number hood wrap. It will be necessary to cut the holes in the hood wrap to accommodate any hood vents or heat extractors however. The 1LE hood wrap must be installed by a certified "wrap" technician. If your dealership/body shop does not have a certified installer, contact Ryan Scislowicz at Kay Automotive Graphics. His phone number is 248-377-4999, extension 3640. He will be able to direct the dealership to the local certified installer.
