# Service Bulletin

Bulletin No.: 17-NA-355

**Subject:** Front and/or Rear Fascia Peeling

Brand:	Model:	Model Year:		VIN:		Engine:	Transmission:
		from	to	from	to		
Chevrolet	Corvette	2017	2019			All	All

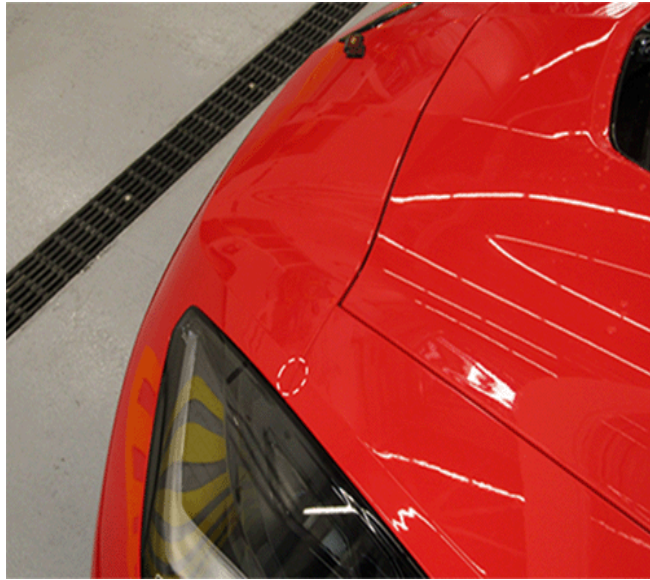
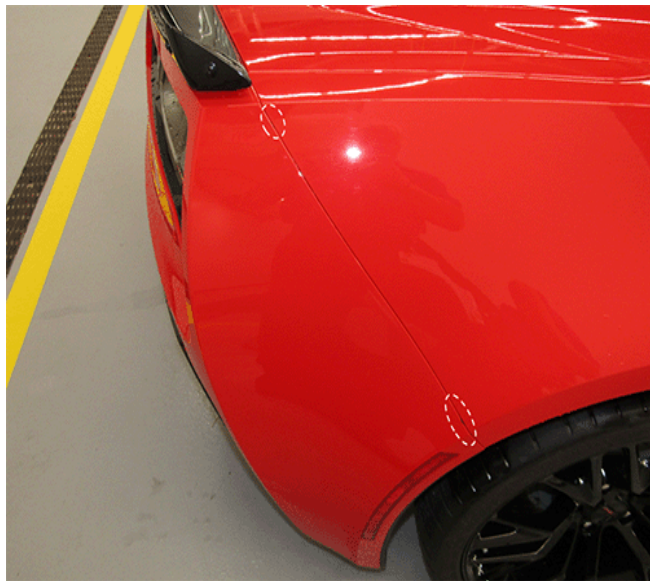
Some customers may comment that a front and/or rear upper fascia may be peeling at the interfacing edge to the fender or quarter panel. Some examples are shown circled in the graphics above.

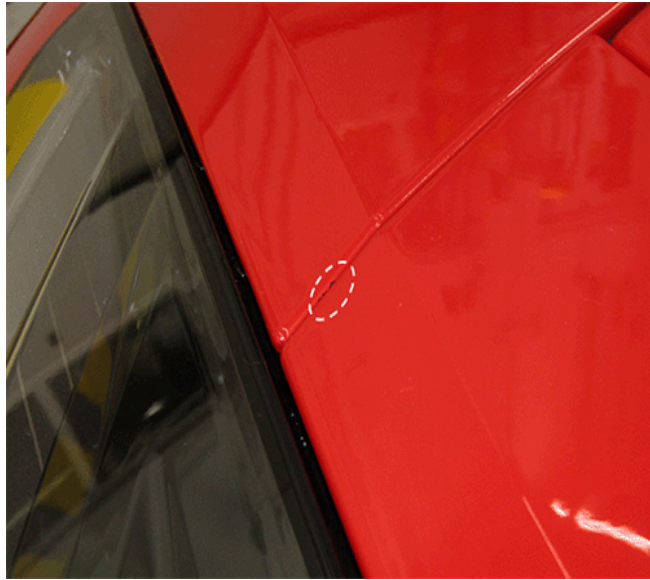
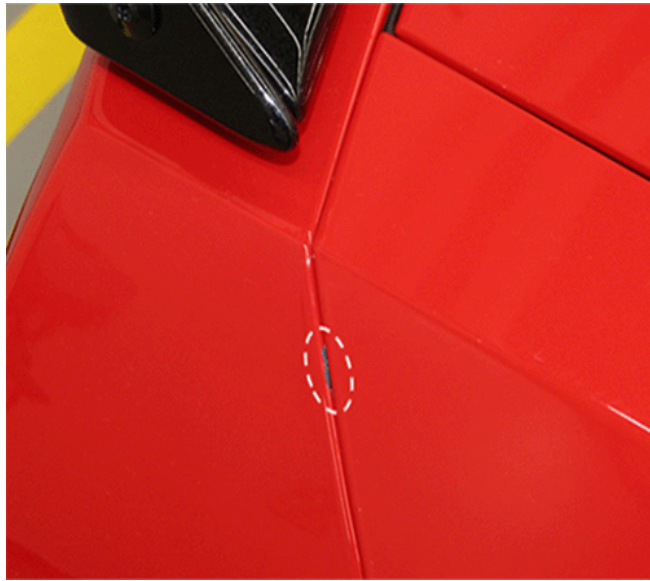
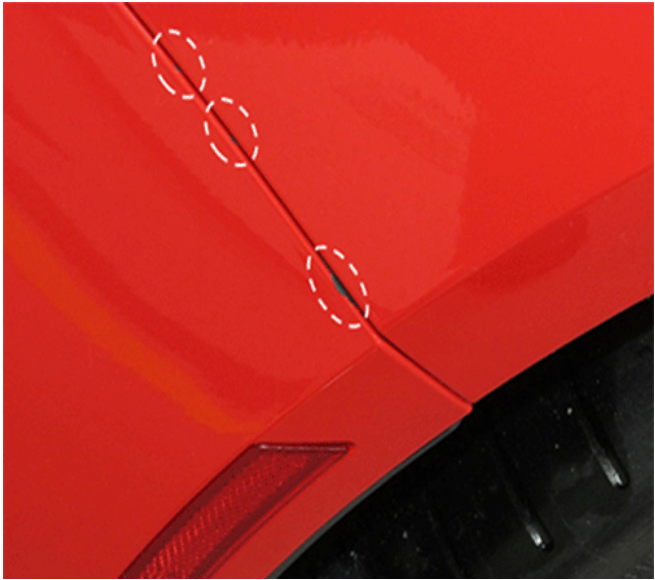
<p data-bbox="1419 739 1482 758">4891595</p> <p data-bbox="537 768 1390 821">The cause of the condition may be lack of paint adhesion due to improper surface preparation.</p>
<p data-bbox="131 932 253 957"><b>Correction</b></p>	<p data-bbox="537 831 1438 905"><b>Important:</b> Refer to the latest revision of the GM Approved Refinish Materials book to identify the paint systems you may use that have been engineered to meet GM standards.</p> <p data-bbox="532 915 1422 1026">The latest revision of the GM Approved Refinish Materials is found in GM Service Information (SI) under Unit Repair Manual/Specialty Publications. A PDF copy of the GM Approved Refinish Materials booklet is located on the Genuine GM Parts website at <a href="http://www.genuinegmparts.com">www.genuinegmparts.com</a>.</p> <p data-bbox="537 1033 1414 1060">Refinish the front and/or rear upper fascia(s) following the Service Procedure below.</p>

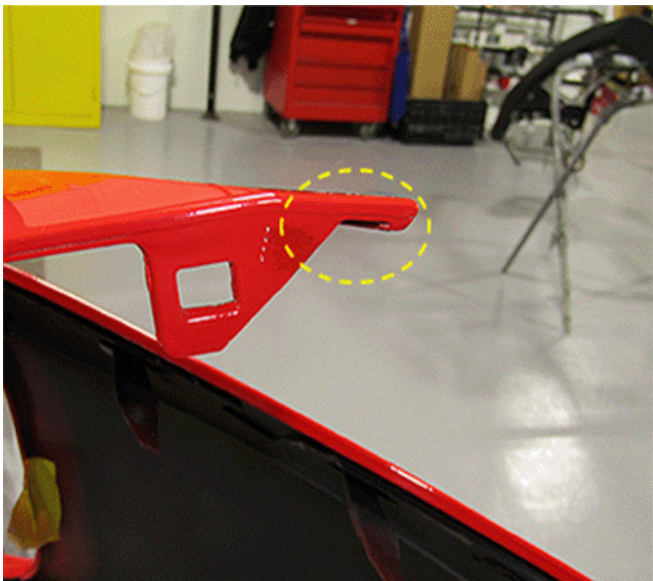
4891618

**Note:** The right side location of the mylar tape is shown circled in the graphic above.

**Important:** Ensure the front fascia paint is allowed to fully cure before applying the mylar tape.

12. If the paint repair was completed on a FRONT fascia, add a piece of protective mylar tape to EACH front upper corner of the fascia, following the steps below:

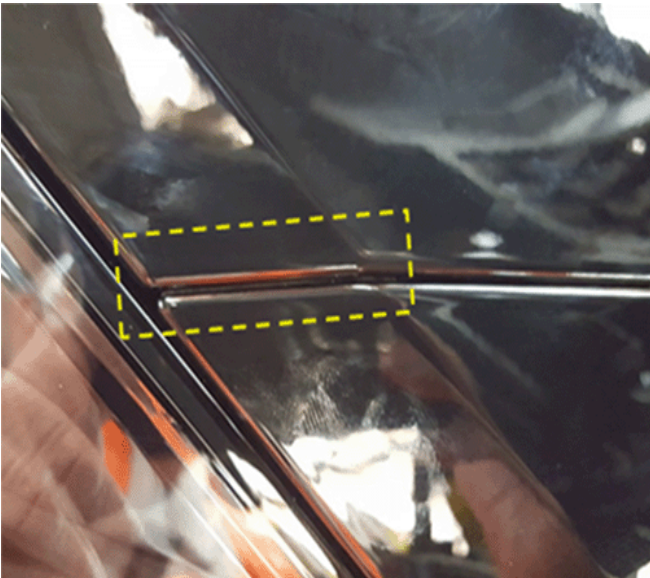
4891630

**Note:** As shown in the graphic above, no Mylar tape should be visible on the A-surface once the front fascia is reinstalled.

- 13. Reinstall the front and/or rear fascia(s). Refer to *Front Bumper Fascia Replacement* and/or *Rear Bumper Upper Fascia Replacement* in SI.
