Service Bulletin

Bulletin No.: 19-NA-126

Subject: Emergency Trunk Release Key Will Not Turn, Unable to Open Trunk from Lock Cylinder Behind Rear Seat Back, Information on Convertible Key Extender

Brand:	Model:	Model Year:		VIN:		Engine:	Transmission:
		from	to	from	to		
Chevrolet	Camaro - Convertible	2016	2019			All	All

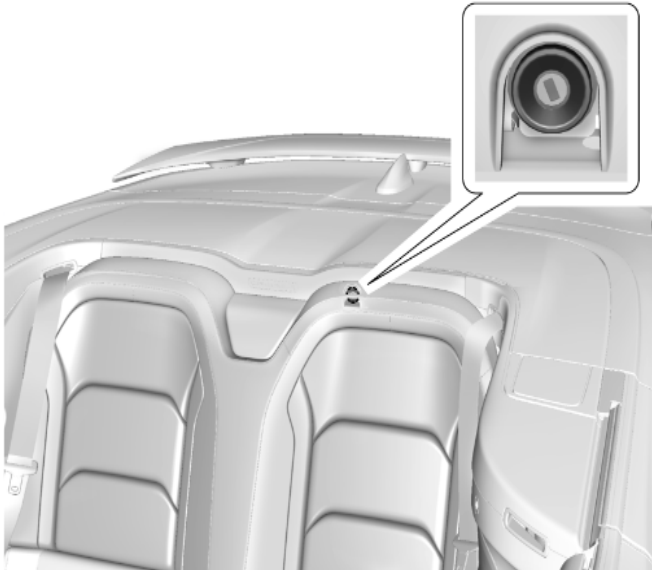
<p style="text-align: right;">5338393</p> <p>Some customers may comment that they have difficulty turning the key in the emergency trunk release cylinder, located behind the upper, center of the rear seatback cushion.</p>

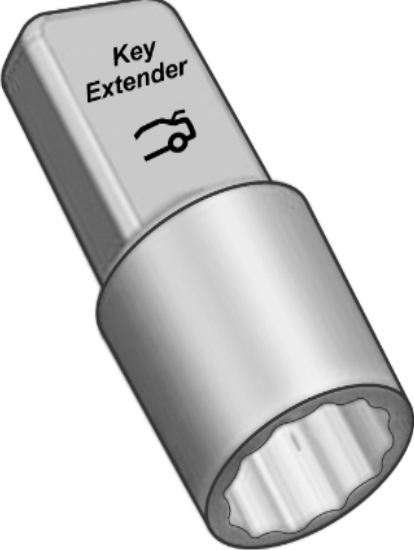
<p style="text-align: right;">5338396</p> <p>All convertibles come with a key extender packaged in with the loose shipped items from the assembly plant. The key extender should be placed in the glove box at the time of PDI.</p>
<p>Correction</p>	<p>Caution: Failure to use the key extender could cause the key to twist and break in the cylinder.</p> <p>The key extender should be used when opening the trunk, from the lock cylinder located behind the rear seat back cushion.</p> <p>Additional information regarding the proper usage of the key extender can be found in the Emergency Trunk Release (Convertible Only) section of <i>Trunk</i> in the Owner Manual.</p>
