SERVICE BULLETIN

APPLICABILITY: 2019MY Impreza
 2019MY Ascent
SUBJECT: A/C System Inoperative

NUMBER: 10-92-19R
DATE: 06/26/19
REVISED: 08/19/19

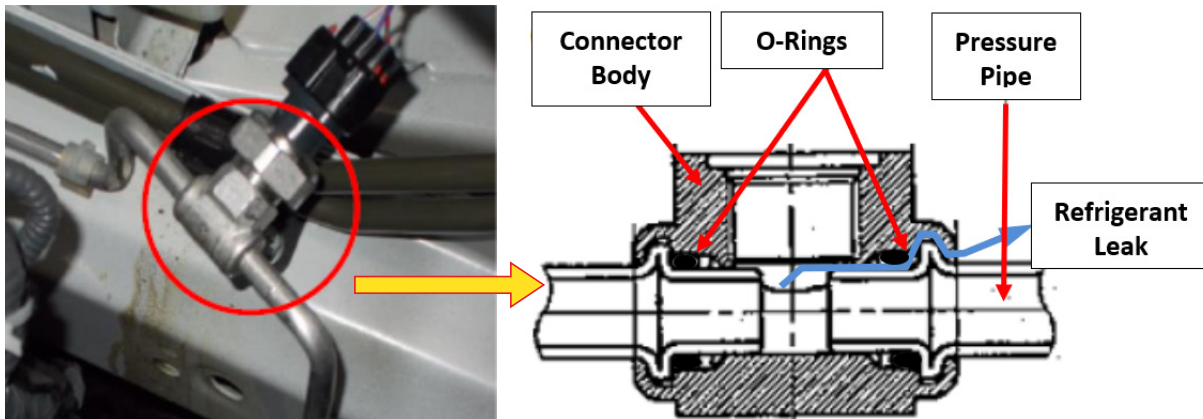
This bulletin announces a change made to optimize the sealing of the pressure switch connector used on a metal refrigerant pipe on the models above. The sealing capability of the connector may have been compromised during manufacture and result in a refrigerant leak. This condition has been determined to primarily effect vehicles produced during January and February 2019.

The new A/C pipes were incorporated into production per the table below:

Model	Starting VIN	Applicability
Impreza	K*614550	4-Door
	K*731734	5-Door
Ascent	K3463823	All

Description	Part Number	Application
PIPE-EVAPORATOR COOLING	73431FL10A	Impreza
	73431FL11A	
	73431XC00A	Ascent
