Subject:
**WIRELESS CHARGING PAD INSTALLATION INSTRUCTIONS
CORRECTION**
Service Alert No.: SA-002/20

Last Issued: 01/06/2020

2019-2020 Mazda3

2020 CX-30

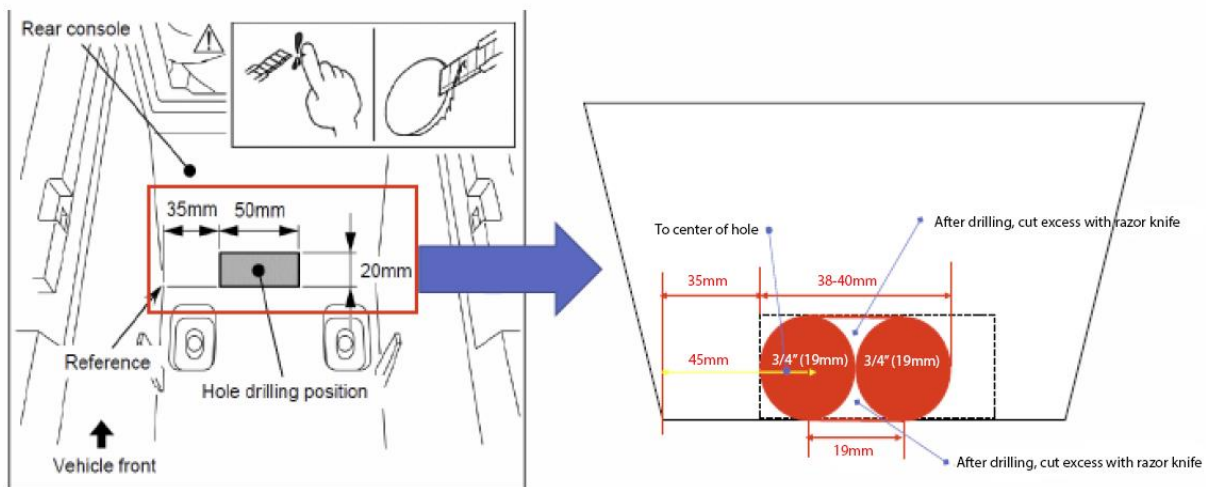
Section 6 of the Wireless Charging Pad instructions call for the use of an "ultrasonic cutter" to cut a rectangular hole for the harness to pass through and to serve as an access point to pop the wireless charger base out should service be required. Since an "ultrasonic cutter" is not readily available, follow the Repair Procedure to cut the rectangular hole.

A 19mm or 3/4" hole saw can be used instead of an "ultrasonic cutter" to cut a rectangular hole as shown.
