## SERVICE INFORMATION BULLETIN

**APPLICABILITY:** 2012MY-2016MY IMPREZA

SUBJECT: Hub Remover / Special Tool - J-53014

**NUMBER:** 14-24-20

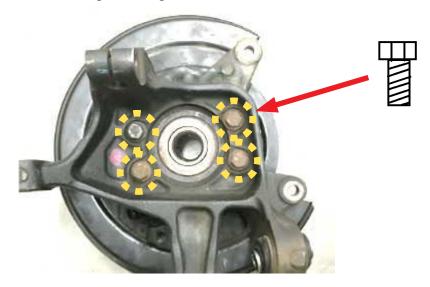
1. Remove the 4 hub housing fastening bolts.

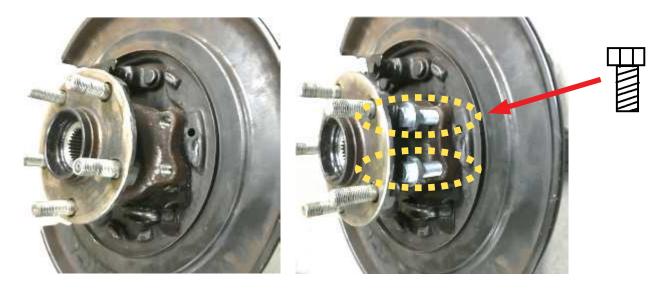
2. Thread 2 bolts into the outer hub bolt holes.

**NOTE:** Make sure the bolts clear the hub bolts. (NG photo shown here)

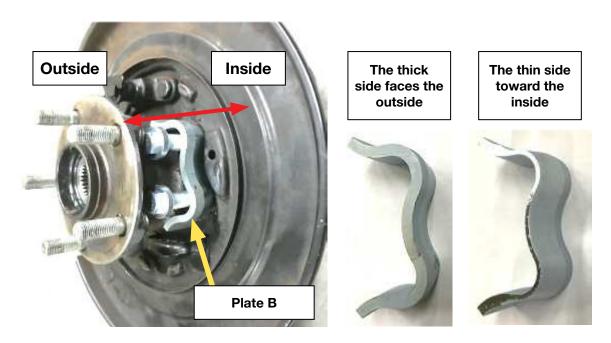
3. Attach Plate B 28499SG020 to the face between the hub unit and the back plate. NOTE: Pay attention to the mounting direction of Plate A.

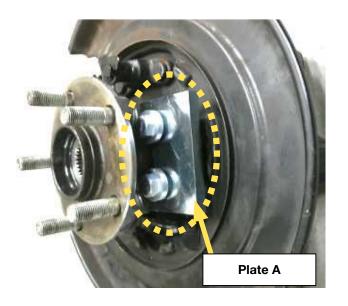
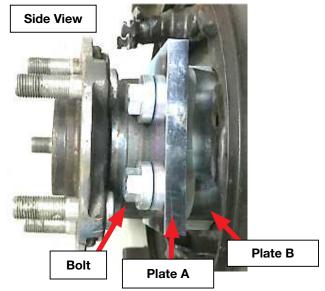
**4.** Attach Plate A between Plate B and bolt flange. Tighten by hand until the bolt is seated on Plate A.

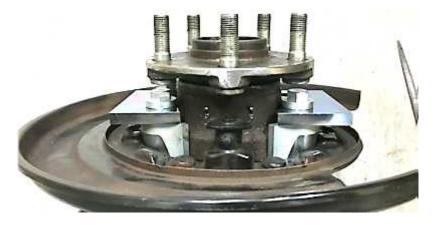
5. Install plates A, B, bolts on the opposite side.

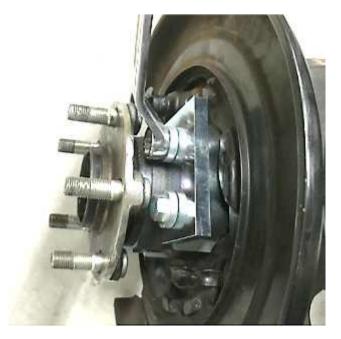
**6.** Remove the hub unit by tightening the bolts using a 14 mm box-end wrench in a crossing pattern as shown below.

**NOTE:** Tighten the bolts in a crossing pattern to evenly apply axial force. If force is unevenly applied, the hub unit may stick in the housing and become extremely difficult to remove.

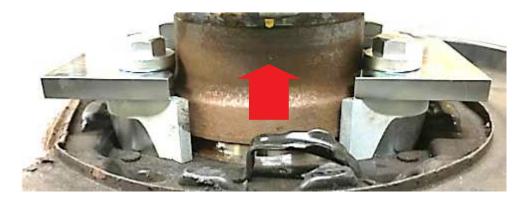
7. By tightening the bolts as specified, the hub should release from the housing normally.

**NOTE:** If rust sticking is severe, the use of penetrating lubricant (e.g. PB Blaster or equivalent) is recommended.
