TECHNICAL SERVICE BULLETIN

6.7L - Chassis Cab - Crank/No Start, Incorrect Fuel Level And/OR Collapsed Fuel Tank For Vehicles In Dusty Conditions

20-2105
31 March 2020

Ford 2017-2019 F-Super Duty	Engine: 6.7L
---------------------------------------	--------------

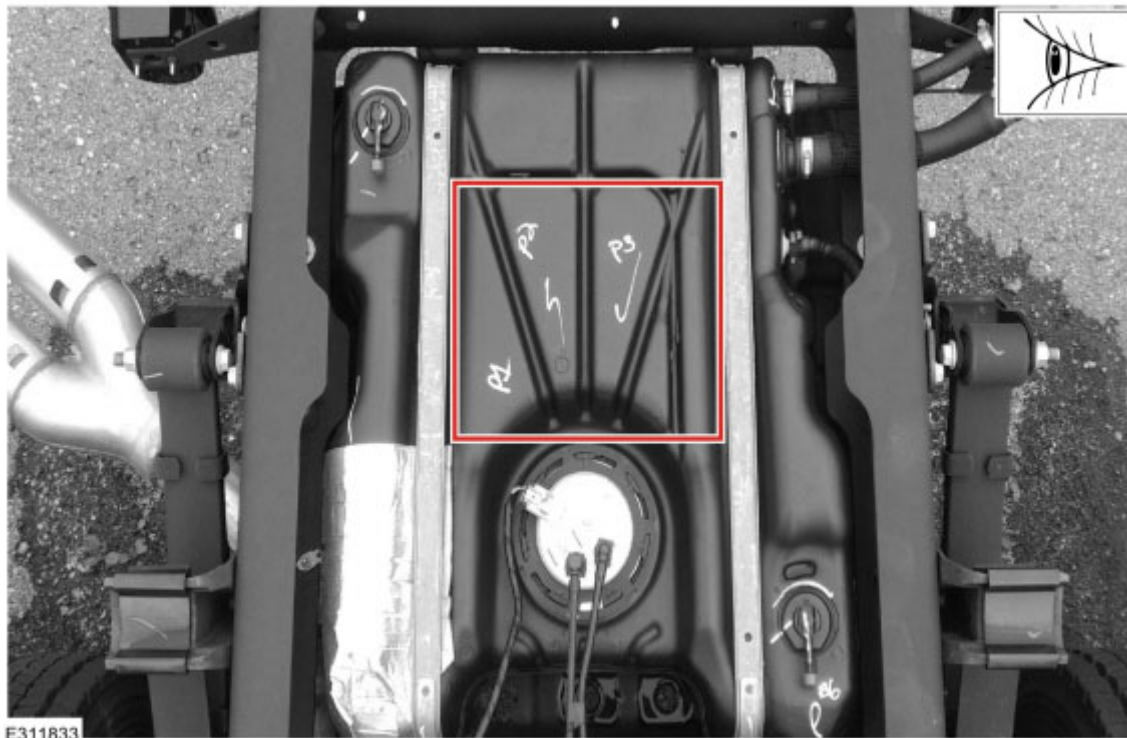
Figure 1

NOTE: The fuel tank will collapse down from the top of the highest portion of the fuel tank as fuel is drawn out and make-up air is not entering the tank.

1. Inspect the top of the fuel tank to determine if it is collapsed. (Figure 1)
 - (1). Access the top of the fuel tank from underneath the vehicle.
 - (2). Lay a straightedge or a flat piece of wood across the top of the fuel tank and measure the depth of the collapsed portion of the tank.

2. Is the tank collapsed down 12 mm (about 1/2 inch) or more with the straight edge laying across the top of the tank?
 - (1). Yes - proceed to Step 3.
 - (2). No - this article does not apply. Refer to the Powertrain Control/Emissions Diagnosis (PC/ED) Manual for normal diagnostics.
3. Drain and remove the fuel tank. Refer to Workshop Manual (WSM), Section 310-01.

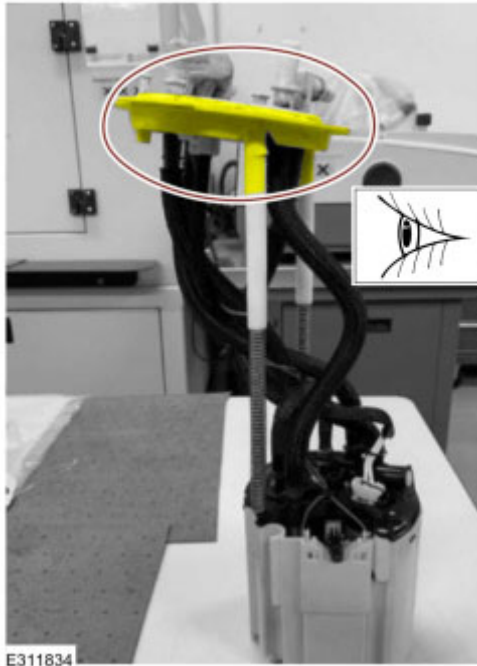
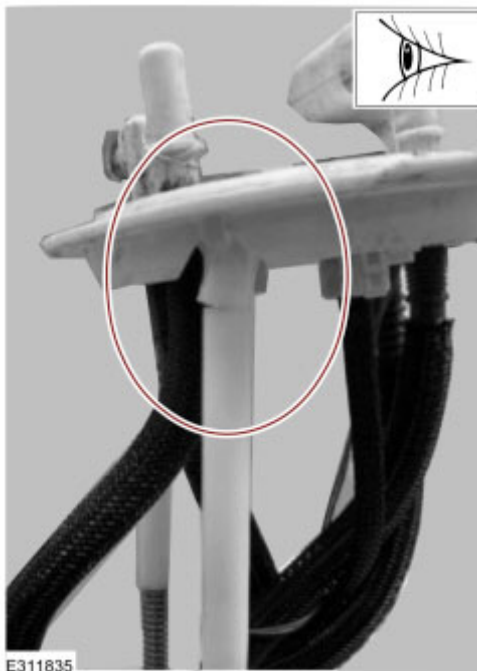
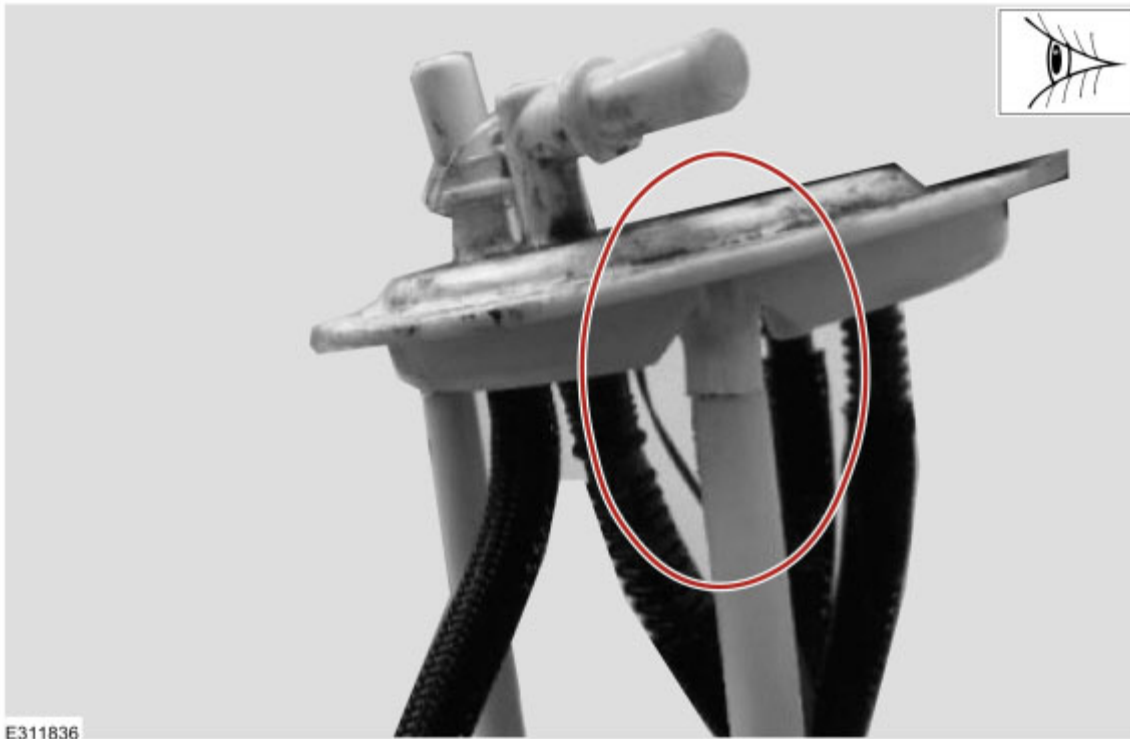
Figure 2

4. Remove the fuel pump/sender unit. Refer to WSM, Section 310-01.
5. Inspect the fuel pump/sender unit for signs of damage to the guiding rods. Standing the fuel pump and sender unit on a flat surface will help to determine if the guiding rods are bent. The top of the fuel pump and sender unit should be level with the surface it is resting on. Is damage present?
 - (1). Yes - replace both the fuel pump/sender unit and the fuel tank. Proceed to Step 6.
 - (2). No - replace the fuel tank only. Proceed to Step 6.
