TECHNICAL SERVICE BULLETIN

Stop Safely Now Message In The IPC

20-2140
23 April 2020

Ford 2012-2016 Focus Electric

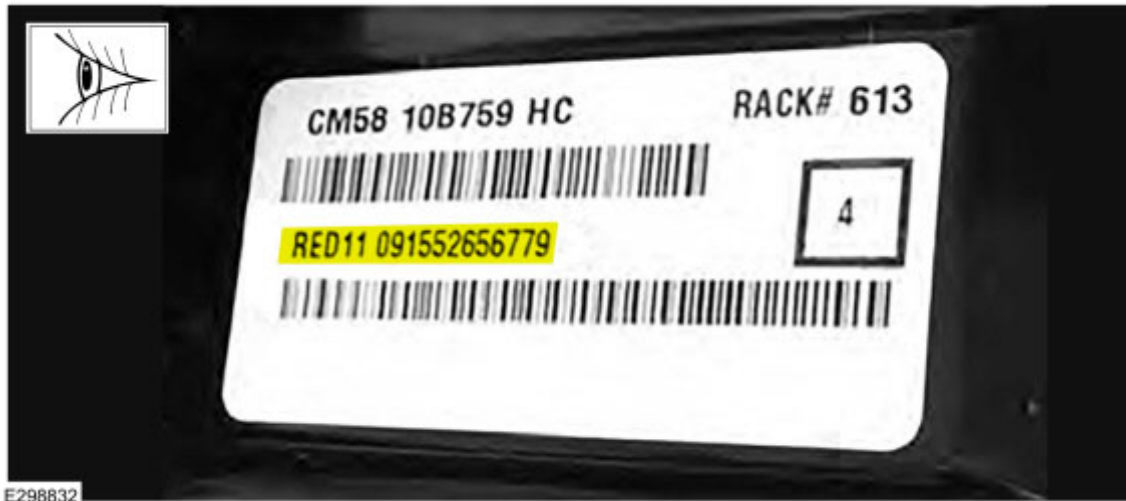
Figure 11

1. Locate and record the battery serial number on either the upper or lower high voltage battery. (Figures 11)

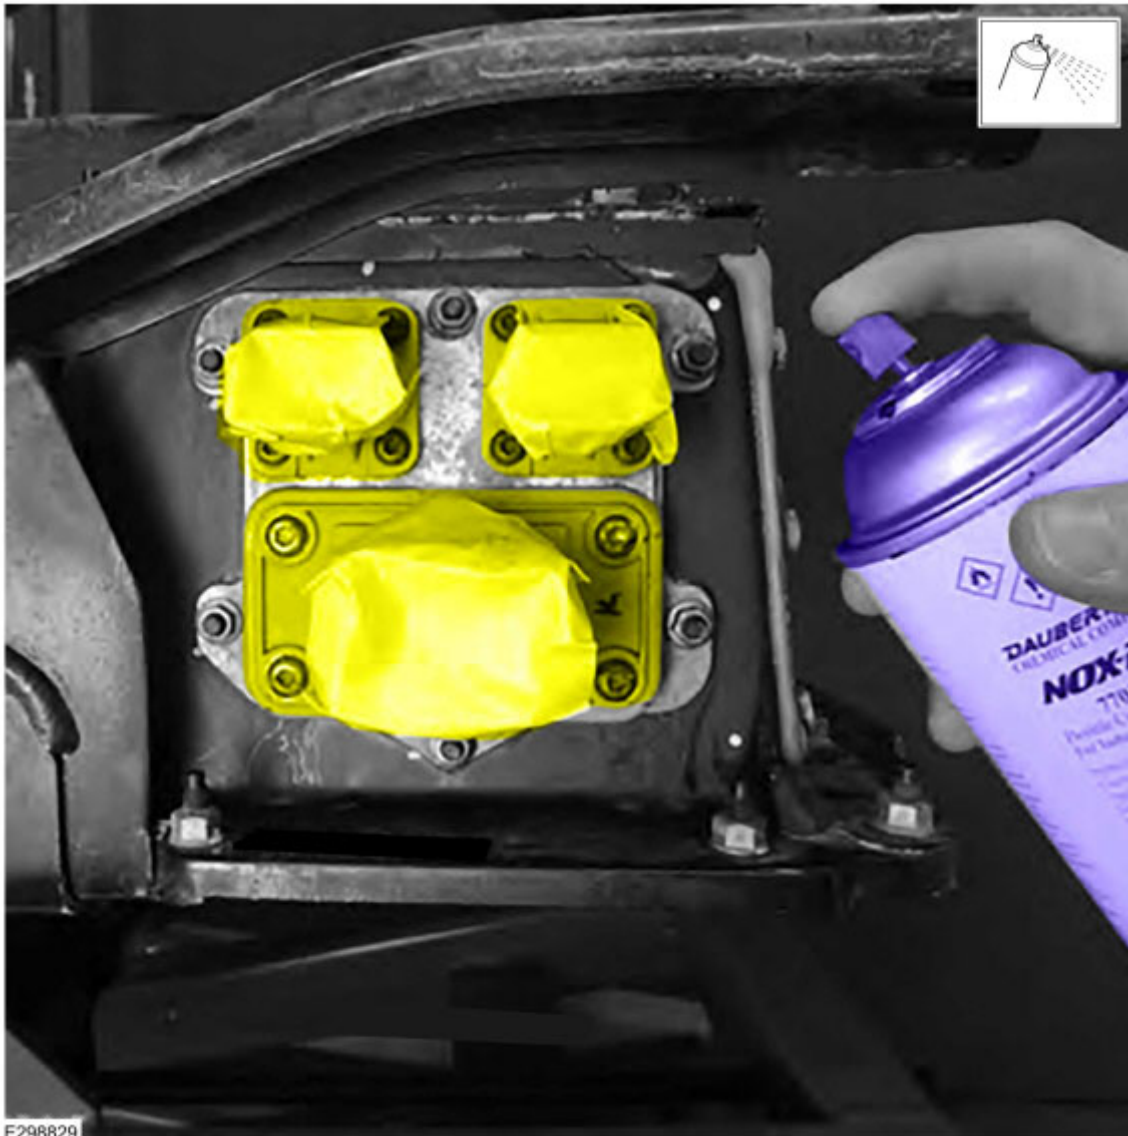
Figure 12

1. Make sure the coroplast tape is completely covering the connector faces. (Figure 12)

2. Spray Daubert NOX-RUST® 7703-W generously around the perimeter of all 3 connectors to the aluminum plate mating surfaces. (Figure 12)
3. Allow the corrosion protection to penetrate for a minimum of 10 minutes.
4. Apply a second coat of corrosion protection.
5. Install the lower high voltage battery into the vehicle. Refer to WSM, Section 414-03A.
6. Proceed to the High Voltage Lower Battery Connector Shield Installation procedure later in this article.

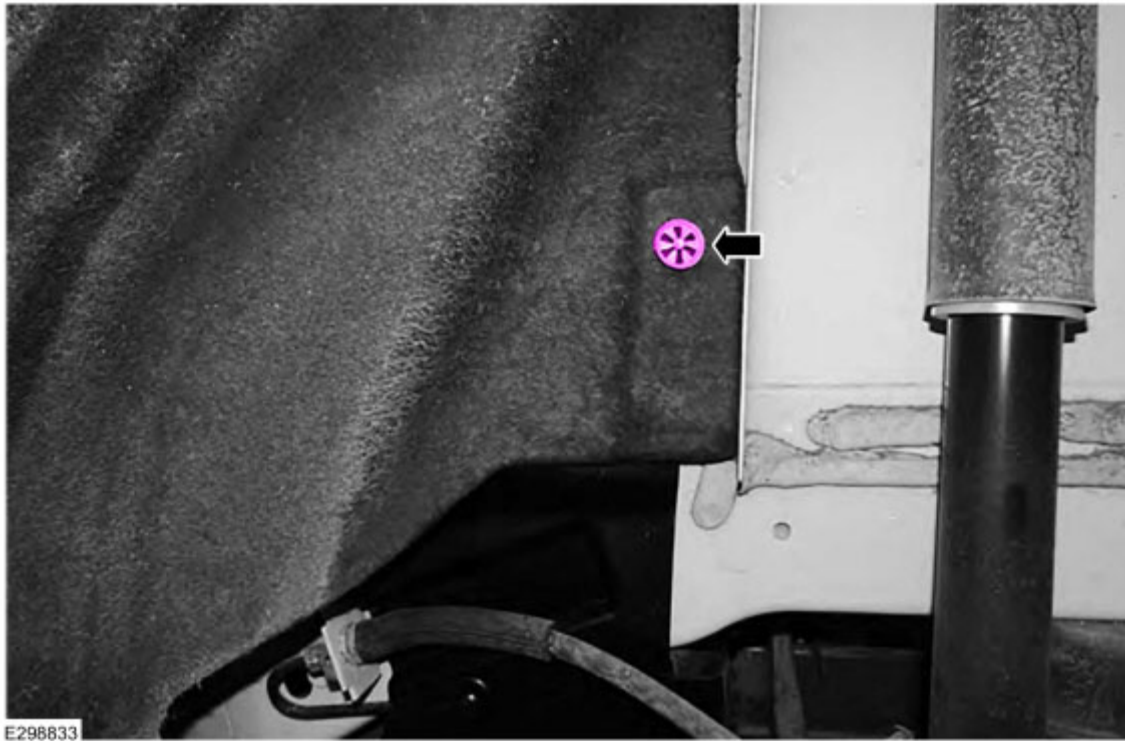
Figure 13

1. Remove the left rear wheel. Refer to WSM, Section 204-04A.
2. Remove the left rear fender well splash shield spring clip washer. (Figure 13)

6. Install the left rear fender well splash shield spring clip washer. (Figure 13)

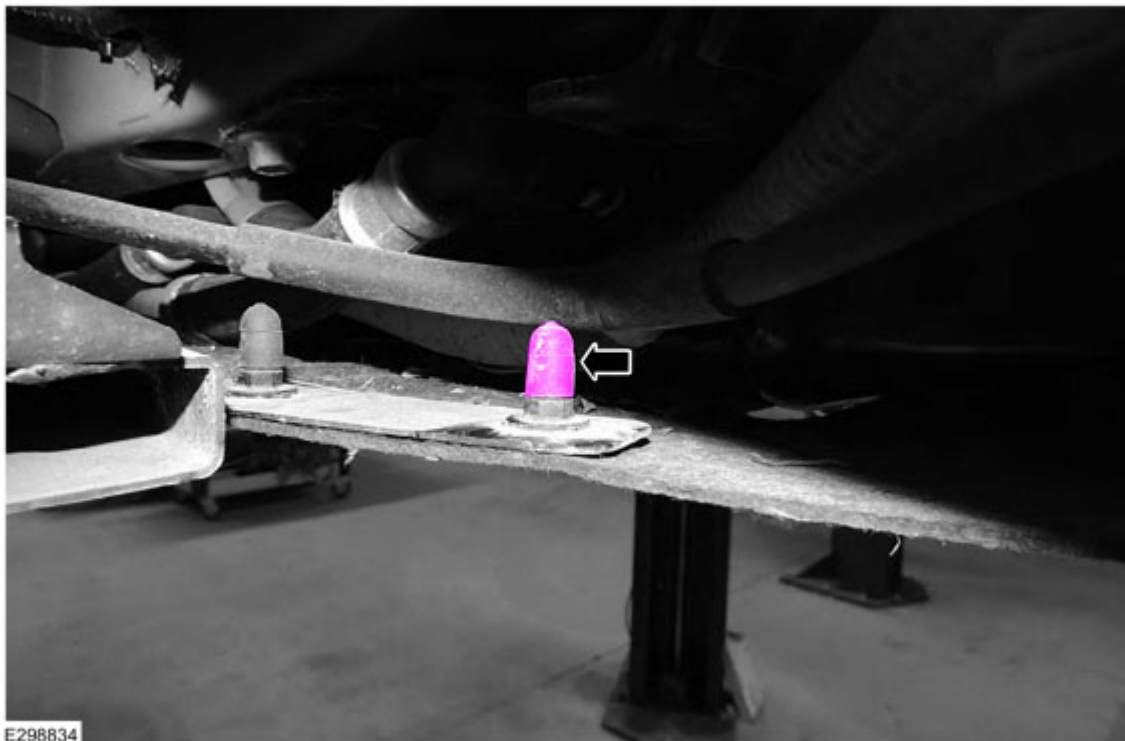
Figure 14

3. Remove the bolt thread rubber cap. (Figure 14)

9. Install the bolt thread rubber cap. (Figure 14)

NOTE: The bolt thread rubber cap must be reinstalled. Failure to install the cap may result in parking brake cable damage.

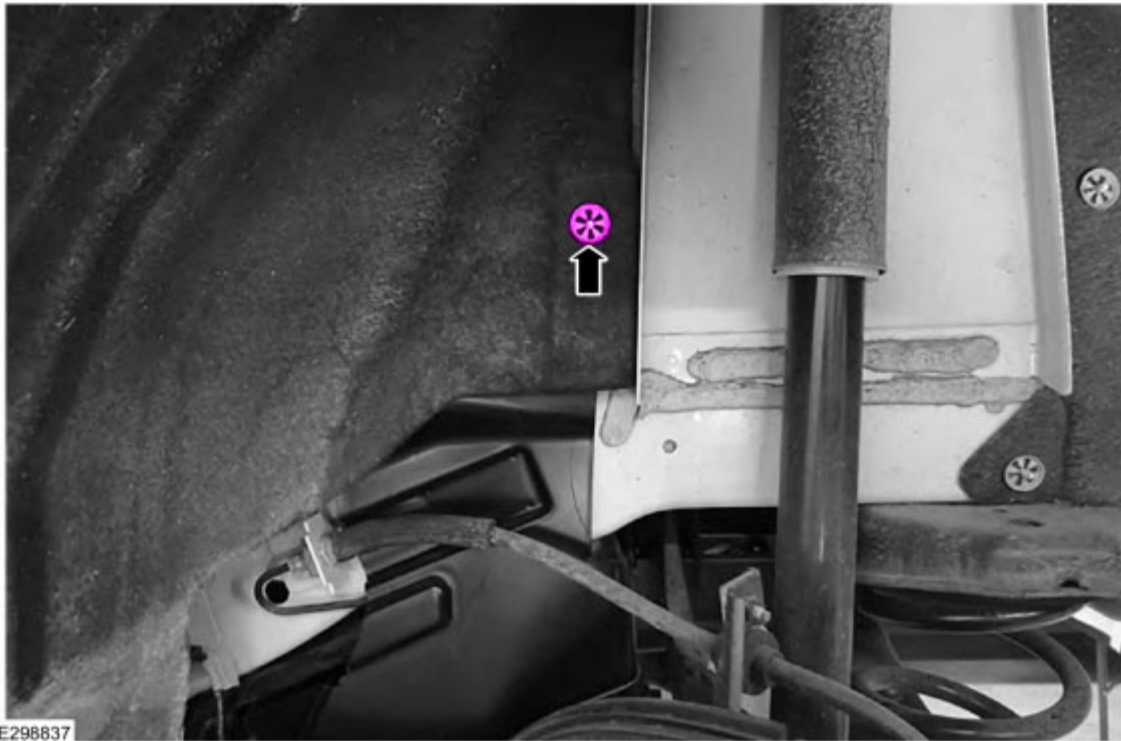
Figure 17

7. Install the high voltage battery shield bolt and push pin. (Figures 17-18)

8. Tighten the high voltage battery shield bolt to 27 Nm (20 lb-ft)
