Service Bulletin

Bulletin No.: 16-NA-383

Subject: Information on Rough Idle, Crank No Start, Extended Crank or Misfire Due to Excessive Carbon on Top of Valves or Sticking Valves, Malfunction Indicator Light (MIL) Illuminated - DTC P0300, P0301, P0302, P0303, P0304, P0305, P0306, P0307, P0308 Set

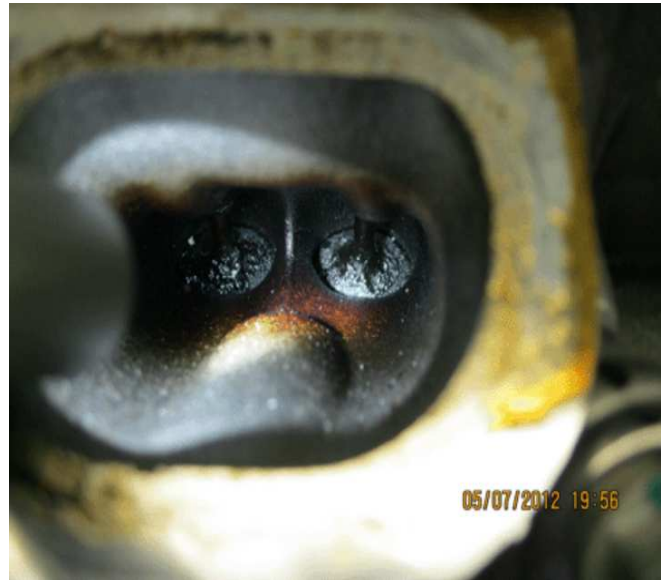
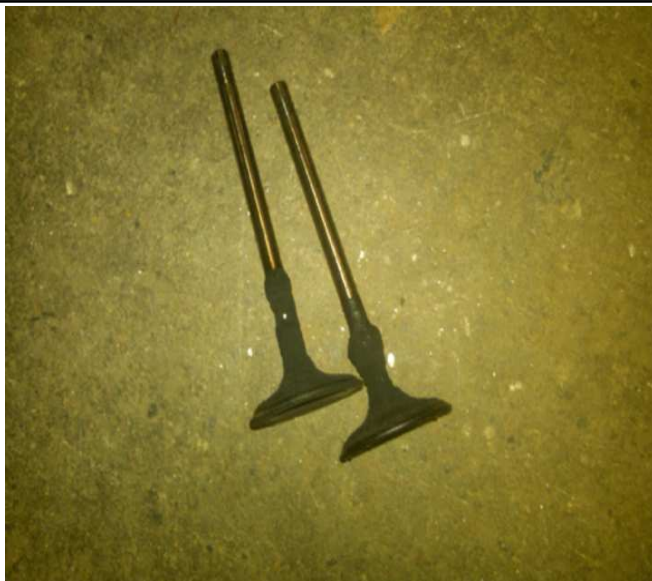
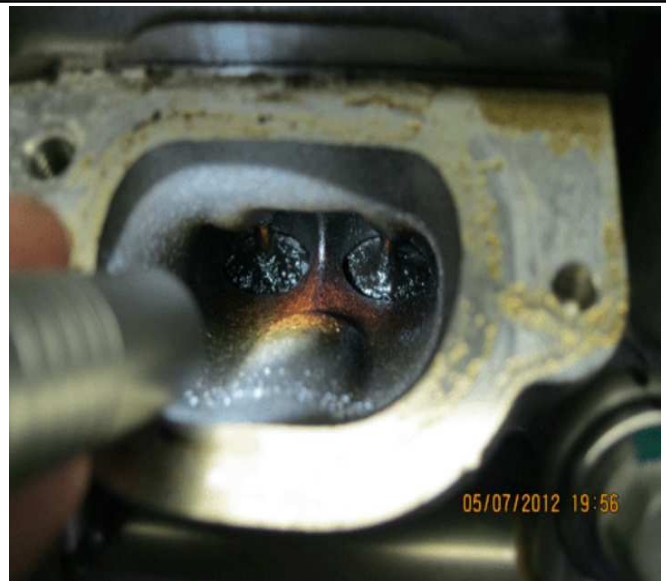
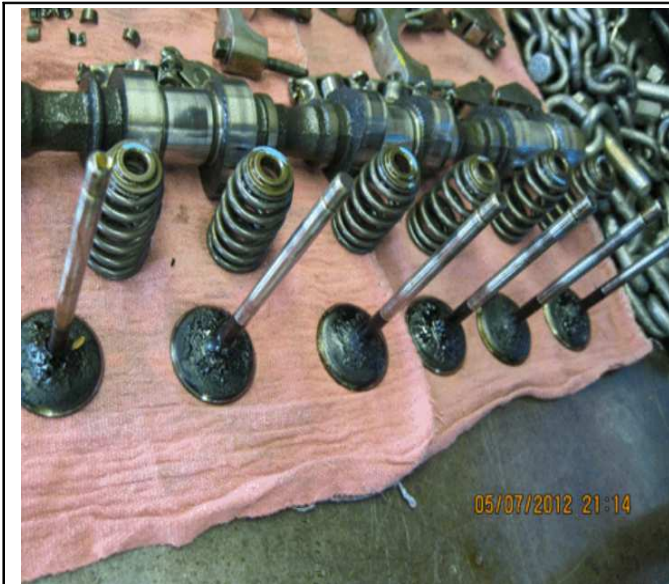
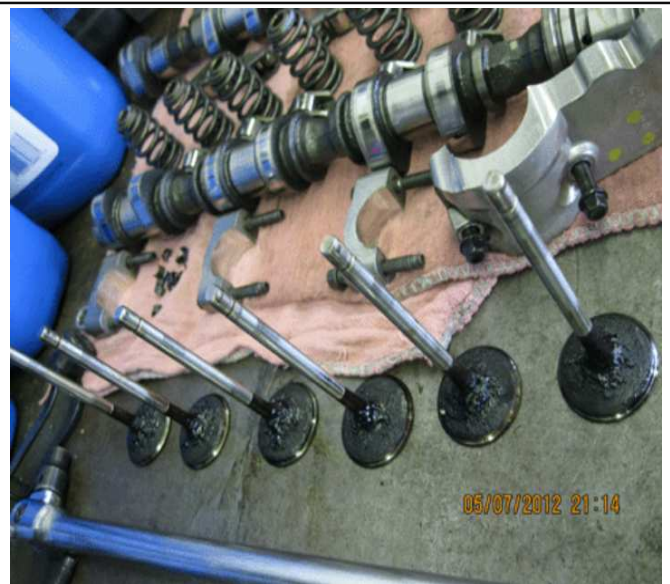
The graphics below may show typical carbon build-up during engine disassembly and inspection of the cylinder heads:

When the engine is cold, the compression on multiple cylinders may be at 0 kPa (0 psi). The engine also may pop through the intake or exhaust while cranking and the spark plugs may be fuel-fouled when inspected. Some engines may also experience valve damage or cam followers that are out of position as a result of this. If this concern is encountered, perform SI diagnosis. If the SI diagnosis leads to a compression loss due to a valve sealing concern and/or eliminates everything else external to the engine, the following information may help:

- If there is no sign of valve damage or cam followers that are out of place, perform the following procedure to free up sticking valves and to remove carbon from the valves and pistons.
- If valve damage is present or if there are cam followers that are out of place, perform engine mechanical repairs as necessary to correct the concern and then perform the procedure below to prevent the concern from returning.
- Perform an upper engine and valve cleaning procedure.
- Below are examples of valves that have gone through a Top Engine cleaning procedure.

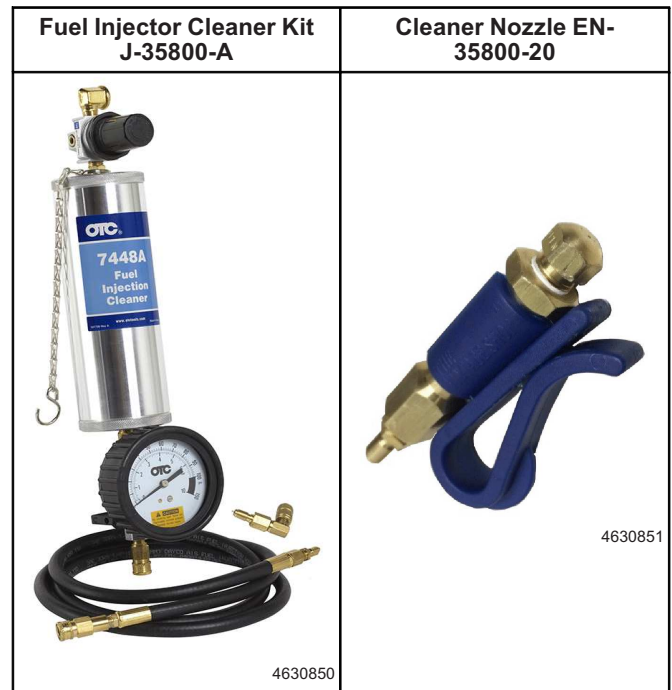
Important: Extreme care must be taken not to hydro-lock the engine when inducing the cleaner, especially if it is induced without Fuel Injector Cleaner Kit J-35800-A or equivalent. If too much cleaner is induced at too low of an RPM, or if you

force the engine to stall by inducing too much cleaner at once, the engine may hydro-lock and bend a connecting rod(s).

1. Fill Cleaner Kit J-35800-A with Top Engine Cleaner, approximately 473 ml (16 oz), and close the cap of the tool tightly. Set the air pressure to 260 kPa (40 psi) at the service tool.
2. Using GDS 2 or a Scan Tool, command engine idle to 2000 rpm to prevent the engine from stalling. Typically 2,000 rpm will be sufficient.

3. In a well-ventilated area with the engine at operating temperature, slowly/carefully induce the Top Engine Cleaner into the engine, which should take approximately 3 minutes.

- ⇒ For best results, it is suggested to induce the cleaner through the throttle body with Fuel Injector Cleaner Kit J-35800-A or equivalent and NEW Cleaner Nozzle EN-35800-20, which has been developed to help atomize the cleaner.
