TECHNICAL SERVICE BULLETIN

Manual Rear Door Lock Inoperative - Built On Or Before 21-Apr-2020

20-2245
28 July 2020

Ford 2020 Explorer

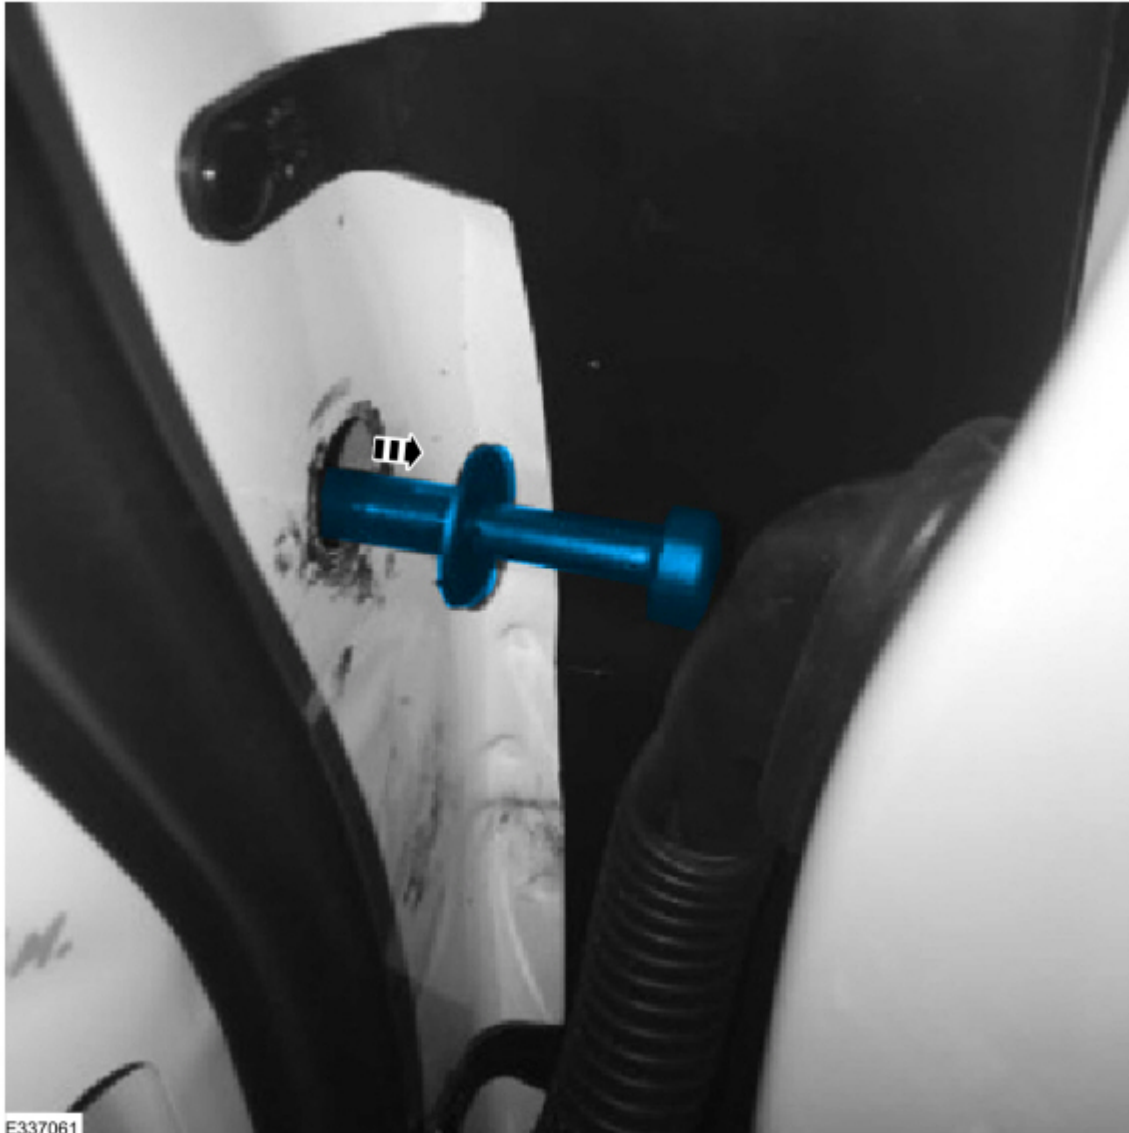
Figure 1

Issue: Some 2020 Police Interceptor Utility vehicles built on or before 21-Apr-2020 may exhibit inoperative manual rear door locks. This may be due to the manual rear door lock cable becoming dislodged from the rear door. To correct the condition, follow the Service Procedure steps to apply adhesive to the manual rear door lock cable.

1. Remove the interior rear door handle and rear door window control switch covers by removing the 8 Torx® fasteners.
2. Remove the rear door window regulator and motor. Refer to Workshop Manual (WSM), Section 501-11, Steps 1-6.
3. Push the manual rear door lock cable to extend the grommet approximately 25.4 mm (1 inch) from the rear door surface. (Figure 1)
