## SERVICE BULLETIN

**APPLICABILITY:** 2014-2017MY Forester

**NUMBER:** 12-223-17

**SUBJECT:** Roof Spoiler Cushion Protrusion

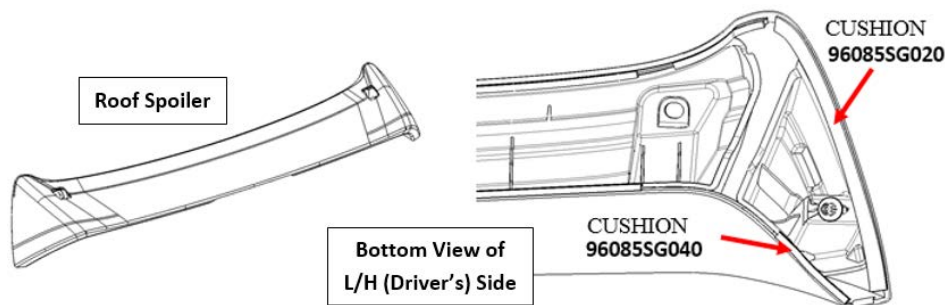
This bulletin provides a procedure for replacement of the black foam rubber insulating cushions for the roof spoiler. In rare cases, the cushion(s) may come loose and begin to protrude out from under the end portions of the roof spoiler where they contact the body.

- Remove the roof spoiler following the procedure in the applicable Service Manual. Always place the spoiler on a blanket (or equivalent) to protect the painted surfaces from damage while performing the repairs.
- **IMPORTANT:** Only remove the 2 cushions indicated in the illustration above.
- Use a mild solvent or parts cleaning spray on a clean shop cloth to remove any residual adhesive and / or remains of the cushions. Make sure the surfaces are totally clean or, the effectiveness of the new part's adhesive may be compromised.
- Familiarize yourself with the proper locations **before** peeling the self-adhesive tape backing on the new cushions as shown below.
- The new cushions need to be within .5 mm of the inside of the molded-in guide line but CANNOT be on it or covering it.
- The smaller (96085SG040) cushions may be slightly shorter than the originals but that is OK.

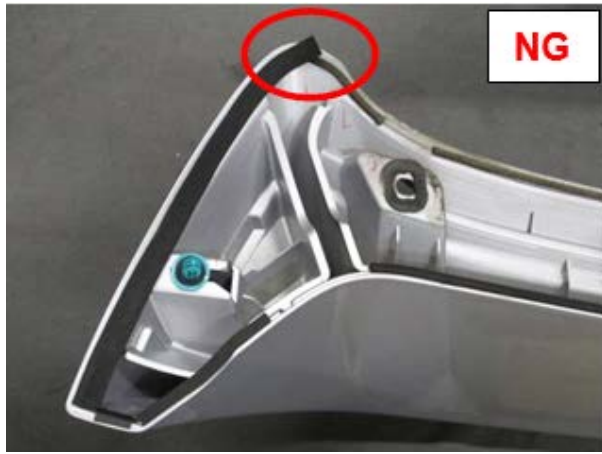
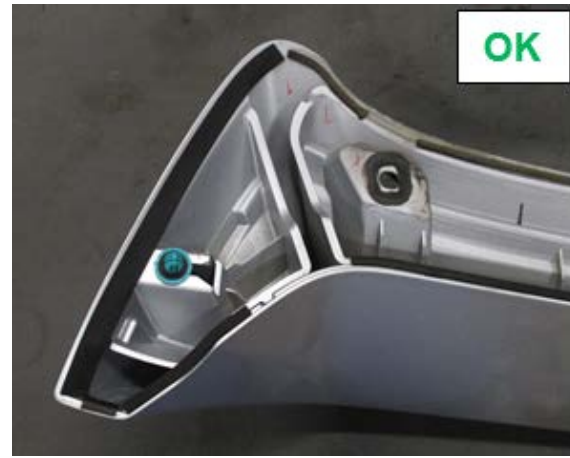
- Using the towelette included in the tape kit, apply adhesion promoter to the surfaces where the new cushions will be installed. (The tape supplied in the kit can be discarded.)
- When installing the larger (96085SG020) cushion, use caution to not stretch it or the end may protrude as shown below. CAREFULLY trim off any excess to look like the OK photo below.

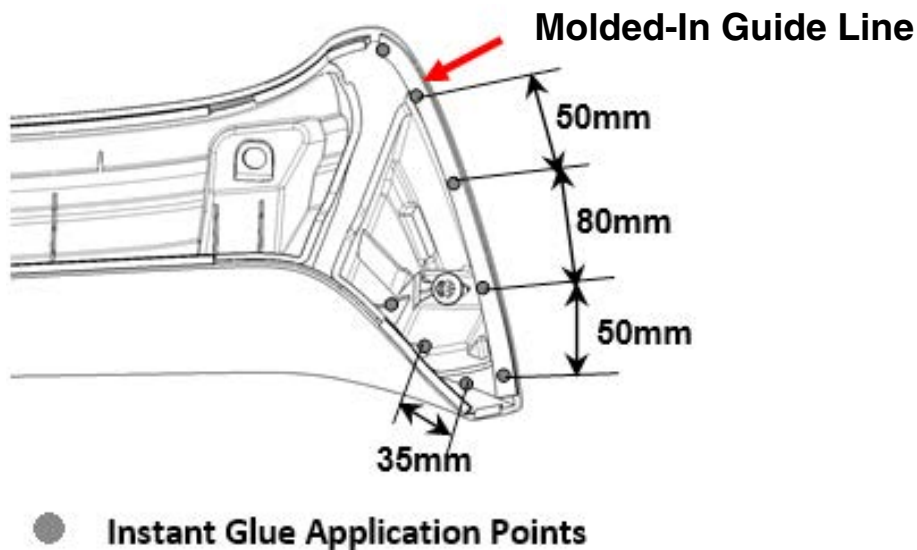
- After installation is complete, **CAREFULLY** apply a small **DROP** of the instant glue to the back side “corner” of the cushions where they overhang the inner spoiler edge. This step provides an extra measure of attachment to prevent the cushions from coming loose.
- **CAUTION:** When using instant glue, always make sure to read all instructions for use, precautions and warnings. Take all necessary precautions to prevent the instant glue from contacting painted finish surfaces of the spoiler.
- Use the illustration below as a guide for the instant glue application; **5** points on the large cushion and **3** points on the small one.

- Allow adequate time for the instant glue to cure (see instructions on package).
- Reinstall the spoiler in reverse order of removal.
