SERVICE BULLETIN

APPLICABILITY: 2020-21MY Legacy and Outback

NUMBER: 12-314-21

SUBJECT: Front Door Weatherstripping- Design Change

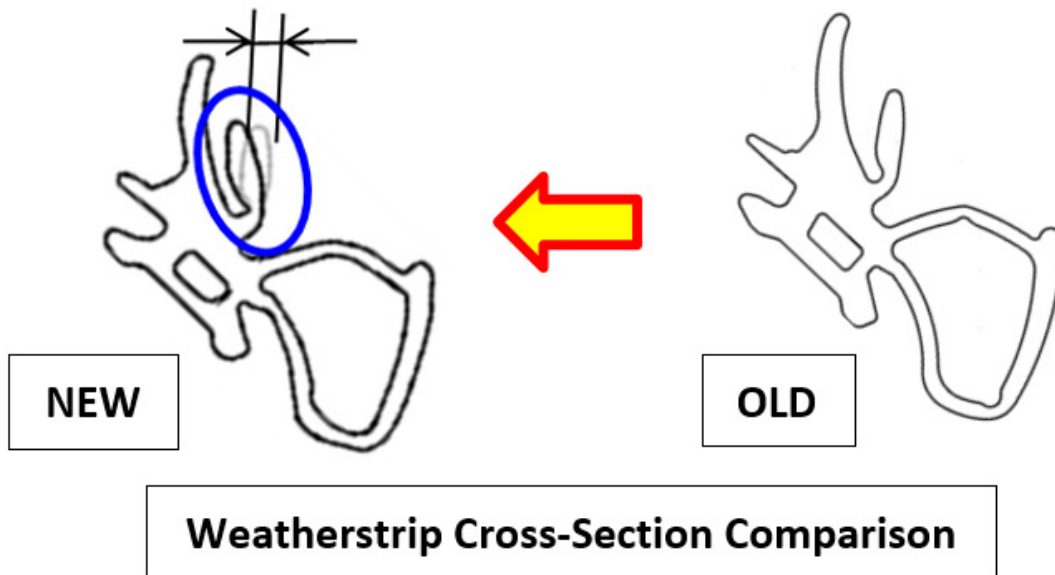
This bulletin announces availability of new weatherstrips designed to eliminate a squeaking / chirp -type sound heard when closing the front doors. The sound is audible when air trapped in the gap between sections of the weatherstrip is squeezed out as the door closes against the vehicle body. The shape (cross-section) of the weatherstrip was changed to reduce the amount of trapped air and eliminate the sound as shown in the illustrations below.

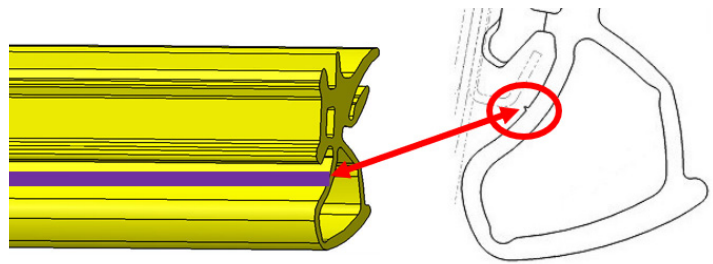
A small ridge has been molded in for identification.

- 63511AN00C for the **RIGHT** front door
- 63511AN01C for the **LEFT** front door.

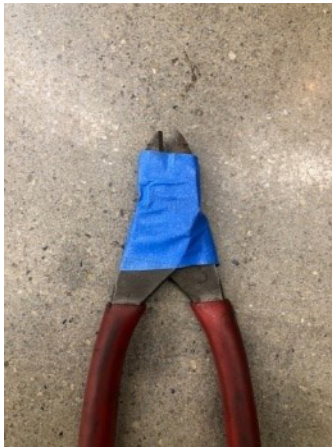
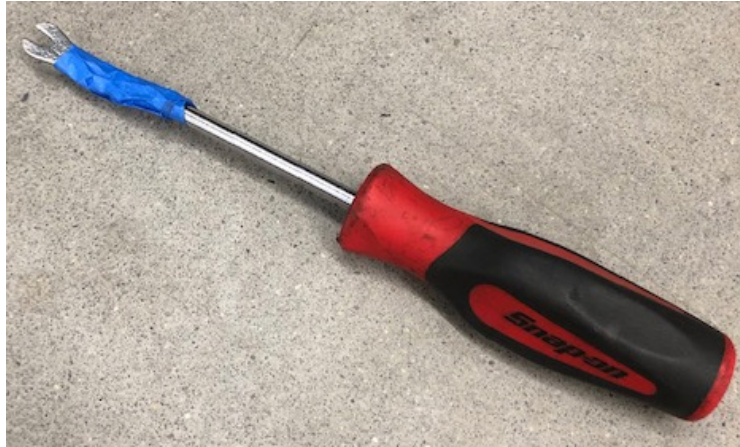
- Pair of Wire Cutters taped to protect the vehicle finish as shown OR a small trim clip removal tool as shown below (e.g. Snap On ASG185B, also taped).

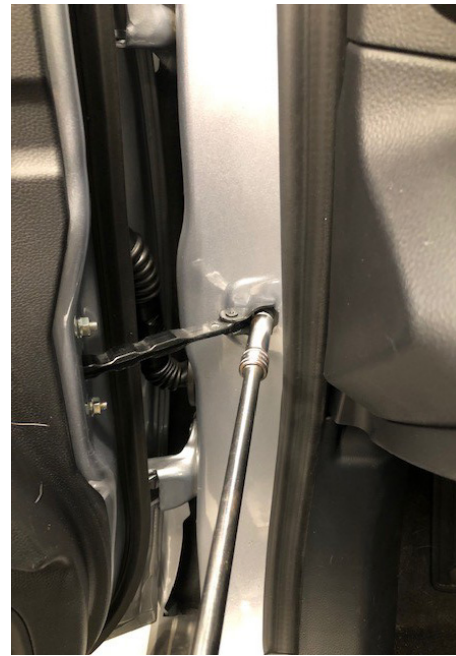
- Remove the 10 mm hex bolt securing the door checker to the body side of the door jamb. This bolt has to be removed as the weatherstrip is positioned between the checker and the door hinges. Once this bolt is removed, use **CAUTION** when moving the door to avoid over-extending it which will cause damage. It is also strongly recommended to avoid working in windy areas.

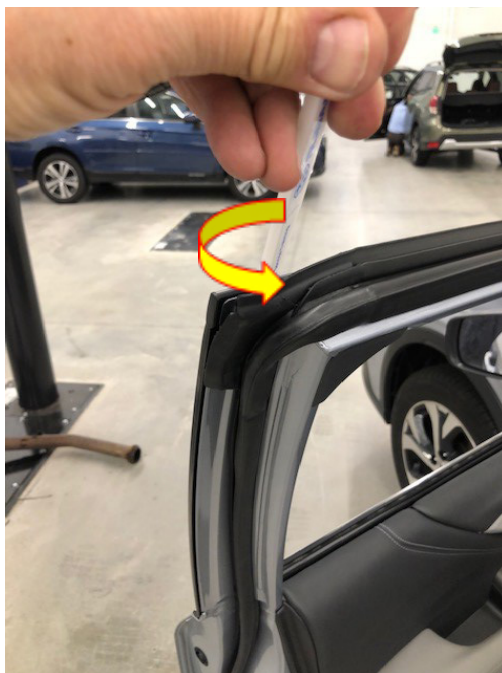
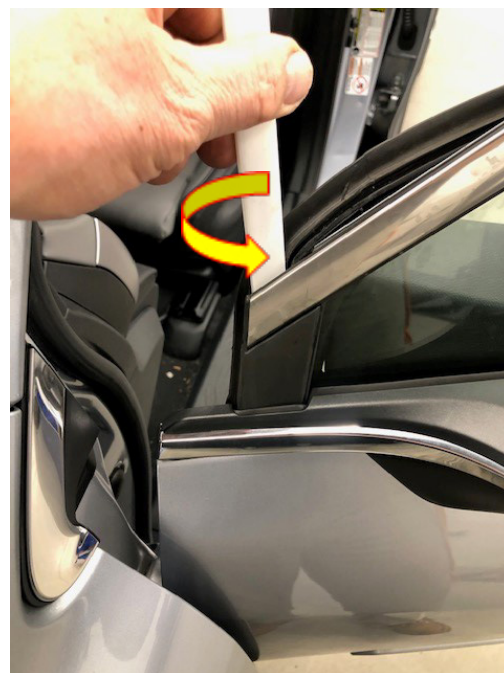
- Using the plastic trim tool, insert between the door frame and weatherstrip then twist it to release the 2 molded-in weatherstrip retaining clips as shown below. One clip is located at the top rear corner, the other in the front jamb area at the belt line.

- ✓ Use the top rear corner as the starting point for both the removal of the original **and** installation of the new weatherstrip.
- ✓ While removing the original weatherstrip, take note of how it is tucked into the channels at the top and back edges of the window frame to make installation easier.

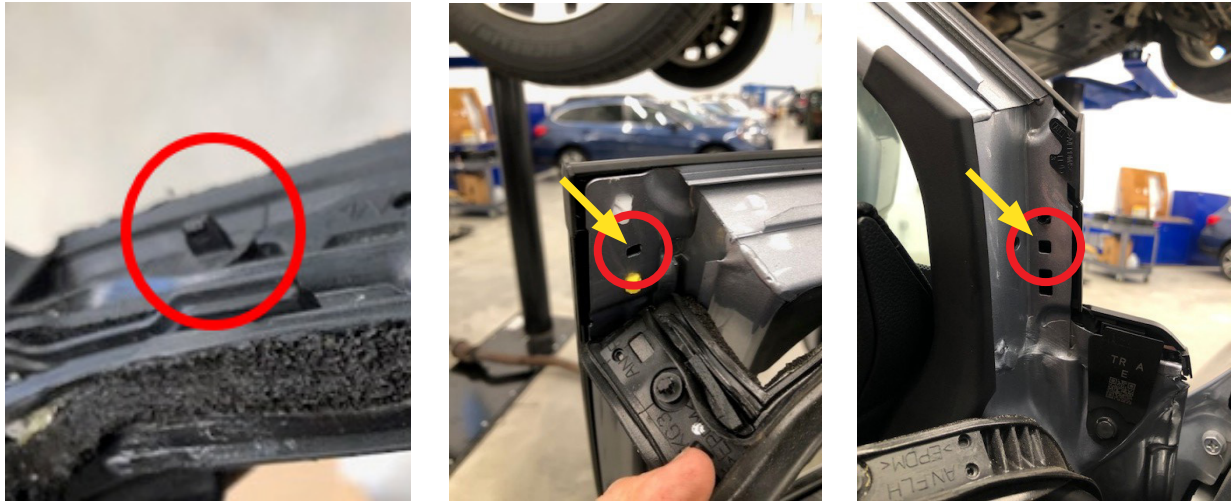
VERY IMPORTANT: The holes in the doors for these 2 clips are square. When installing the new weatherstrip, always confirm the retaining clips are properly aligned with the square holes **BEFORE** trying to push them into place. The clips are not serviceable separately and can crush or break if caution is not used when installing them.

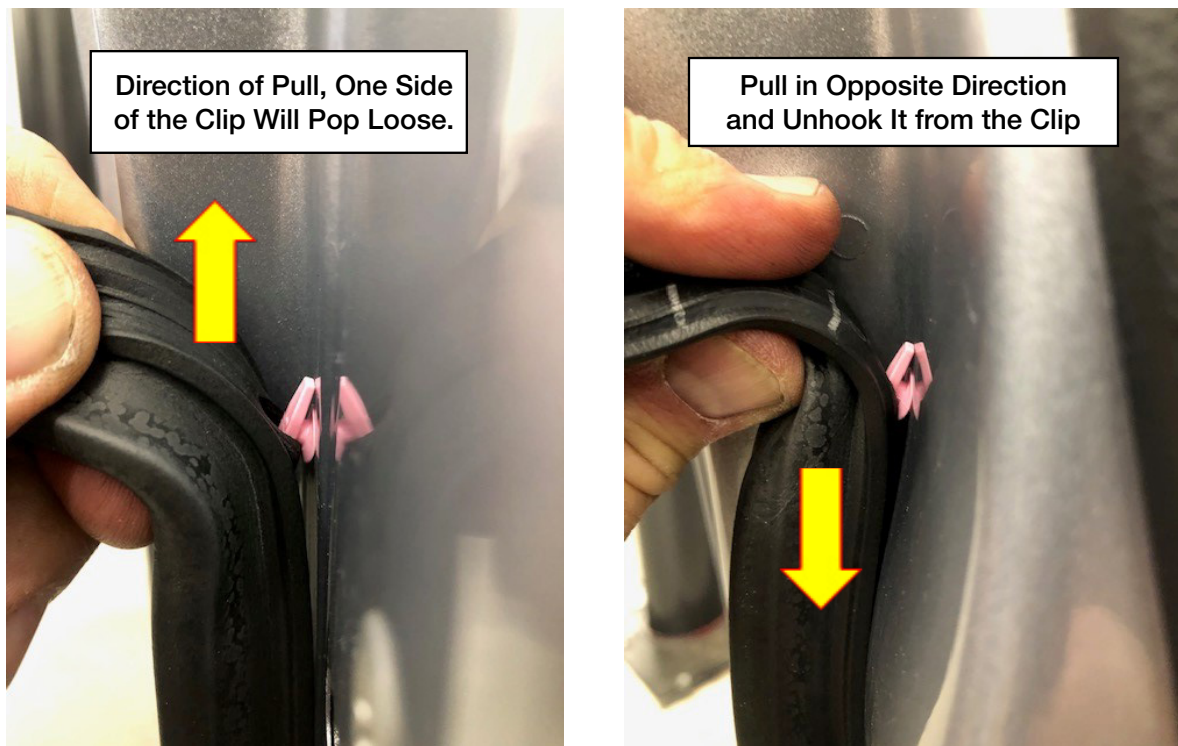
- Remove the original weatherstrip from the retaining T-clips securing it by **CAREFULLY** pulling the weatherstrip in one direction only enough to release it from one side of the “T” then unhooking it off the other side as shown in the sequence below. The replacement weatherstrips come with new T-Clips already installed.

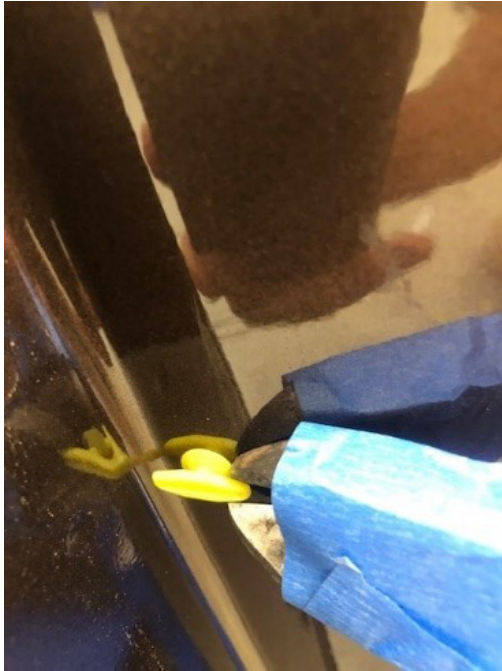
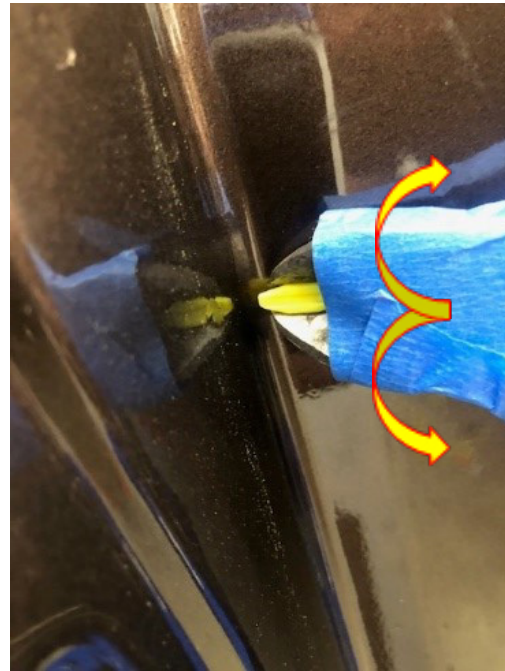
- Use the taped wire cutters or trim clip removal tool to **CAREFULLY** remove the T-Clips. When cutters are used, use caution to not cut the clips by squeezing too tight. “Rock” the cutter side to side or (if a trim clip tool is being used) pry to release but not break them. Any broken clips **must** be retrieved from inside the door to avoid possible rattle concerns.

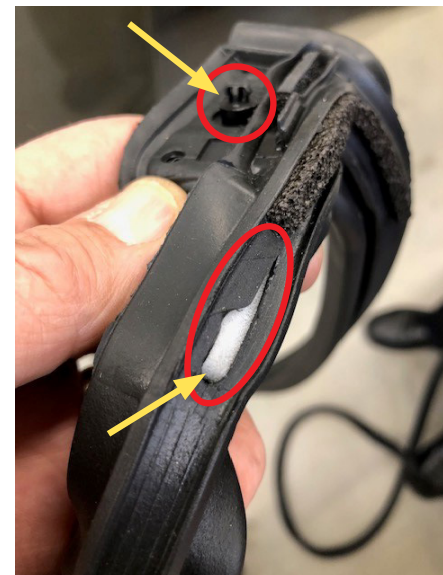
- As shown earlier, start in the upper rear corner when installing the new weatherstrip.
REMINDER: Make sure the 2 molded-in retaining clips are properly aligned with the square holes in the door frame **BEFORE** pressing them into place. The new weatherstrip has a foam “reinforcement” installed inside it near the corner as shown here. The molded-in retaining clip is also called out for reference.

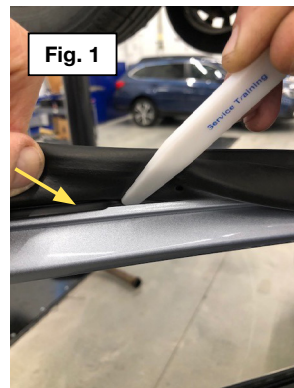
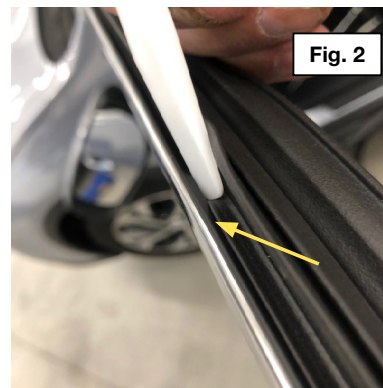
- With the top front corner locked in place, start working the new weatherstrip into the channels along the top and upper front edge of the door **CAREFULLY** using the trim tool as shown below in **(Fig. 1)**. **Fig. 2** shows the trim tool being used to tuck the outer lip of the new weatherstrip under the molding of the door frame. **Do not overlook this important step.**

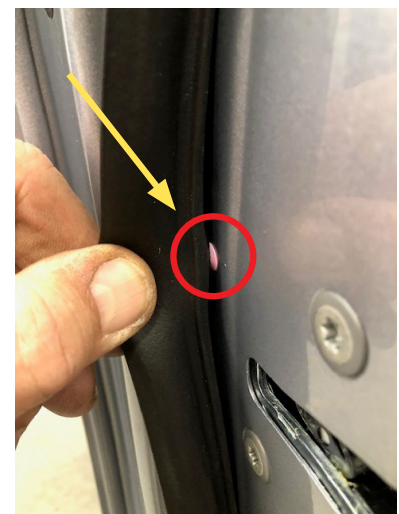
- After confirming alignment with the square hole in the door, press the front molded-in retaining clip into place.
- Make sure all **17** of the new weatherstrip's T-Clips align with their respective holes **BEFORE** starting to push them into place. Removing them without damaging them to re-position the new weatherstrip **MUST** be avoided. When all are installed, as a final check, go back over each one by lightly tugging on the weatherstrip as shown here to confirm all 17 of the clips are fully seated tight against the door frame.
- Reinstall the door checker hex bolt, torque to 33Nm (24 ft. lbs.).
- Road test the vehicle to confirm the repairs and complete the procedure.
