TECHNICAL SERVICE BULLETIN

Manual Sliding Door(s) - Various Manual Sliding Door Related Symptoms

21-2102

| Ford 2015-2021 Transit |

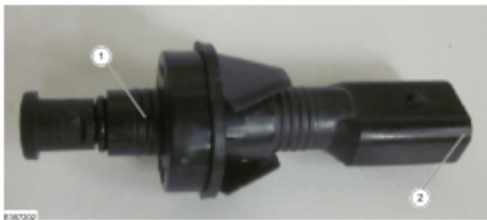
Figure 1

- (2). No - proceed to Step 6.
6. Remove the ajar switch mating connector. Tap the switch connector (Figure 1, Callout 2) lightly using a soft tool to move the switch housing outboard by about 3 to 4 grooves (Figure 1, Callout 1).

| Item | Description |
| 1 | Measurement grooves |
| 2 | Switch connector |

7. Reattach the mating connector.
8. For first time repair attempts, prepare a 5 +/- 0.25 mm spacer by stacking an appropriate number of hard cardboard strips (Example: oil filter box) and bind them together with painter's tape. (Figure 1) Proceed to Step 11.

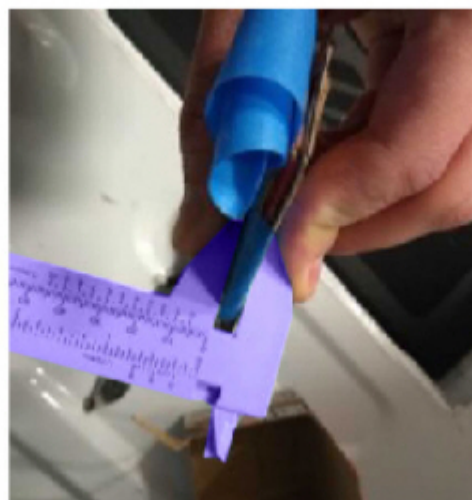
Figure 2

11. Attach the spacer to the inboard rear edge of the door so that the spacer will push on the switch plunger when closing the door. (Figure 2)

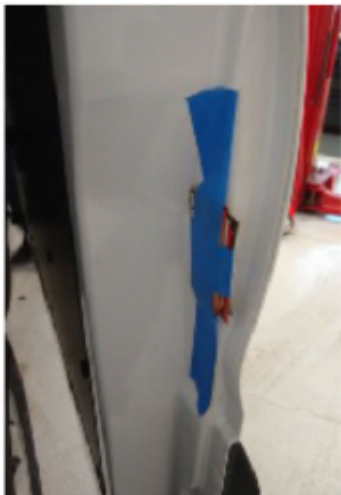
Figure 3

12. Slowly push the door to its fully closed position (2 clicks) to set the switch housing position.

NOTE: Closing the door with too much force or sliding it with too much speed may set the housing depth inaccurately.
