Warranty Extension: 2018-20 Accord Hybrid A/C Condenser

Supersedes 21-015, dated May 28, 2021, to revise the information in **yellow**.

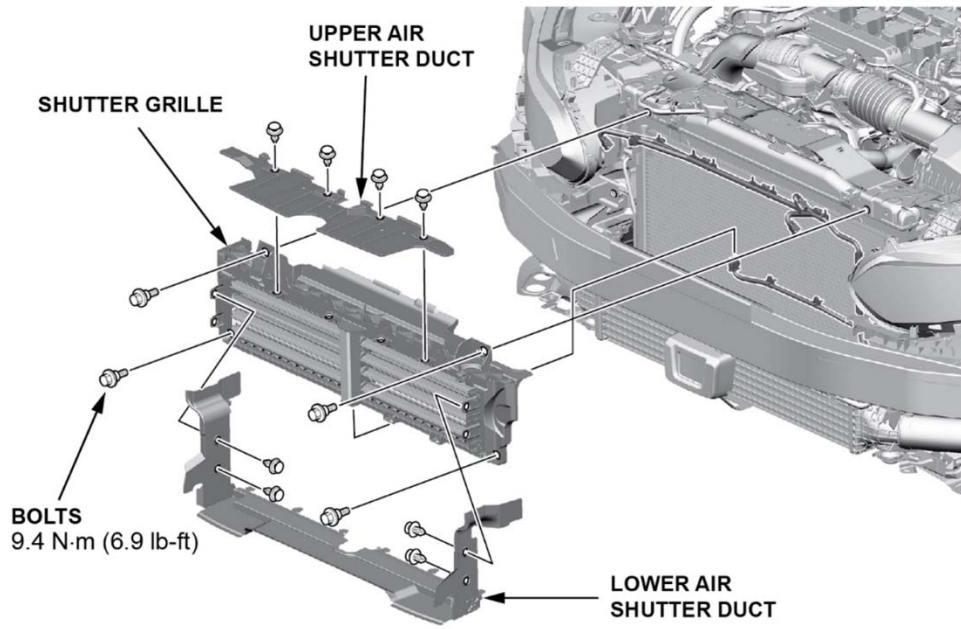
13. Check for leaks in the central condenser area.

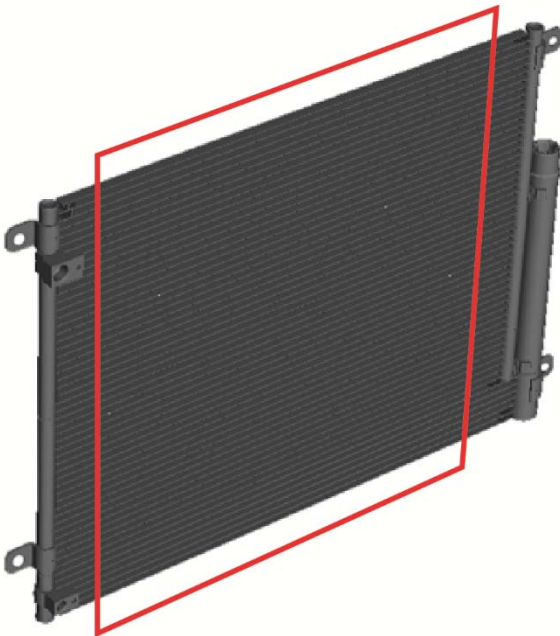
14. Check the joints between the horizontal tubes and the vertical pipes.

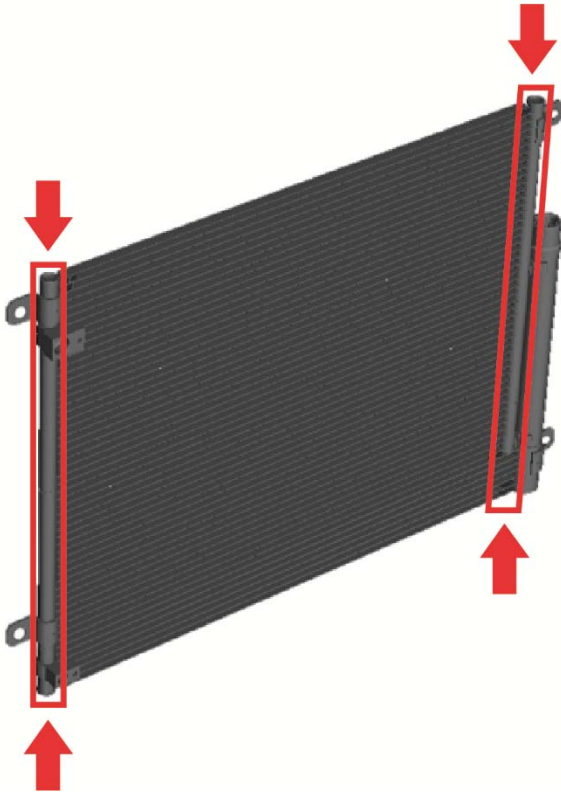
15. Check the inlet and outlet joints and the dryer cap for leaks.

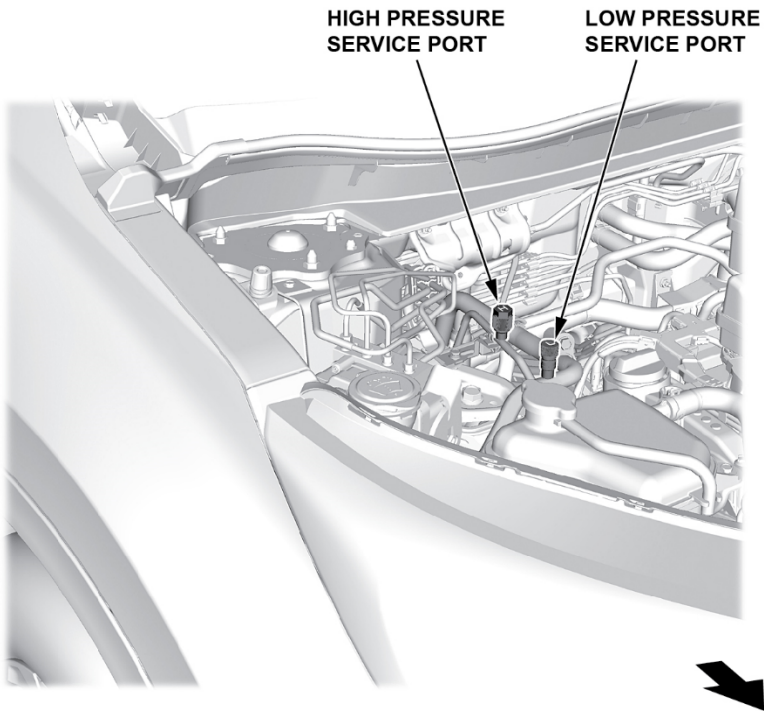
2. Recover the refrigerant from the A/C system.
3. Measure the amount of refrigerant oil removed from the A/C system after the recovery process is completed. Make sure to put the same amount of new refrigerant oil back into the A/C system before charging.

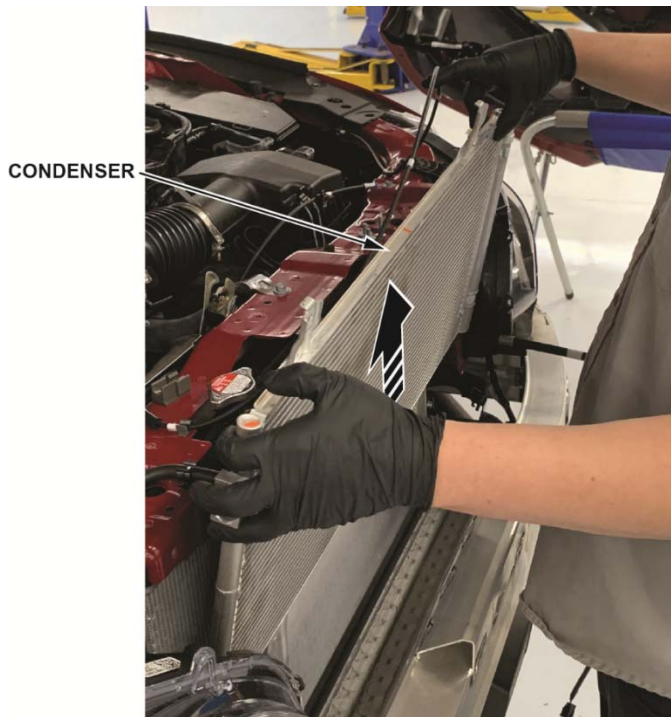
7. Install the new A/C condenser assembly.
8. Install all the removed parts in the reverse order of removal.
 - Receiver pipe – replace the 8 mm O-ring (80873-ST7-000)
 - Discharge hose – replace the 1/2 in O-ring (80872-SN7-003)
 - Shutter grille
 - Horns and horn brackets
 - Front center upper beam
 - Front bumper (Connect foglights if equipped)
 - Front, left front, and right front grille covers
