**SERVICE BULLETIN**

**APPLICABILITY:** 2020-21MY Outback

**NUMBER:** 12-322-21

**SUBJECT:** Cross Bar Integrated Roof Rails – Warped/Wavy Finish

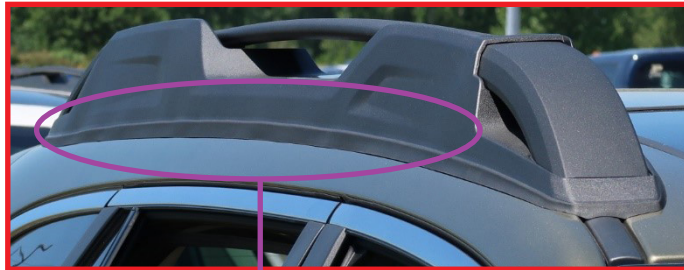
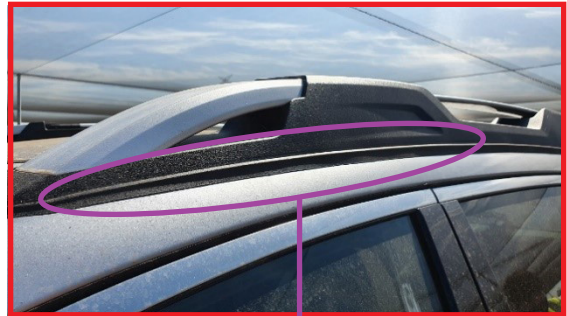
**EXAMPLE:**

This bulletin announces a design change made to the cross bar integrated roof rails. The new roof rails have added reinforcement ribs on the bottom of the rail cover section. The ribs enhance the roof rail rigidity and prevent any “warped” or “wavy” appearance of the rail cover. This condition can be caused by high ambient temperatures and / or extreme sunlight exposure.

**Effected Area of Rail Cover**
