Preliminary Information

PIC6439 Diagnostic Tip for a B1517 DTC

Brand:	Model:	Model Years:	VIN:		Engine:	Transmissions:
			from	to		
Chevrolet	Corvette	2014 - 2019	All	All	All	All

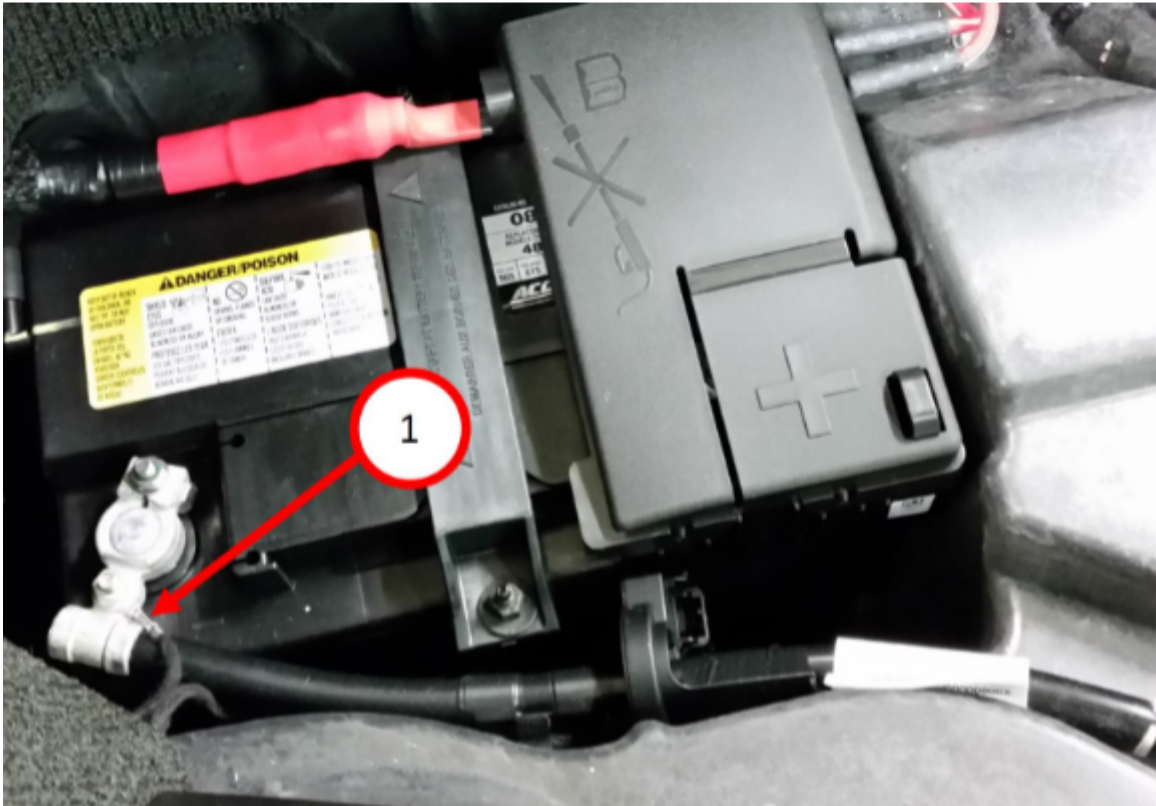
If a B1517 is found set in any module, or even multiple modules, dealership technicians are to first inspect the battery cable connections. In many cases, the small black wire that connects to the larger battery negative cable is loose or damaged. If the vehicle history is reviewed, or the customer is further questioned, it will usually be found that a battery was recently replaced in the vehicle. This may have been done by a tech unfamiliar with the vehicle, a different shop, or even by the customer himself.

Closely inspect the small black wire seen in the photo below. It may be loose, rotated, or pulled out of the actual terminal. Any loose connection or damage to this circuit may cause a B1517, especially with a symptom 5A.

It should also be noted that this is not a manufacturing concern, but rather this issue is caused by improper service work that was previously done on the vehicle. Resecure / repair the connection as needed.
