SERVICE INFORMATION BULLETIN

APPLICABILITY: 2013-20MY Crosstrek
 2010-20MY Forester
 2009-20MY WRX & WRX STI
 2013-20MY BRZ

SUBJECT: Wheel Lug Nuts- Design Change

NUMBER: 05-79-20R
DATE: 12/15/20
REVISED: 09/29/21

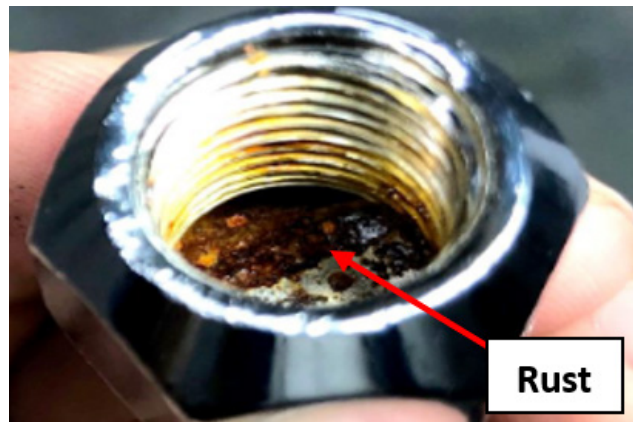
This Service Information Bulletin announces a change made to the wheel lug nuts on the models listed above. The change is in response to a number of reports describing rust inside of the nut as shown here in the example photo. A thicker plating surface is now applied during the manufacturing process to prevent rust from developing.

The new WHEEL NUT part number is **28171AJ001**.

NOTE: Any orders placed for the old part numbers **28171AG000** and **28171AJ000** will be automatically switched to the new **28171AJ001** part number.
