SERVICE BULLETIN

APPLICABILITY: 2015-19MY Legacy / Outback

NUMBER: 12-228-21

SUBJECT: Front Seat(s) / Squeaking Sound

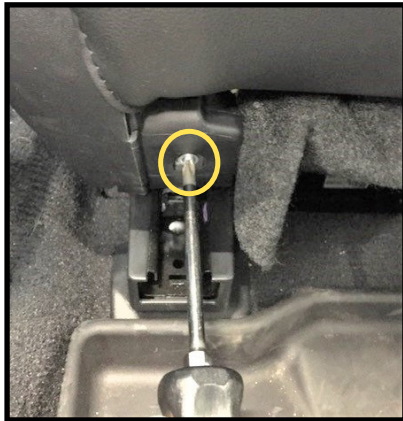
STEP 3) CAREFULLY remove the outer seat hinge cover by first removing the mounting screw located on the back outer corner of the seat. Release the clips and claws in the direction indicated below. This will expose the rear pipe and spacer washer on the outside section of the seat frame.

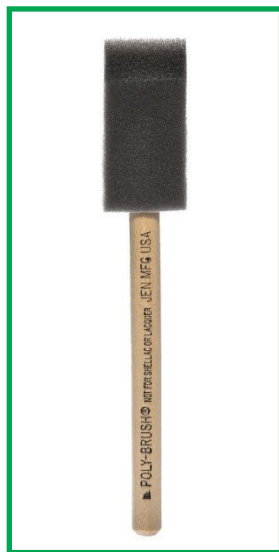
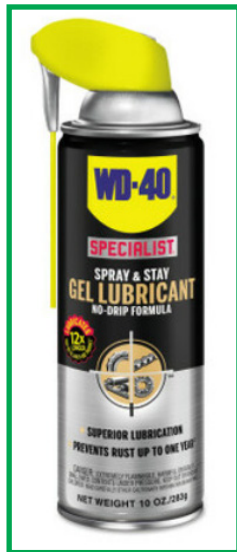
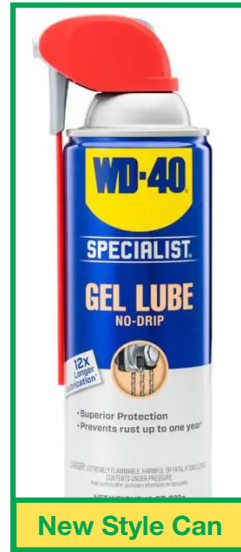
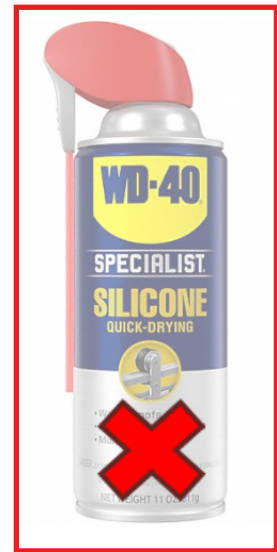
STEP 4) Prepare a foam brush with WD-40® Specialist Gel Lubricant Spray (MFG #300103). The lubricant packaging is outlined in **green** below. Saturate the foam brush with the lubricant. Both the lubricant and brush are available from most hardware supply outlets and/or online resources.

CRITICAL: DO NOT use any silicone base lubricant (EXAMPLE is outlined in **red** below). Use of a silicone base lubricant may damage the surrounding electronic components.
