Bulletin No.: PIT5866

## PIT5866 Home Screen Bar missing on left side of Integrated Center Stack (ICS)

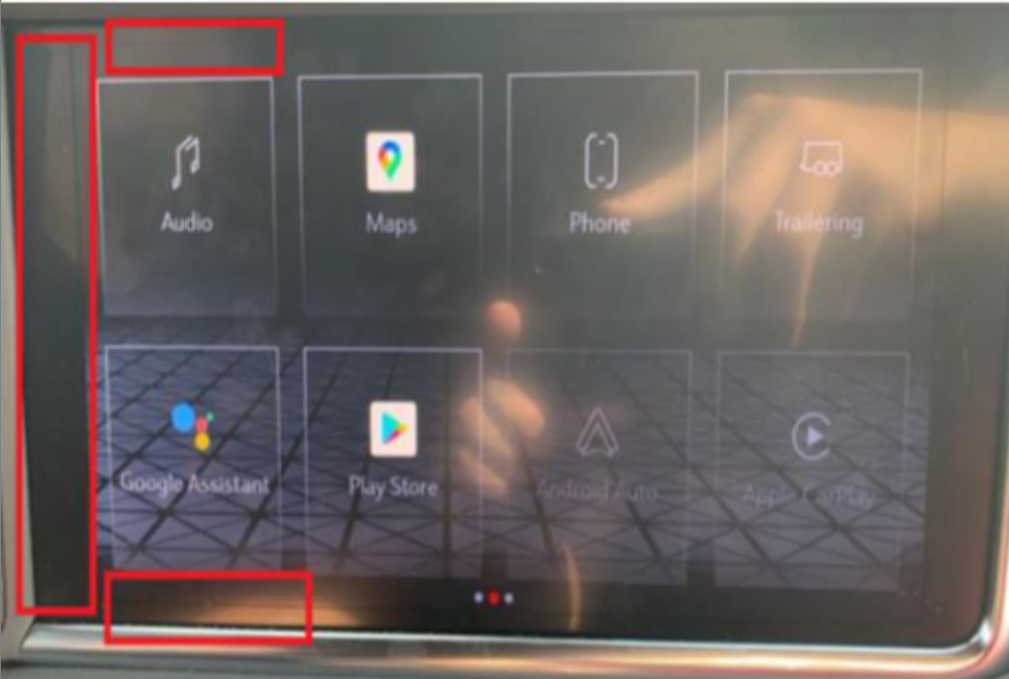
<b>Involved Region or Country</b>	<b>United States, Canada, Mexico</b>
<b>Additional Options (RPO)</b>	IOK
<b>Condition</b>	<p><b>Customers will notice that the home screen bar is missing on the left side of the display.</b></p> <p><b>EX. Defect</b></p>

Condition is occurring in W160.4 software and reason is unknown at this time.

**General Motors Engineering is investigating the concern and once a repair is available this PI will be updated. Please do not replace any parts for this issue**
