Preliminary Information

PIC6293F Installation Of the GM Accessory Interior Spectrum Lighting Kit

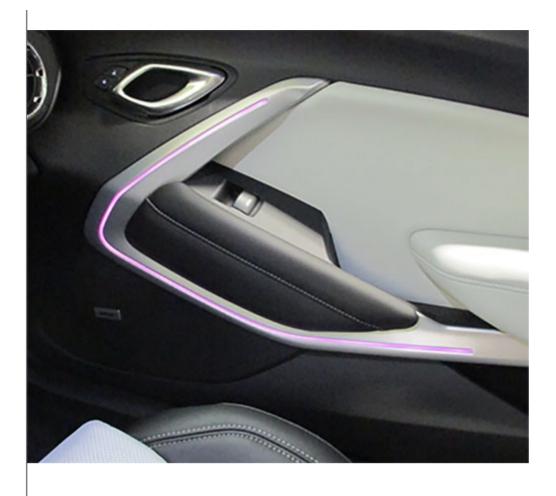
2) Footwell Lighting only

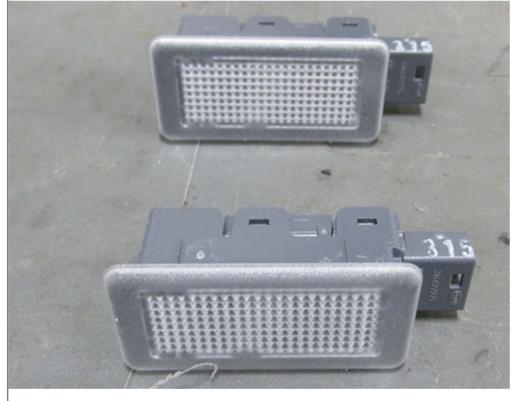
3) Light up Accent Lighting on the door panels AND Footwell Lighting

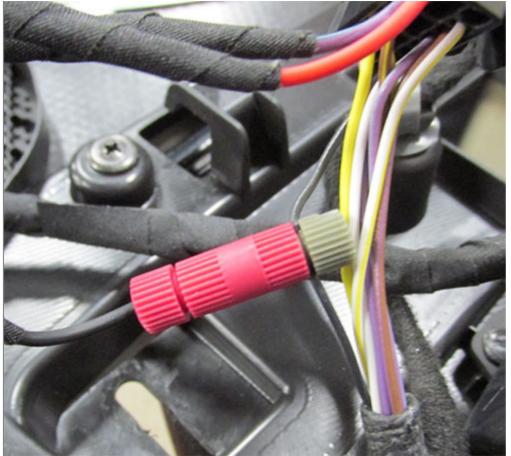
- Another common issue that is seen relates to the Posi-Tap connectors used in the kit. These connectors are used to splice the accessory harness to the vehicle's wiring harness. Dealership technicians are to go back through the installation and verify that each connector is tight. If one or more of these connecters is/are loose, this will cause any number of performance issues with the kit. The connector shown in the photo below does not have tape or a zip tie covering it for clarity. Once the connector is properly installed, the instructions have the technician tape back the splice to the main harness using cloth tape. This will prevent the connector from loosening up over time.
