FORD:

2006-2015 F-650, F-750

Some 2006-2015 F-Super Duty 650/750 vehicles equipped with exterior tubular stainless steel west coast style mirrors may have a loose mounting bracket due to poor rivet retention.

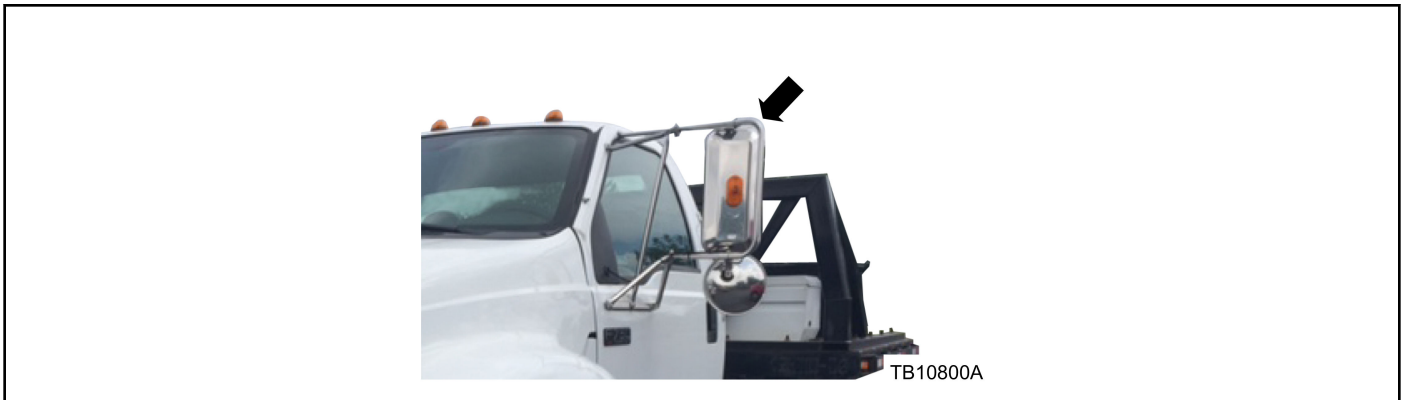
Figure 1 - Article 15-0164

1. Is the vehicle equipped with exterior tubular stainless steel west coast style mirrors? (Figure 1)

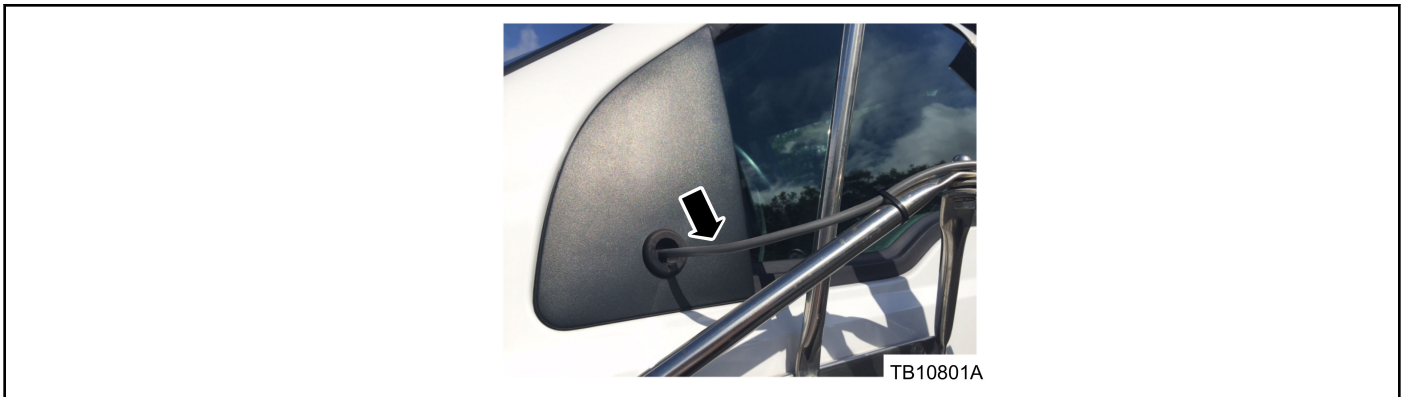
Figure 2 - Article 15-0164

- a. Yes - proceed to Step 2.
 - b. No - this article does not apply.
2. Is there a wire harness routed from the door sail panel to the exterior tubular stainless steel west coast style mirror head? (Figure 2)

- a. Yes - use the heated sail mirrors and proceed to Step 3.

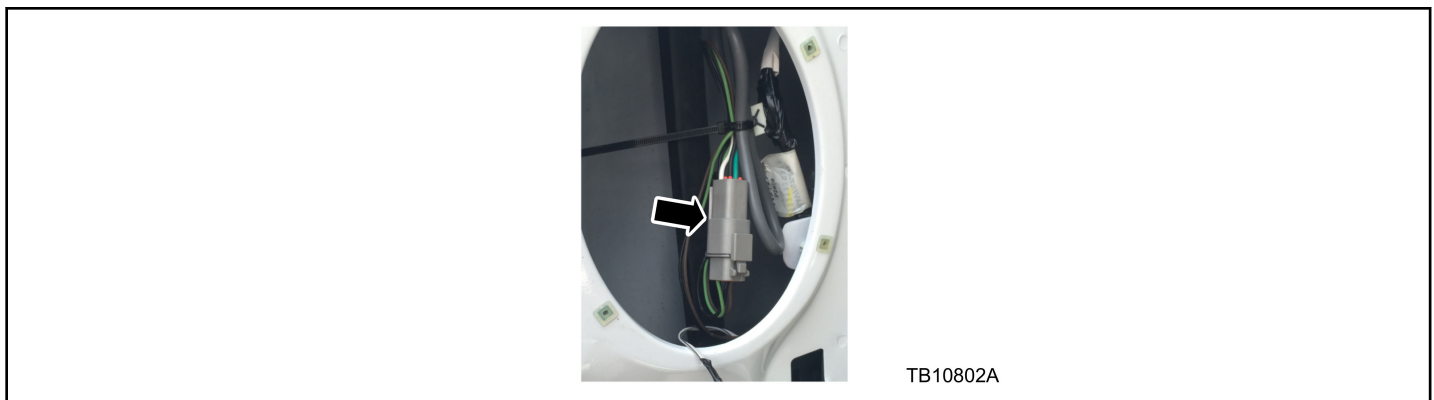
Figure 3 - Article 15-0164

- 6. Locate the exterior tubular stainless steel west coast style mirror wiring from the door sail area and follow the harness down to the mirror 6-way electrical connector, accessing it via the speaker opening in the door sheet metal. (Figure 3)

- 7. Is the color of the exterior tubular stainless steel west coast style mirror electrical connector shell black? (Figure 3)
 - a. Yes - cut the yellow/white/green wires 100 mm (4") from the back of the 6-way mirror connector.
 - b. No - cut the green/white/black wires 100 mm (4") from the back of the 6-way mirror connector.
- 8. Remove the four (4) rubber plugs to access the sail panel retainers.
- 9. Remove and discard the four (4) exterior sail panel attachment nuts. (Figure 4)

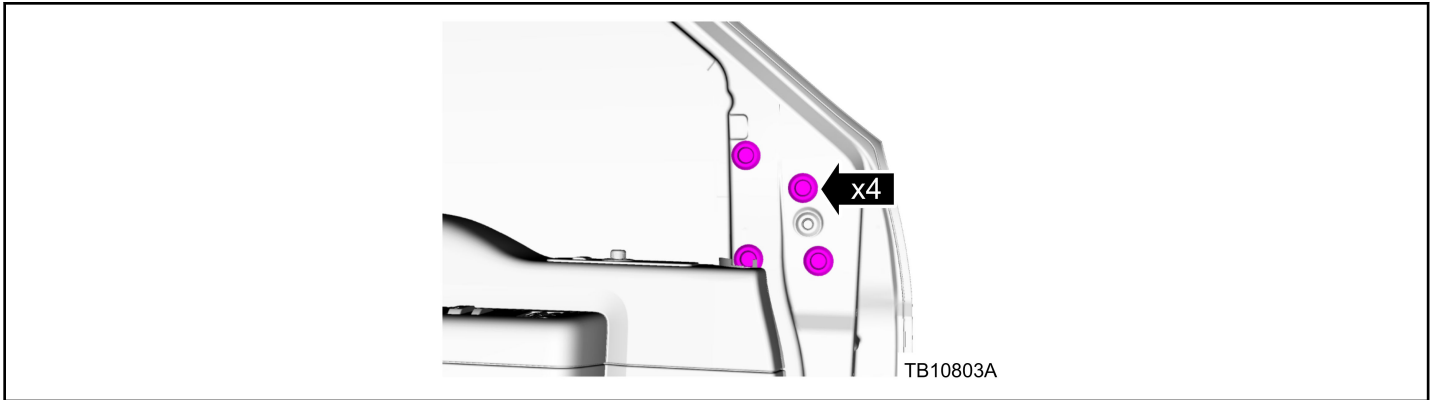
Figure 4 - Article 15-0164

- (4) Remove the exterior sail panel. Refer to Workshop Manual (WSM), Section 501-09.
 - (5) Attach the non-heated sail mirror to the door and install the four (4) mirror attachment nuts. Tighten to 11 Nm (97 lb-in.). (Figure 4)

12. Feed the new sail mirror wire harness through the access hole in the sail mount surface as the mirror assembly is placed into its mounting position and install the four (4) mirror attachment nuts. Tighten to 11 Nm (97 lb-in) (Figure 4).
