TECHNICAL SERVICE BULLETIN

Shifter Not Moving The Transmission To The Proper Gear Position

22-2066

Ford
2013-2018 C-MAX Hybrid
2015-2018 Edge
2014-2019 Escape
2013-2016 Fusion
2013-2021 Transit Connect

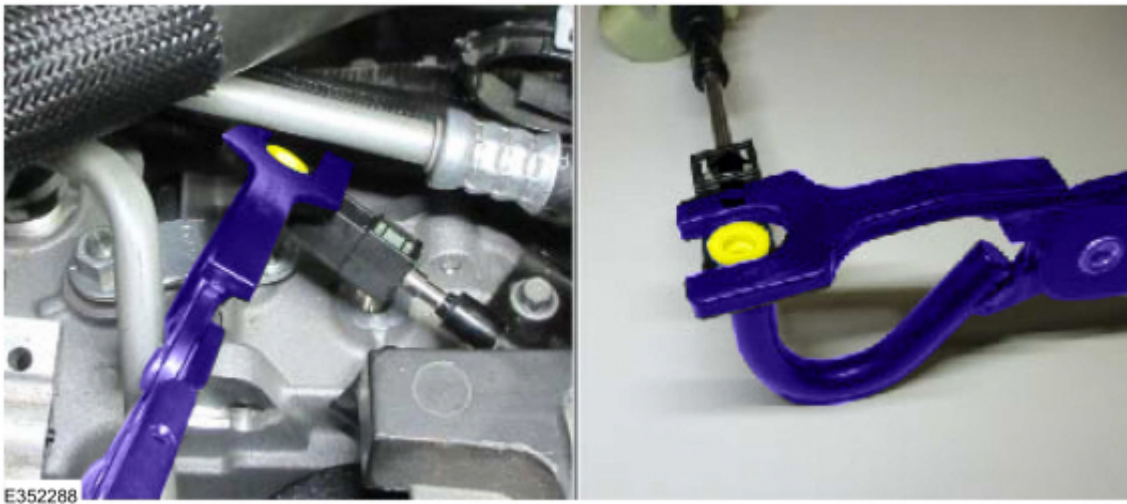
Figure 7

- Using a tool such as a Lisle 38350 - Exhaust Hanger Removal plier to press bushing out. The shoulder of the bushing is positioned upward, small end of plier is pressing the bushing out. (Figure 7)

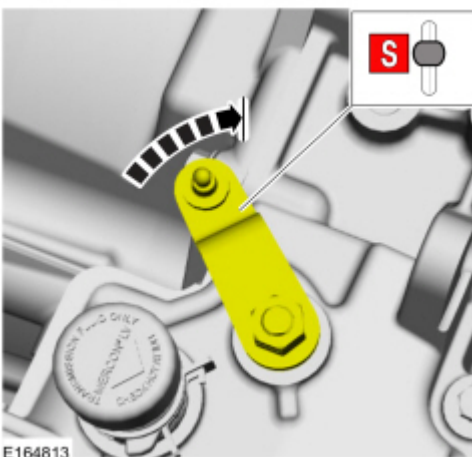
Figure 9

5. Place the vehicle's transmission gear selector in drive (D).
6. Rotate the manual control lever clockwise until it stops. (Figure 9)
