TECHNICAL SERVICE BULLETIN

Snap, Click And/Or Pop Noise From The Door Check When Opening/Closing The Front Door(s)

22-2321

Ford 2015-2022 Transit

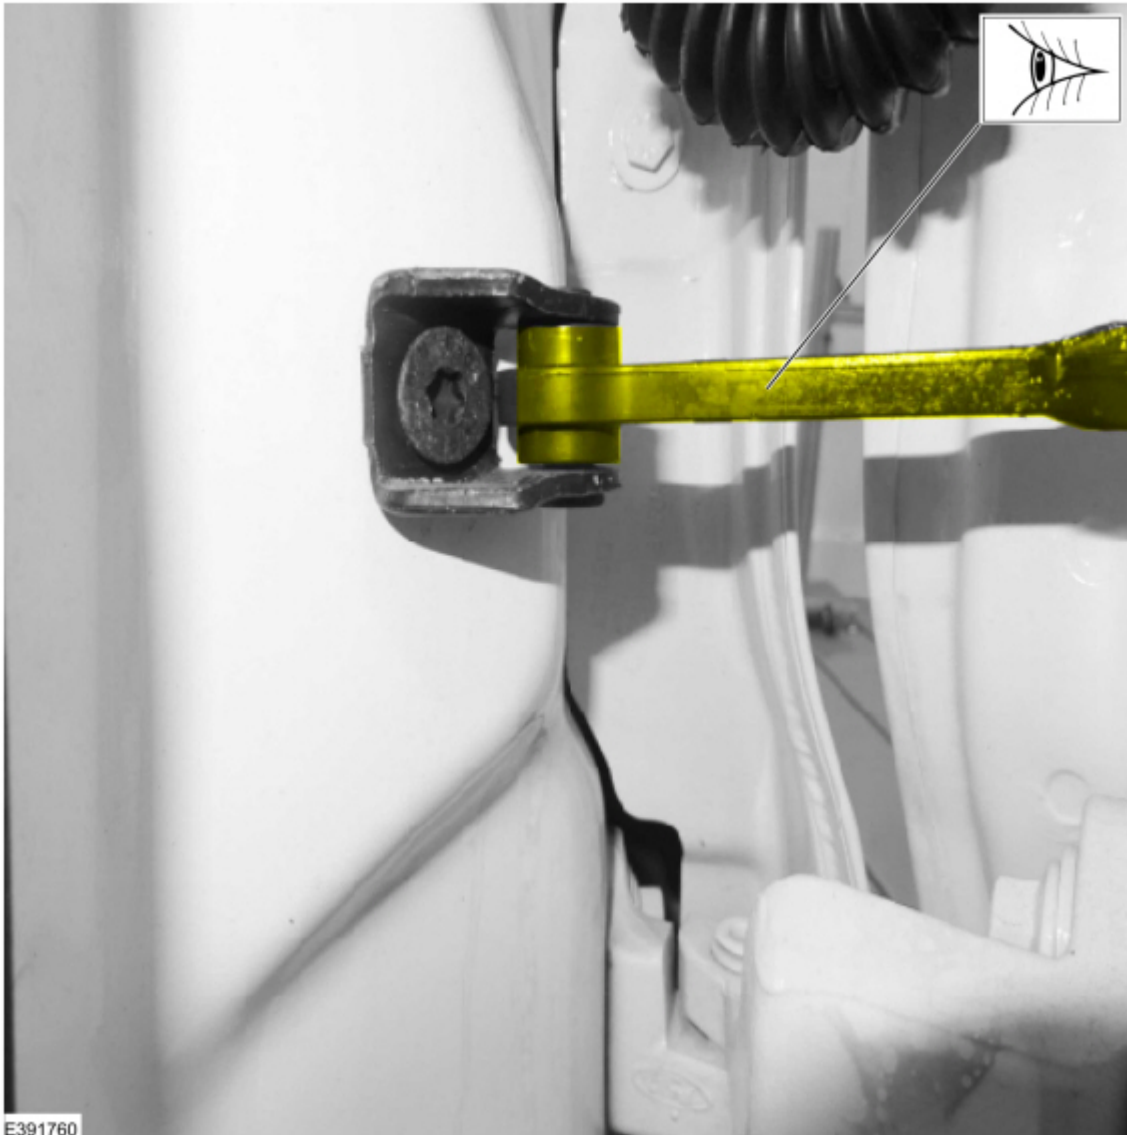
Figure 1

1. Inspect the door check. (Figure 1) Is the door check cracked/broken?

(1). Yes - replace the door check and fastener. Refer to Workshop Manual (WSM), Section 501-03 Body Closures. Proceed to Step 2.

(2). No - replace only the fastener. Proceed to Step 2.
