## TECHNICAL SERVICE BULLETIN

### Moan Noise In The Rear Brakes When Vehicle Is Driven In Reverse On Cold Weather And/Or High Humidity

22-2326

<b>Ford</b>
2021-2022 Bronco Sport
2020-2022 Escape

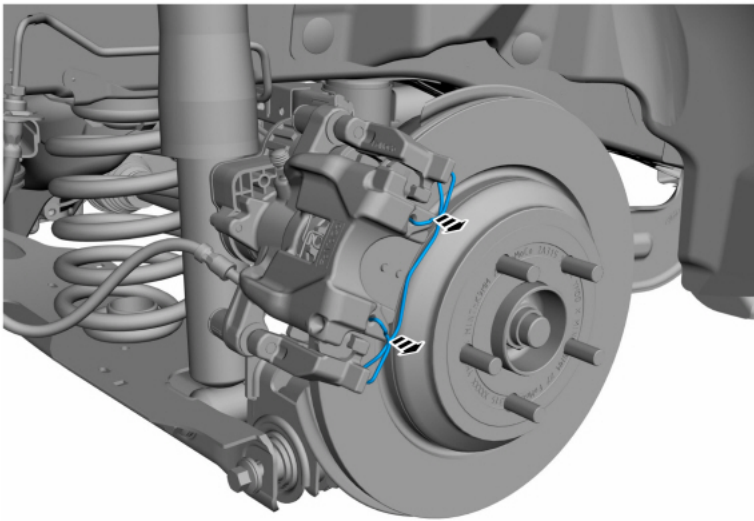
Figure 1

1. Activate the brake service mode. Refer to the Workshop Manual (WSM), Section 206-00 Brake System > General Information > General Procedures.
2. Remove the wheel and tire. Refer to the WSM, Section 204-04A Wheels and Tires > Removal and Installation.
3. Remove the brake caliper spring. (Figure 1)

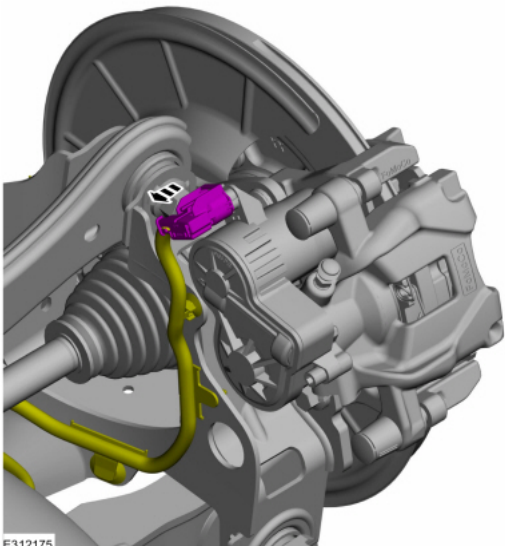
Figure 2

4. Disconnect the parking brake electrical connector. (Figure 2)

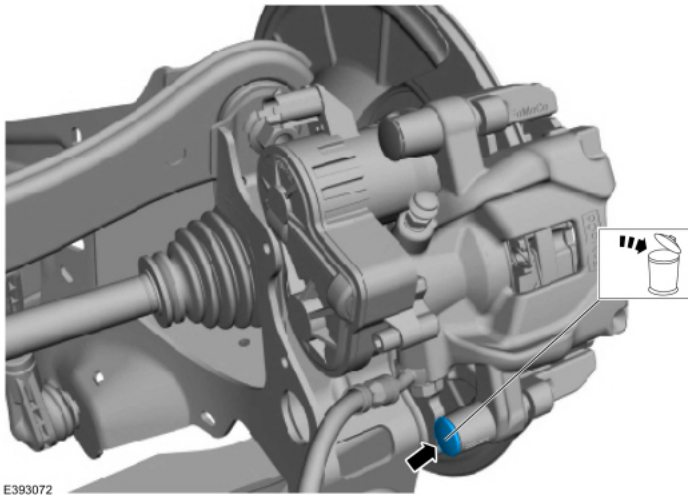
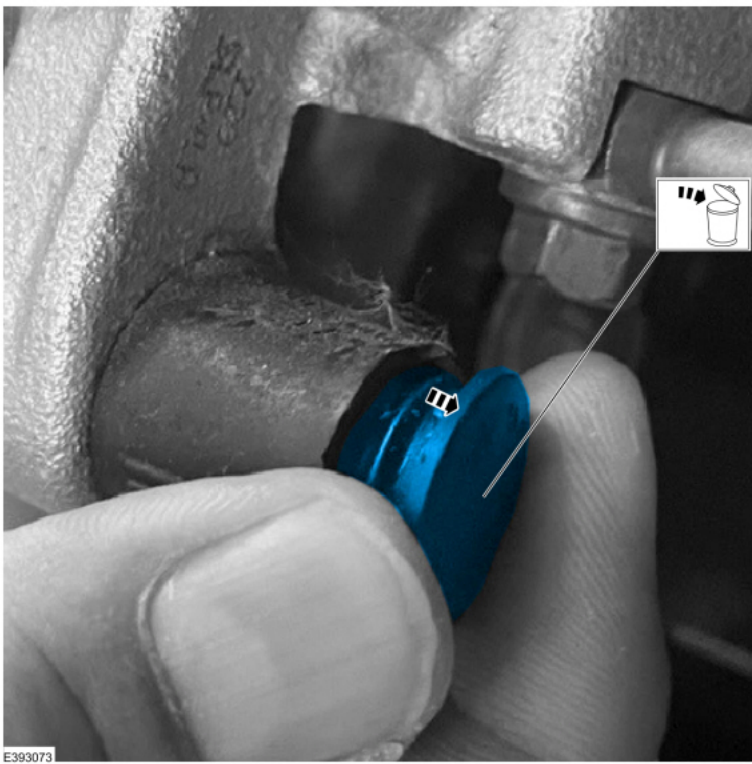
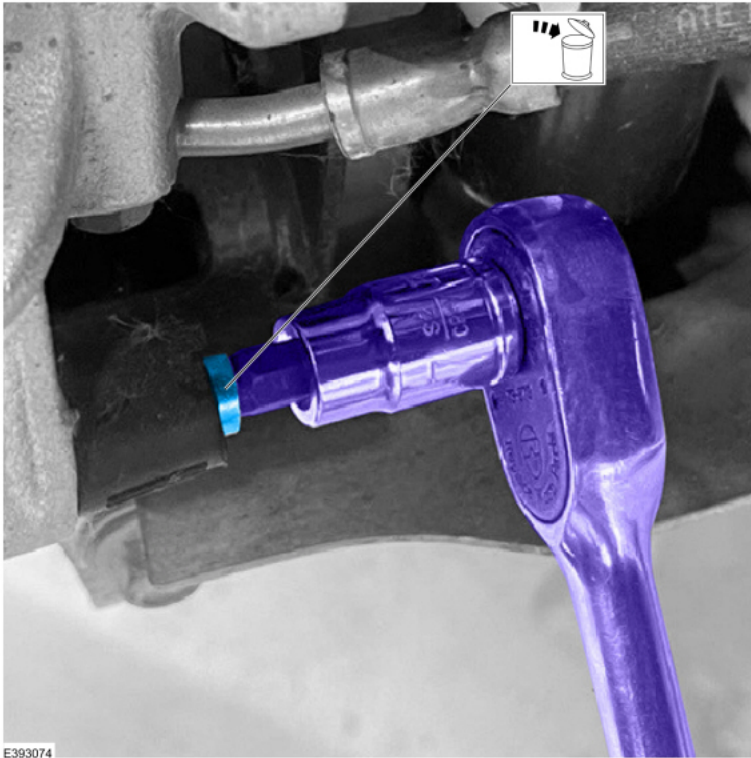
5. Remove and discard the brake caliper guide pin cap and guide pin on the opposite side of the bleeder. (Figures 3-5)

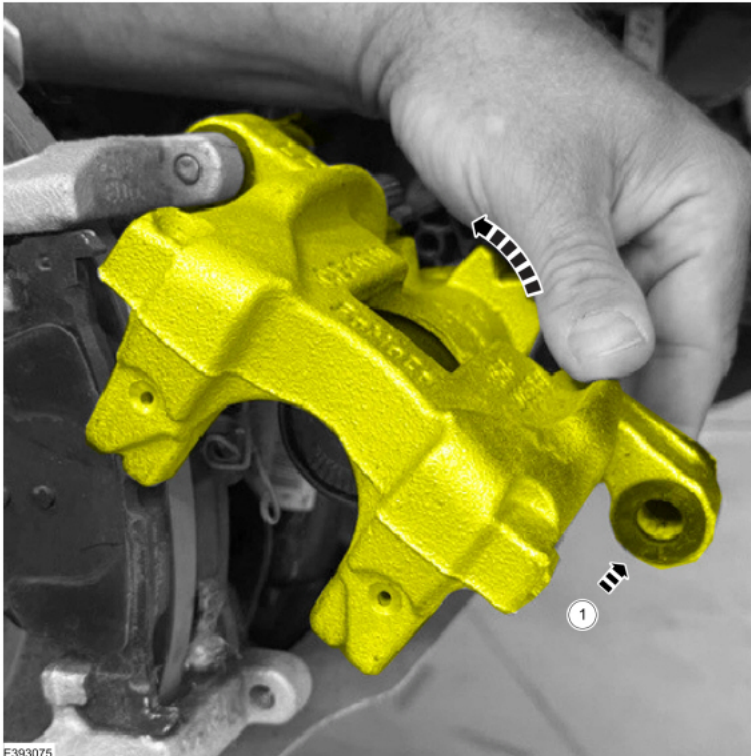
6. Rotate the rear caliper upwards to access to the bushing housing. (Figure 6, Callout 1)  
Figure 6

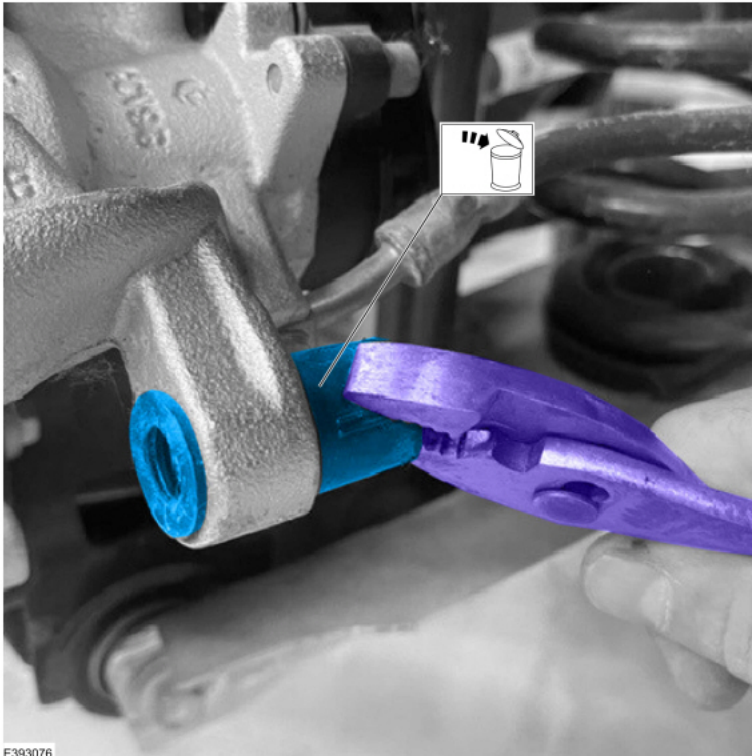
7. Using 6 in. slip joint pliers, remove and discard the standard bushing located on the opposite side of the bleeder. (Figure 7)  
Figure 7

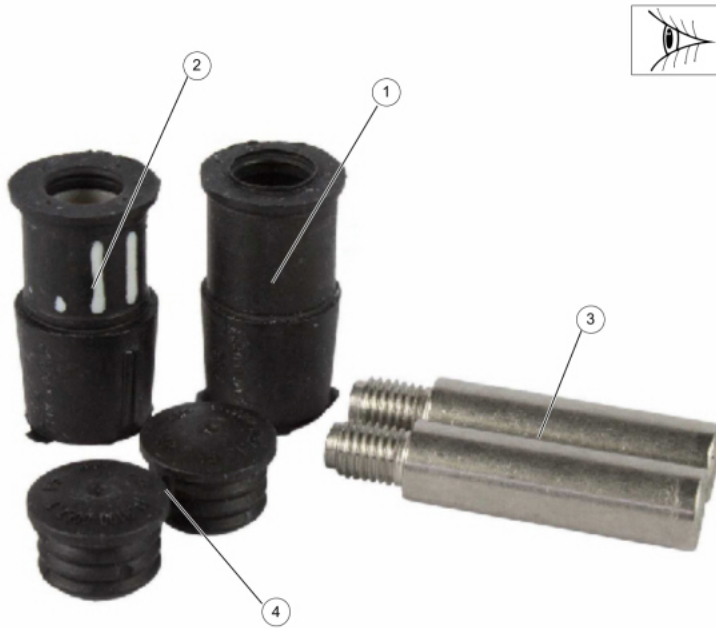
Figure 8 - Rear reinforced bushing kit contents

Item	Description
1	Standard bushing (1 piece)
2	Reinforced bushing (1 piece)
3	Guide pins (2 pieces)
4	Guide pin caps (2 pieces)

8. Install a new reinforced caliper bushing.

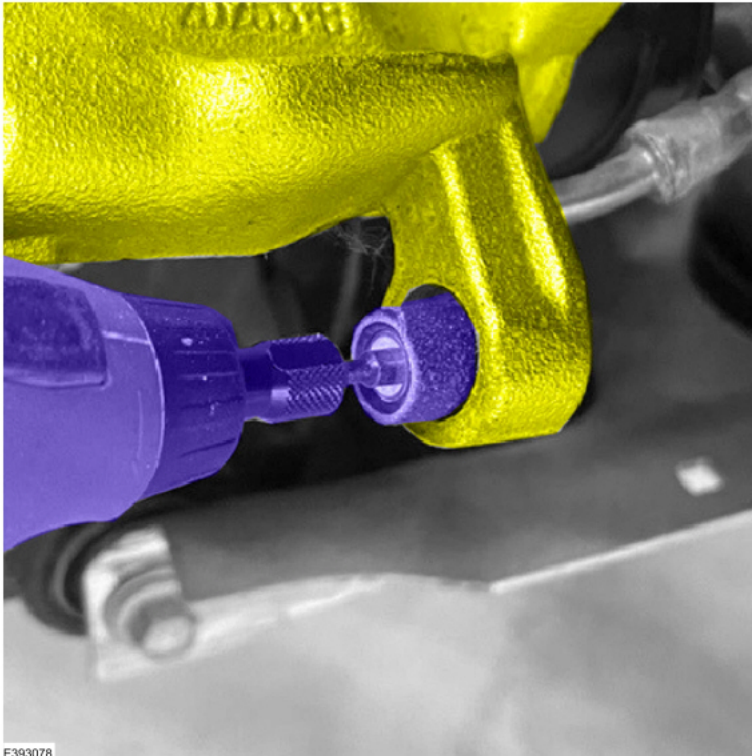
Figure 9

(1). Use a 1/2 in. drum sander bit to clean the caliper bushing housing. (Figure 9)

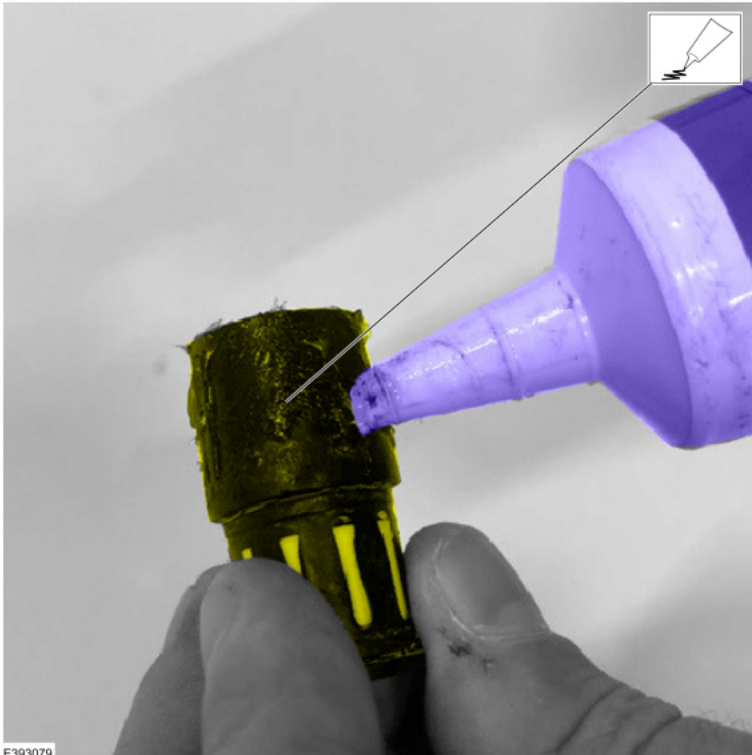
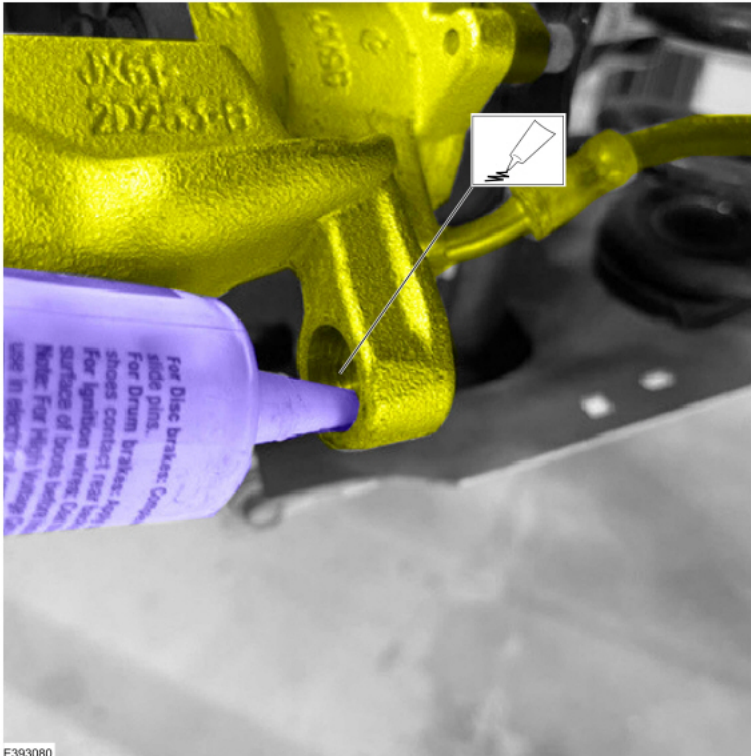
(3). Lubricate the bushing and bushing housing with Motorcraft® Silicone Brake Caliper Grease and Dielectric Compound. (Figures 10-11)

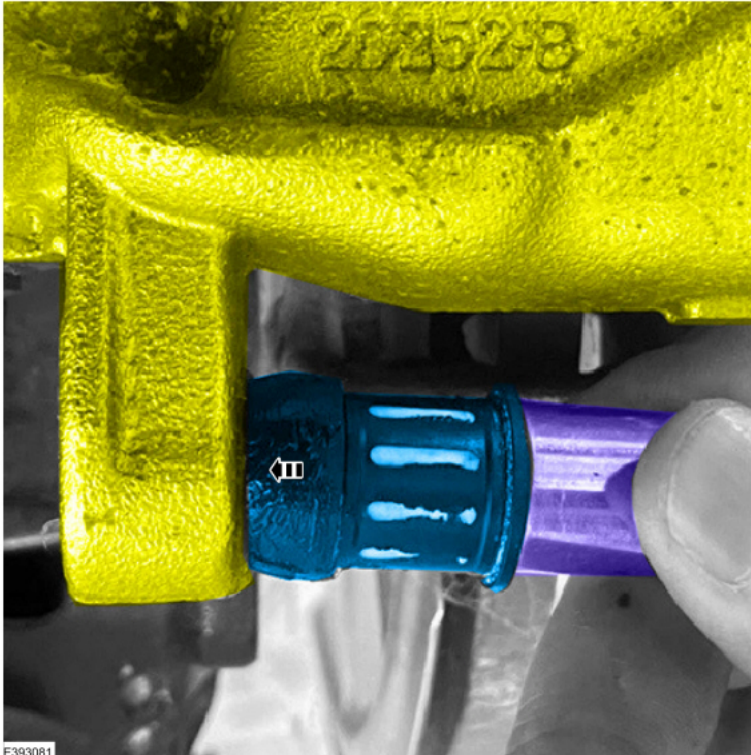
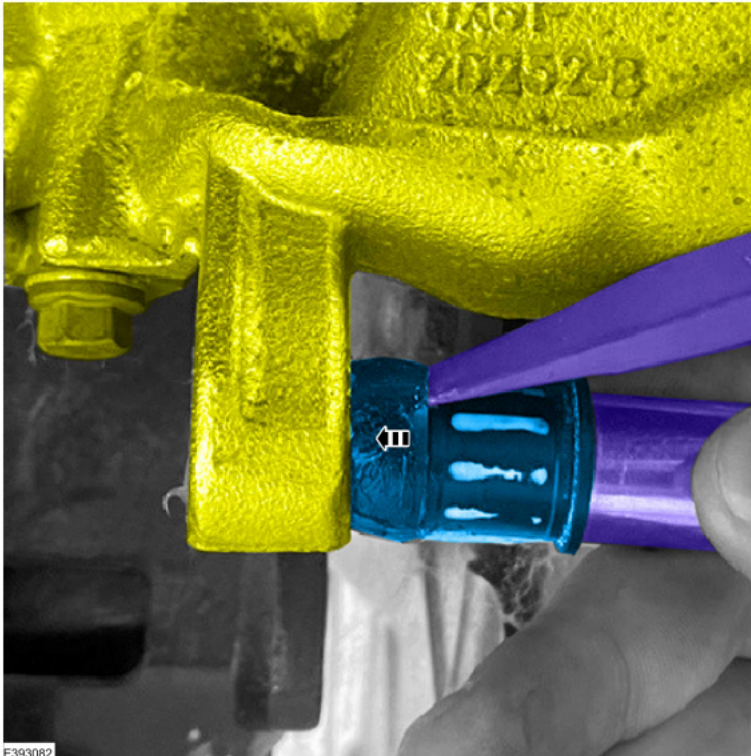
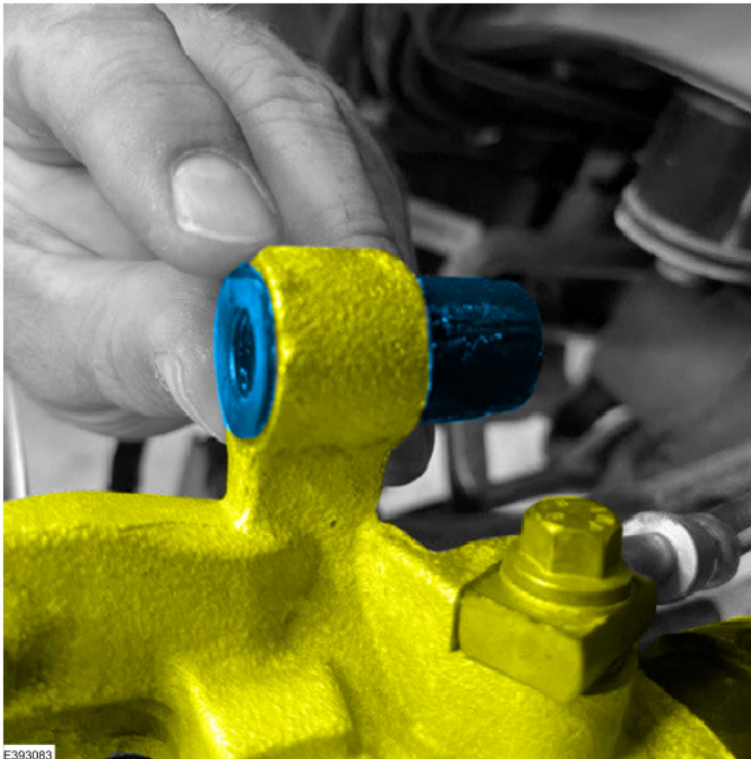
- (4). Use an appropriate diameter socket, such as a 13 mm 3/8 drive chrome deep socket, to push the bushing into the caliper bushing housing. (Figures 12-14)
- Use a plastic trim tool to help guide the bushing into the housing.

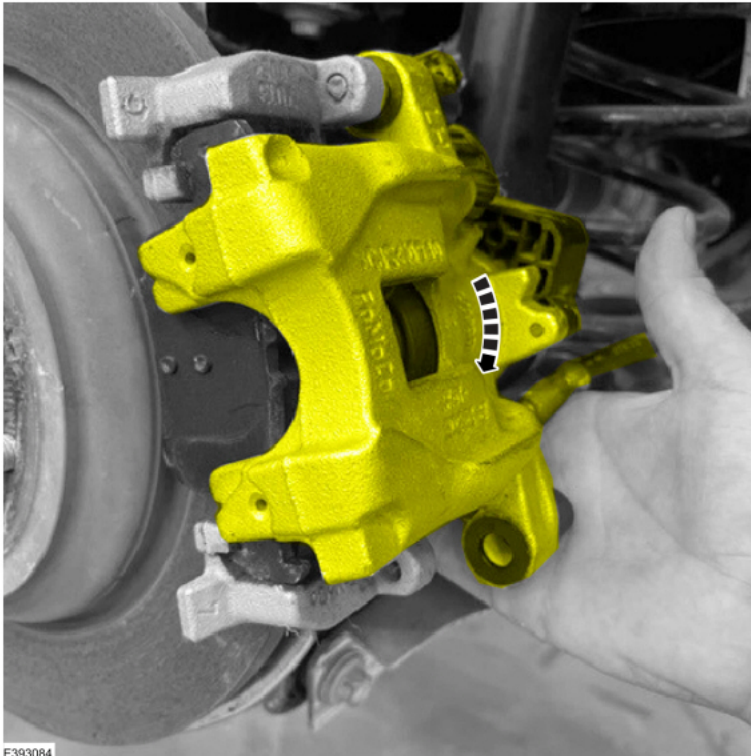
Figure 15

9. Rotate the rear caliper downwards. (Figure 15)
